## Serious Incident - Final Report -

AAIS Case No. AIFN/0007/2011

## Failure of Undercarriage AFT Crosstube

Type: Bell 412EP

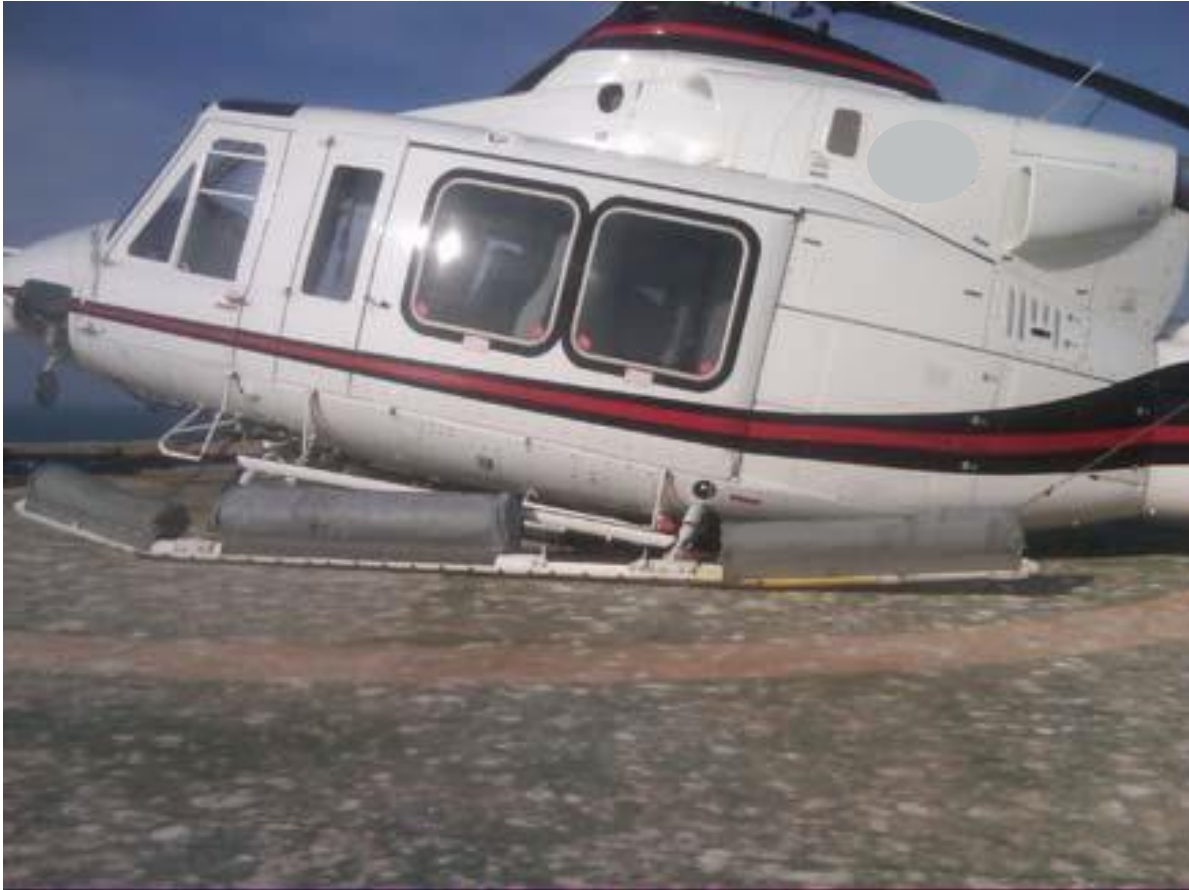
**Photo 1.** A6-FLV following aft crosstube failure

Damage to the aircraft consisted of the failed undercarriage aft crosstube, part number D412-664-203, and resulting damaged fuselage skin panels in the area of the aft crosstube tunnel, near the grounding receptacle, on both sides of the fuselage.

The fracture of the aft crosstube occurred on the starboard side, close to the crosstube pivot point. The crosstube tunnel skin was damaged and the emergency life raft inflation cylinder attachment brackets sustained damage. The rocking beam pivot assembly was detached.

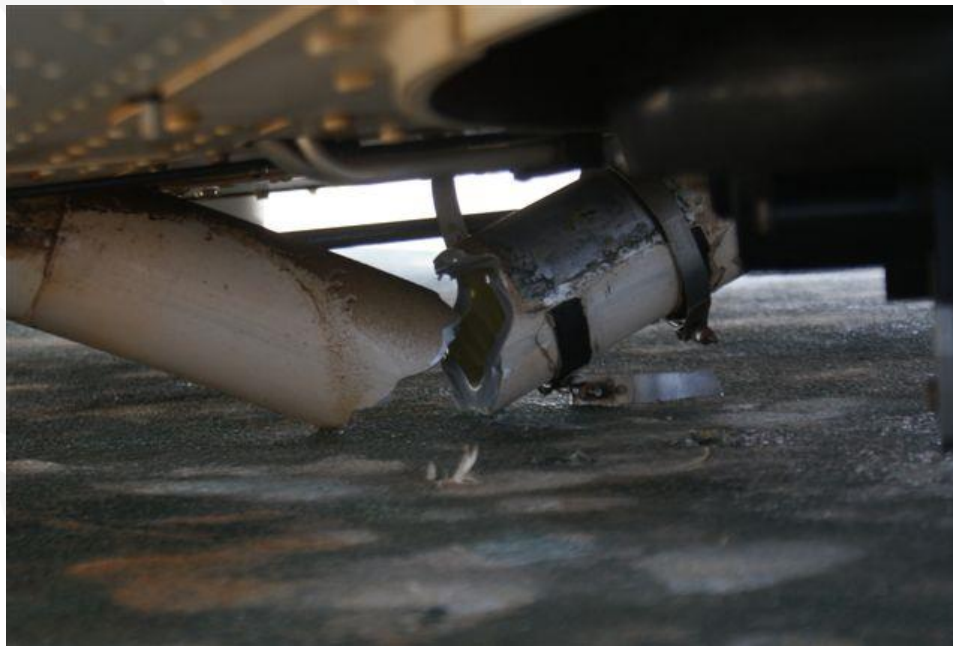
**Photo 2. Failed Undercarriage Aft Crosstube A6-FLV (looking aft)**

On inspecting the aircraft, the crew noticed that the undercarriage aft crosstube (supporting the undercarriage skids in the aft) had failed approximately at the mid-point and that both sections of the failed crosstube had pivoted around the rubber absorber mounts. The crosstube failure allowed the aircraft aft fuselage to settle almost onto the surface of the helideck.

After I had another look from the front of the aircraft, it was then clear to see the very center or apex of the crosstube had failed with both halves of the crosstube pivoting around the rubber absorber mounts and the bend radius of each half crosstube inflicting panel damage on the fuselage in the crosstube tunnel area near the grounding receptacle on both sides of the aircraft.

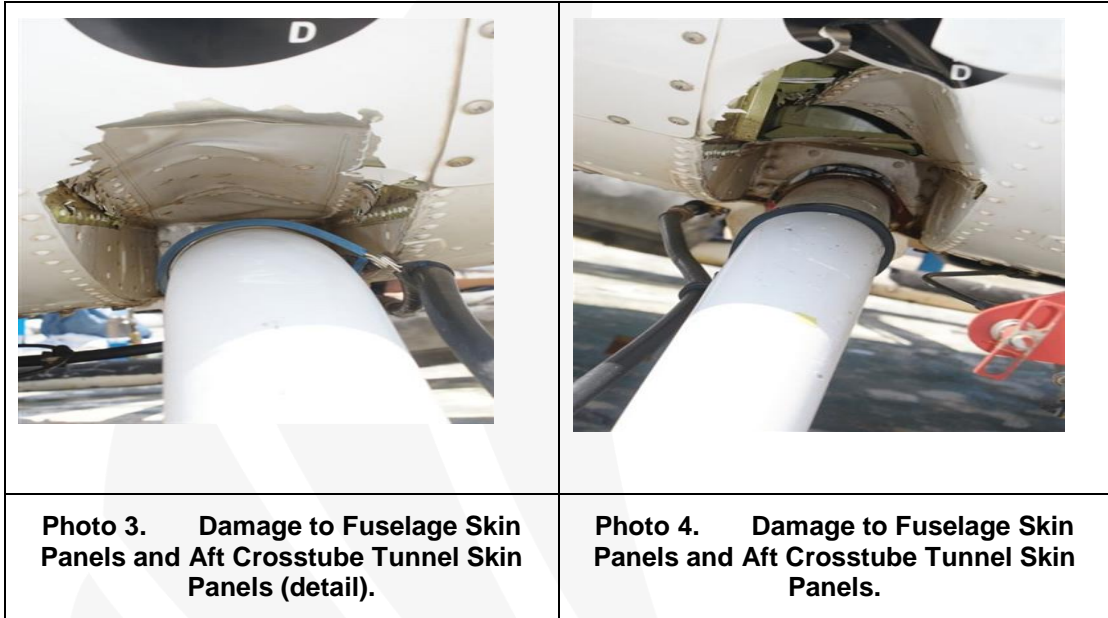
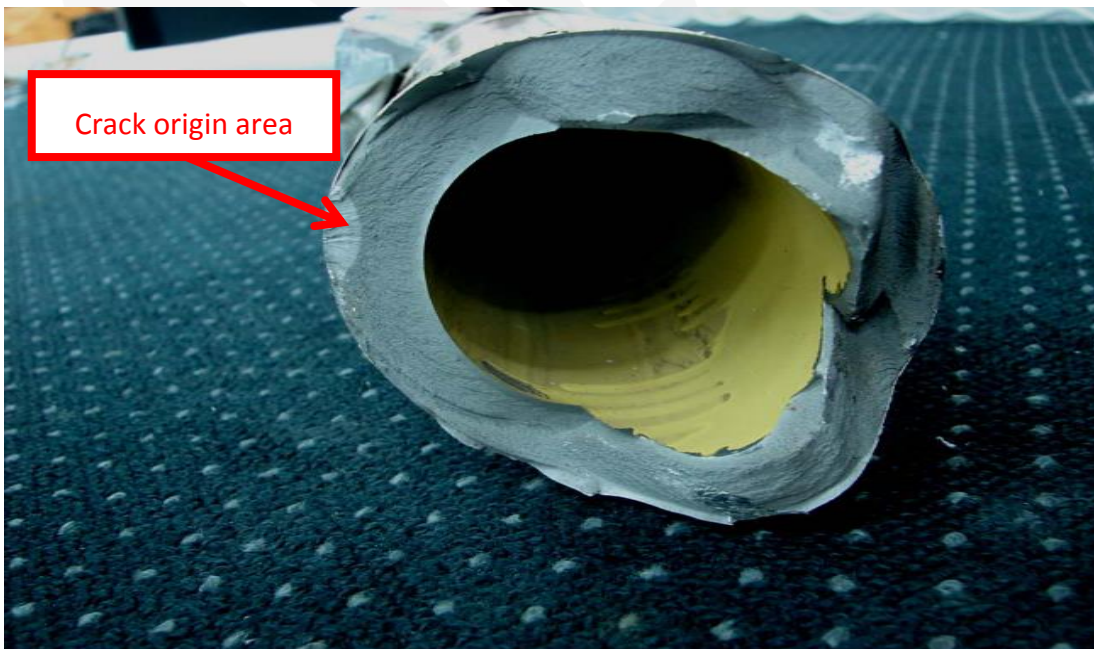
**Photo 5. Fracture surface exhibited beach marks / striations originating from the surface of the inner radius of the bend.**

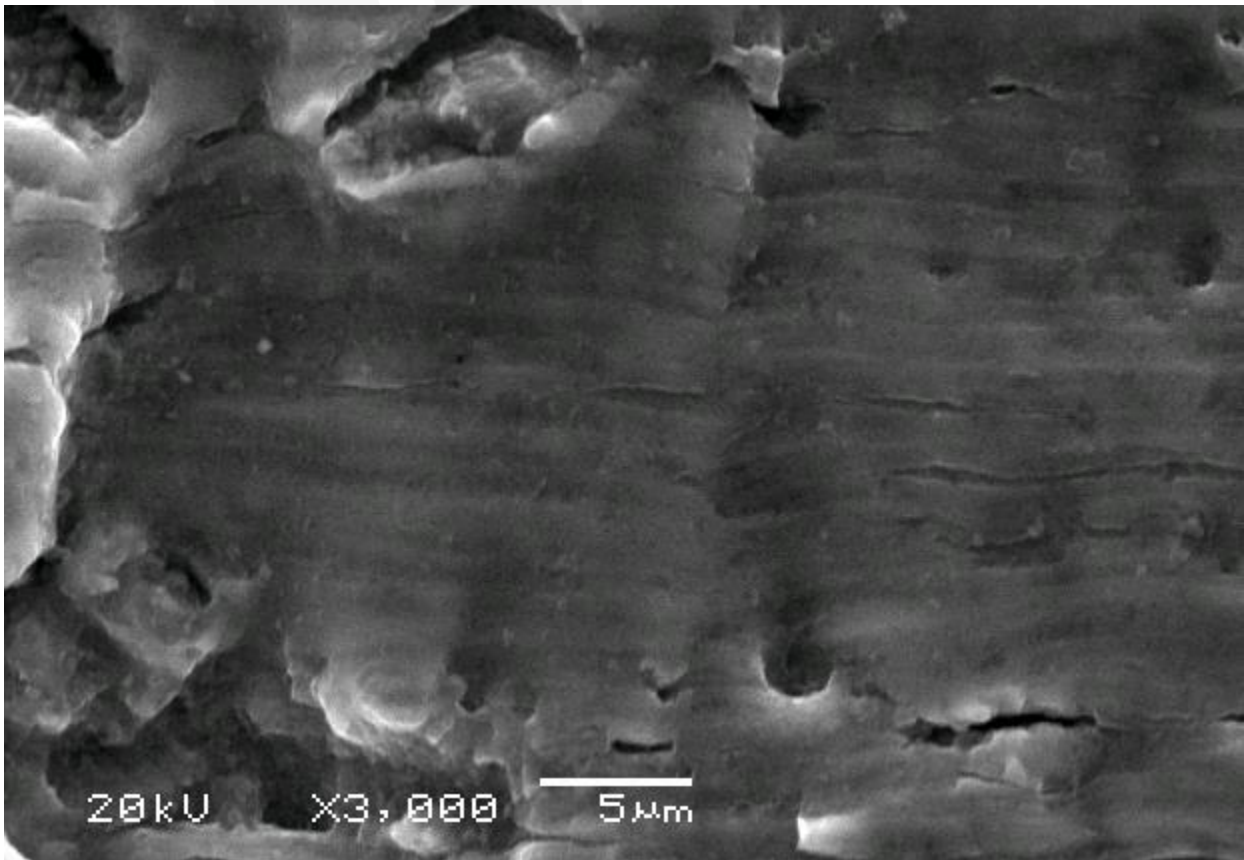
**Image 1 Showing fatigue striations (parallel features) at the middle of the fatigue fracture zone.**

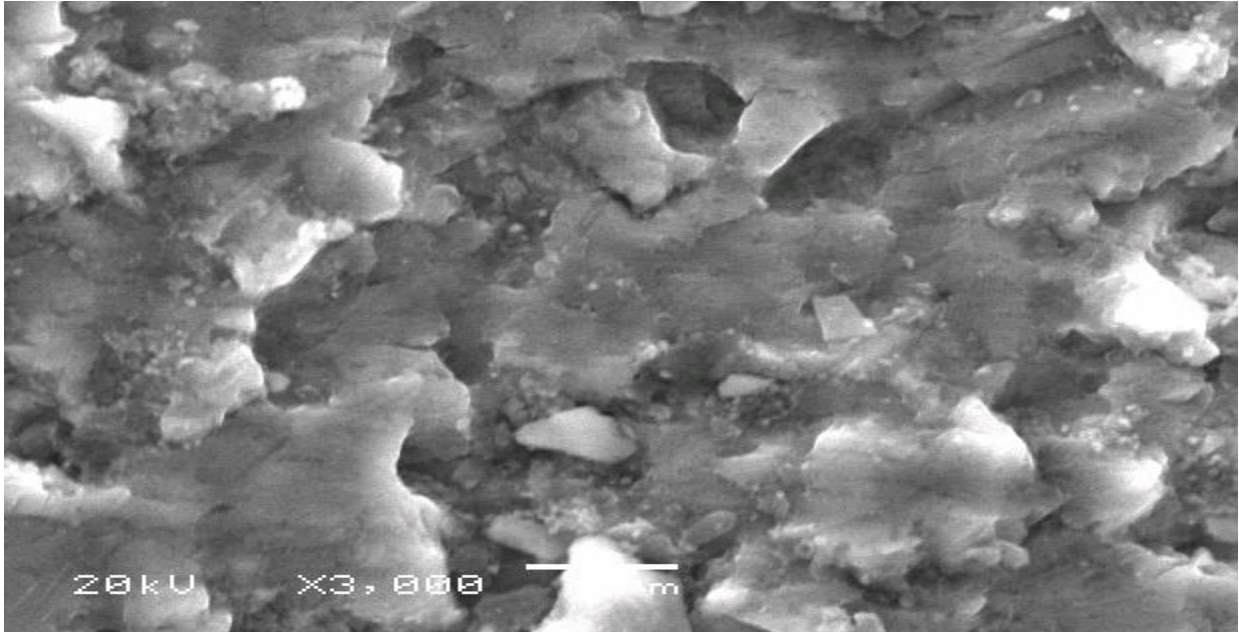
<sup>7</sup> No well-defined striations observed due to oxidation damage. Striation spacing assumed the same as for Field 2.

**Image 2 Showing faint fatigue striations (parallel features) of a field near the crack origin.**

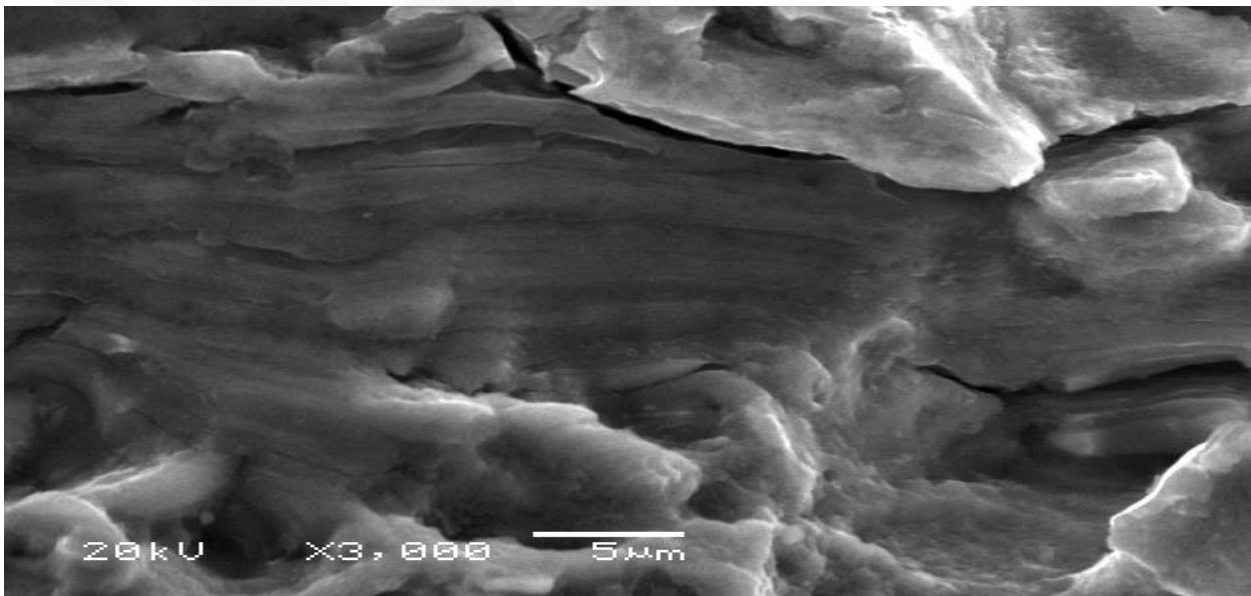
**Image 3 Showing fatigue striations (parallel features) adjacent to the final fracture zone.**

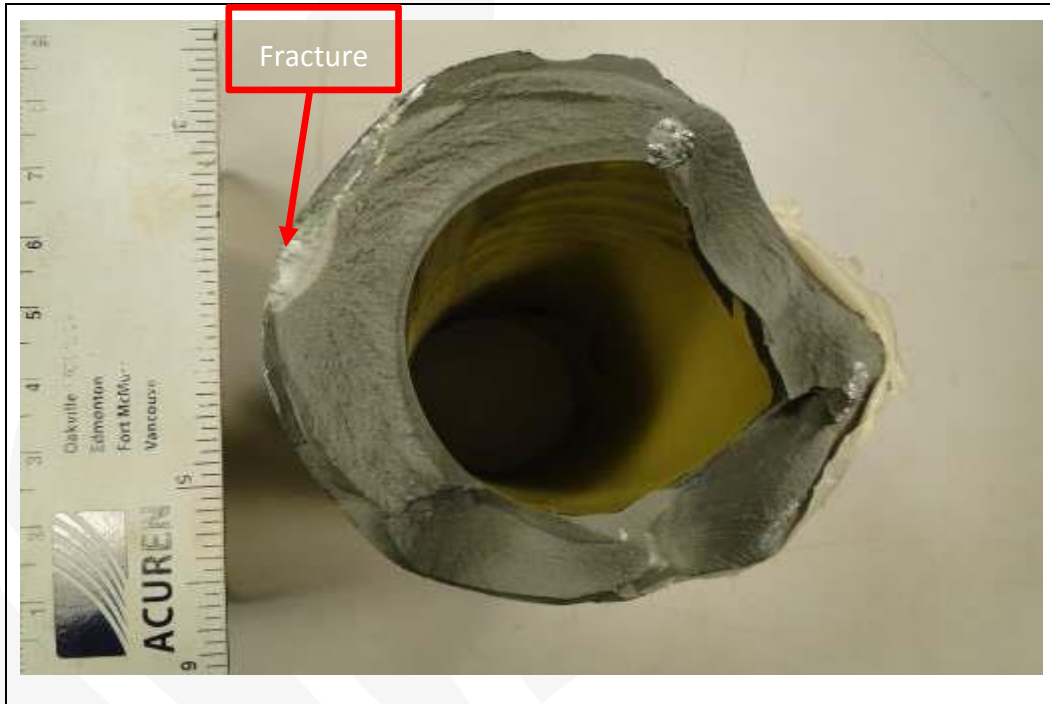
Photo 6. Fractured surface

The laboratory after performing a visual examination and measuring the section of the crosstube received, which was found to be approximately 90.4 mm (~3.56 inches) in diameter, 164 mm (~6.46 inch) in length (the longest portion) and had 16.4 mm (~0.65 inch) wall thickness. In addition it was mentioned that the observed beach marks suggested a fatigue crack initiation, which had colour differentiation with bright grey signifying the cracked benchmarks and the dull grey signifying the remaining area (see photo 5 and 6).

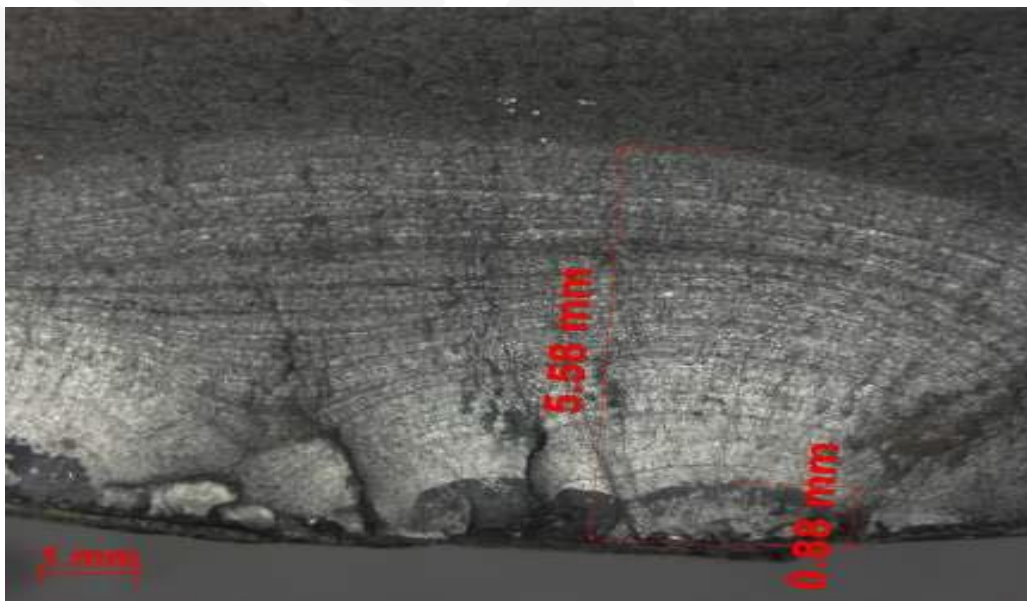
Figure 2 Fatigue Cracked Area

The laboratory indicated that the figure 2 “*shows the thumbnail area removed from the mating fracture surface. All the measurements were made on this sample. The thumbnail region was photographed under the stereo microscope and measurements were made on the picture. Image analysis measurements were verified prior making the measurements*”.

The report indicates that the “*acceleration voltage was 20 kV (10 kV and below the image did not appear good).*” The path measured in Figure 2 was divided into five approximately equal distances and pictures were taken after the initial 0.88 mm from the initiation point.

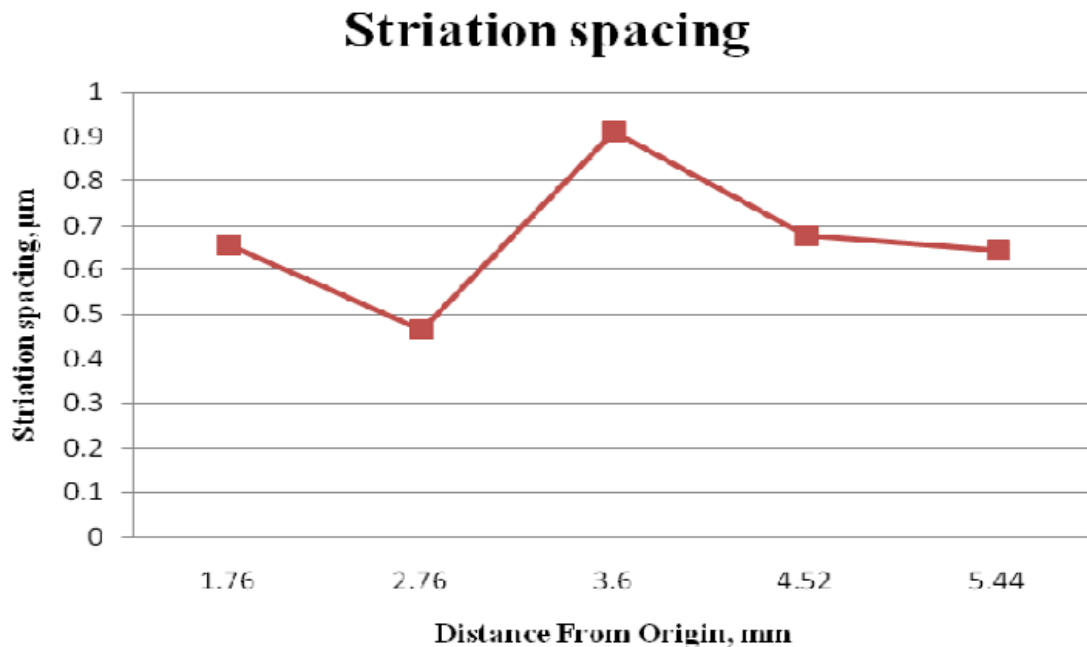
**Figure 3** Variation in Striation spacing.

The striations observed were counted at a measured distance and tabled. The following table shows the distance from the crack origin to the area where striations counted and the average striation spacing in that area (see table 7). In addition the laboratory showed the striation spacing at each distance (see figure3) and calculated the total number of *striations over the 5.58 mm length counted to be approximately 8,314.*

All failures appear to be low cycle fatigue failures. This particular part is designed to yield in service to prevent higher loads from being transferred into the airframe and consequently operates under extremely high stress. Repeated landings at high weight and on slippery surfaces contributes to high stress in this part.

SB 11-2 was issued by the landing gear manufacturer on the 25<sup>th</sup> April 2011 informing the operators that : *“Due to unexpected failures of 0412-664-203 high gear aft crosstubes at a low number of landing cycles, a life limit of 10000 landings has been established for all 0412-664-203 high gear aft crosstubes. Crosstubes that already exceed the life limit must be replaced immediately”*.

In addition if all landing gears accumulated more than 7500 landing should be removed stripped of paint, and LPI inspected. In case crosstube found not be cracked it could have be refinished and re-installed.
