AIRCRAFT ACCIDENT REPORT AND EXECUTIVE SUMMARY

Reference:	CA18/3/2/0836	
Aircraft Registration	ZS-SPZ	Date of Incident	16 March 2011		Time of Incident	1213Z
Type of Aircraft	Piper PA-34-200 Seneca		Type of Operation		Private	
Pilot-in-command Licence Type		Private	Age	26	Licence Valid	Yes
Pilot-in-command Flying Experience		Total Flying Hours	262,5		Hours on Type	31,6
Last point of departure		Port Alfred Aerodrome (FAPA)				
Next point of intended landing		Port Alfred Aerodrome (FAPA)				
Location of the incident site with reference to easily defined geographical points (GPS readings if possible)						
Port Alfred Aerodrome on runway 10R						
Meteorological Information						
Number of people on board	1 + 1	No. of people injured	0	No. of people killed	0	
Synopsis						
<p>The instructor and student were conducting a commercial test flight at Port Alfred aerodrome. On approach for landing, the nose gear failed to extend. After several unsuccessful attempts to get the wheel down, it was decided to retract the main gear and land without wheels to minimise damage.</p> <p>The propellers were feathered as the aircraft crossed the threshold of runway 10R and the touchdown was smooth and

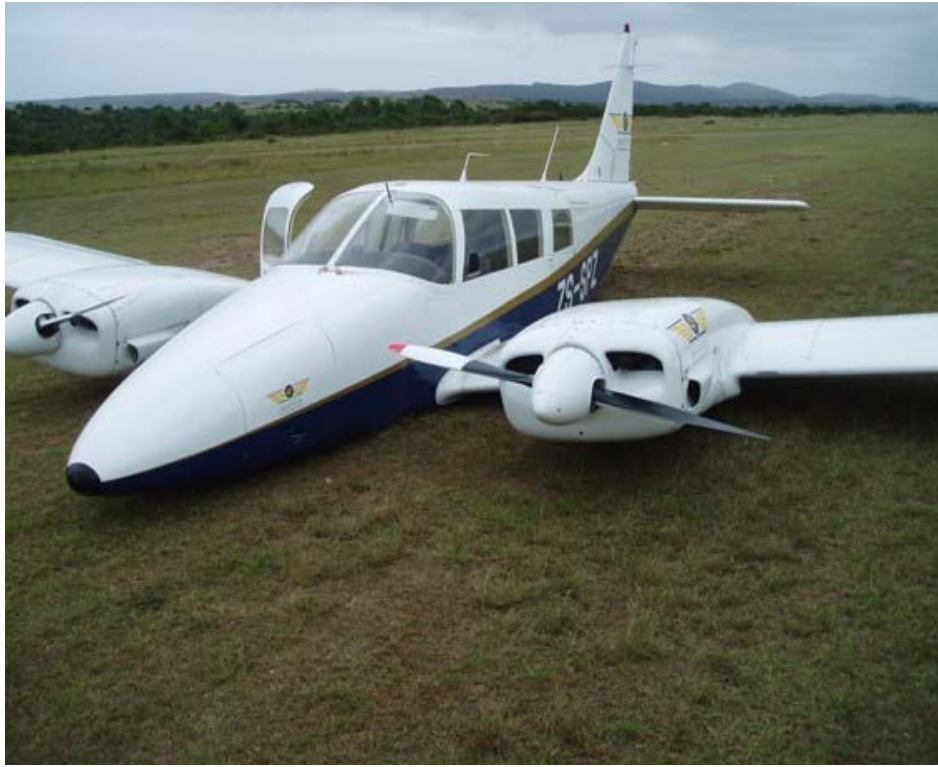
1.3.1 The lower surfaces of the aircraft were substantially damaged.

Figure 1. The aircraft after the wheels-up landing.

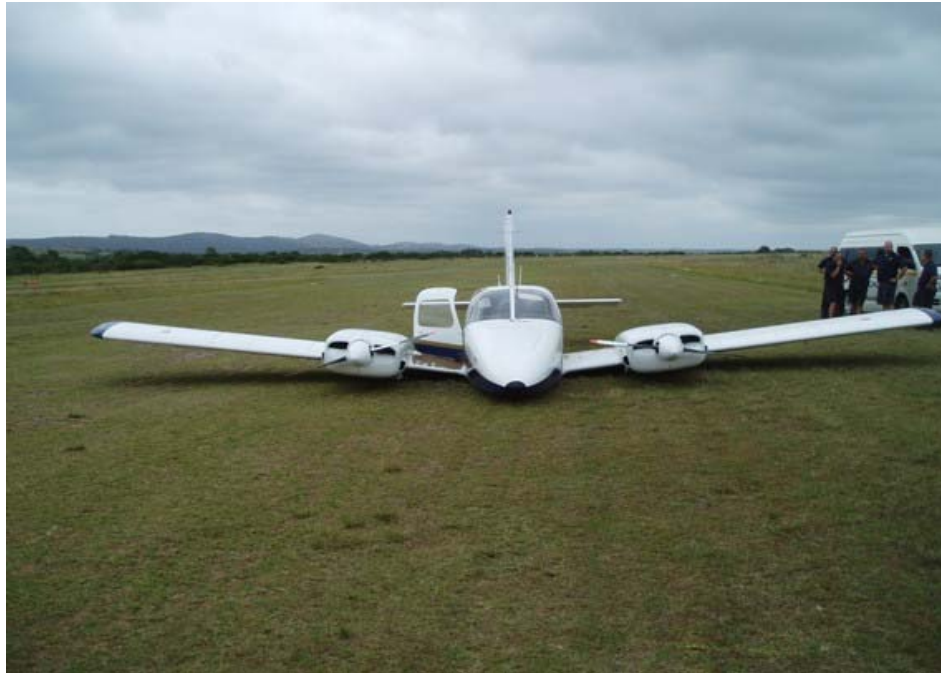
1.1.5 After several unsuccessful attempts to lower the nose gear, the main undercarriage was retracted. The propellers were then feathered and a smooth wheels-up landing performed. Neither propeller made contact with the ground. The aircraft slid to a halt a short distance from the first touchdown and sustained damage to its bottom surfaces.

Figure 2. Front view of the aircraft after the wheels-up landing.

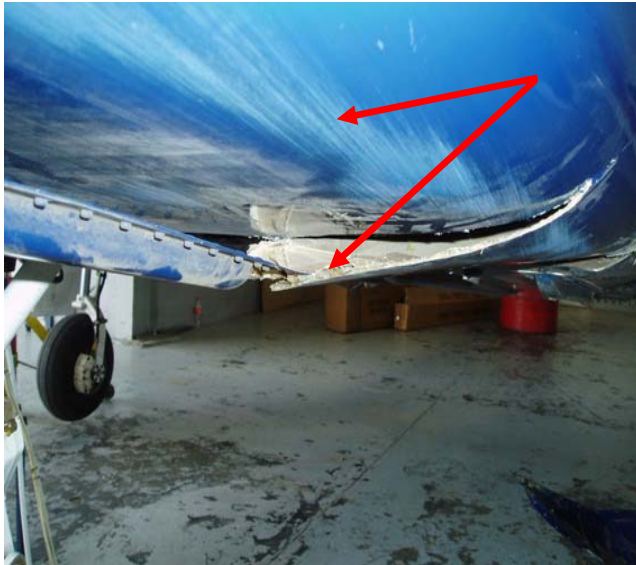
(AMO), who was also the operator of the aircraft, to establish the cause of the nose wheel extension failure. The AMO was unable to replicate the failure on ZS-SPZ when the aircraft was on jacks in the hangar. On disassembling the nose wheel, the engineers uncovered previous damage and repair work on the nose wheel bay. The quality of the repair was poor, the work having been carried out without proper preparation of the fibreglass material.

Figure 3. Tear in the fibreglass and scuffing on the lower surfaces.

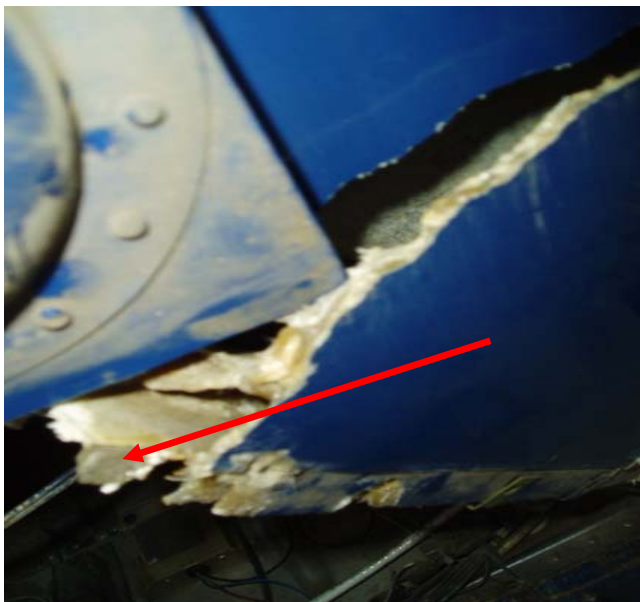
Figure 4. The discolouration indicates an earlier repair. A fibreglass spar which runs the length of this section of the nose cone is designed to provide some rigidity to the structure. This spar was fractured, enabling the entire nose to twist under the aerodynamic forces of the ram air entering the wheel bay when the doors were open. This twisting was sufficient to cause the side of the wheel bay to press against the undercarriage mechanism, thus preventing the nose wheel from extending.

2.3 On disassembling the nose wheel, AMO engineers uncovered previous damage and unsatisfactory repairs, the work having been carried out without proper preparation of the fibreglass material. As a result, the fibreglass had fractured, causing the side of the wheel bay to press against the undercarriage mechanism and prevent the nose wheel from extending.

- 3.2.1 The nose wheel failed to extend due to a fracture of the fibreglass material, which caused the side of the wheel bay to press against the undercarriage mechanism.
- 3.2.2 Contributory: Poor maintenance.

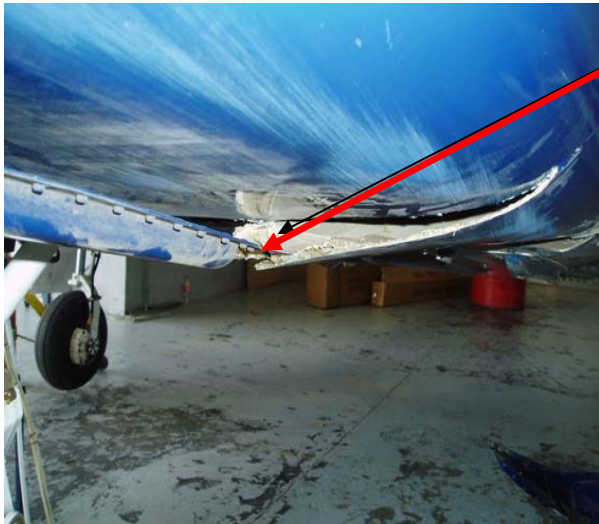
The AMO were unable to replicate the nose wheel extension failure on ZS-SPZ when the aircraft was on jacks in the hangar. This implied that either the damage caused had resulted in the obstruction being removed or that the cause was dynamic – that it had to do with the pressures of the airflow in flight that caused the snagging of the wheel in the wheel bay. On disassembling the nose of the aircraft, previous damage and repair were uncovered. The previous repair was not good, having been carried out without proper preparation of the fibreglass material.

The tear in the fibreglass indicated by the arrow shows discolouration when examined with the naked eye; it is indicative of an earlier repair.

The entire nose was replaced with a repairable item from the rebuild hangar and further tests were then conducted and the aircraft was certified serviceable.

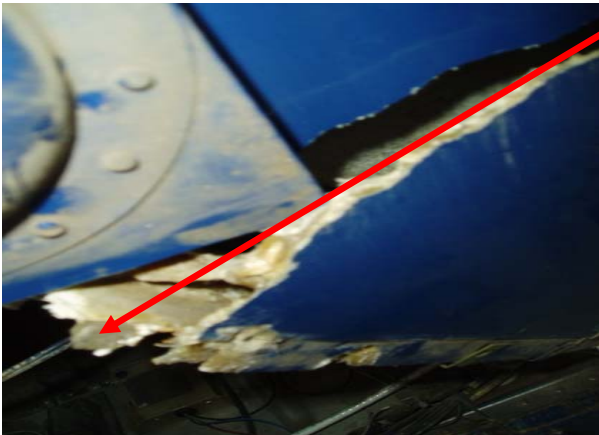
This discolouration is more visible in the second photograph. What is important is that there is a fibreglass spar which runs the length of this section of the nose cone which is supposed to provide some rigidity to the structure. This spar was also fractured; this enabled the entire nose to twist under the aerodynamic forces of the ram air entering the wheel bay when the doors are open. This twisting is sufficient to cause the side of the wheel bay to press against the undercarriage mechanism, thus preventing the wheel from extending.
