AIRCRAFT ACCIDENT REPORT AND EXECUTIVE SUMMARY

Reference:	CA18/2/3/8912	
Aircraft Registration	ZS-PSC	Date of Accident	27 March 2011		Time of Accident	1330Z
Type of Aircraft	Cessna 206		Type of Operation	Sport (Para drop)		
Pilot-in-command Licence Type	Commercial		Age	32	Licence Valid	Yes
Pilot-in-command Flying Experience	Total Flying Hours	447		Hours on Type	104	
Last point of departure	Delta 200 (FADX)					
Next point of intended landing	Delta 200 (FADX)					
Location of the accident site with reference to easily defined geographical points (GPS readings if possible)						
Fire Service Road outside Delta 200 Airfield FADX (GPS Position S33° 38 44 E018° 28 20)						
Meteorological Information	Surface wind: 225 $\%$ 10 kt, temperature: 28 $^{\circ}$ C, V isibility: CAVOK					
Number of people on board	1+0	No. of people injured	0	No. of people killed	0	
Synopsis	<p>On 27 March 2011, at approximately 1320Z, the pilot accompanied by a group of skydivers took off from runway 20 at Delta 200 on a paradrop flight with the intention of landing back at Delta 200 after dropping the skydivers. The pilot stated that after dropping the last group of skydivers at about 11000 feet, he was cle

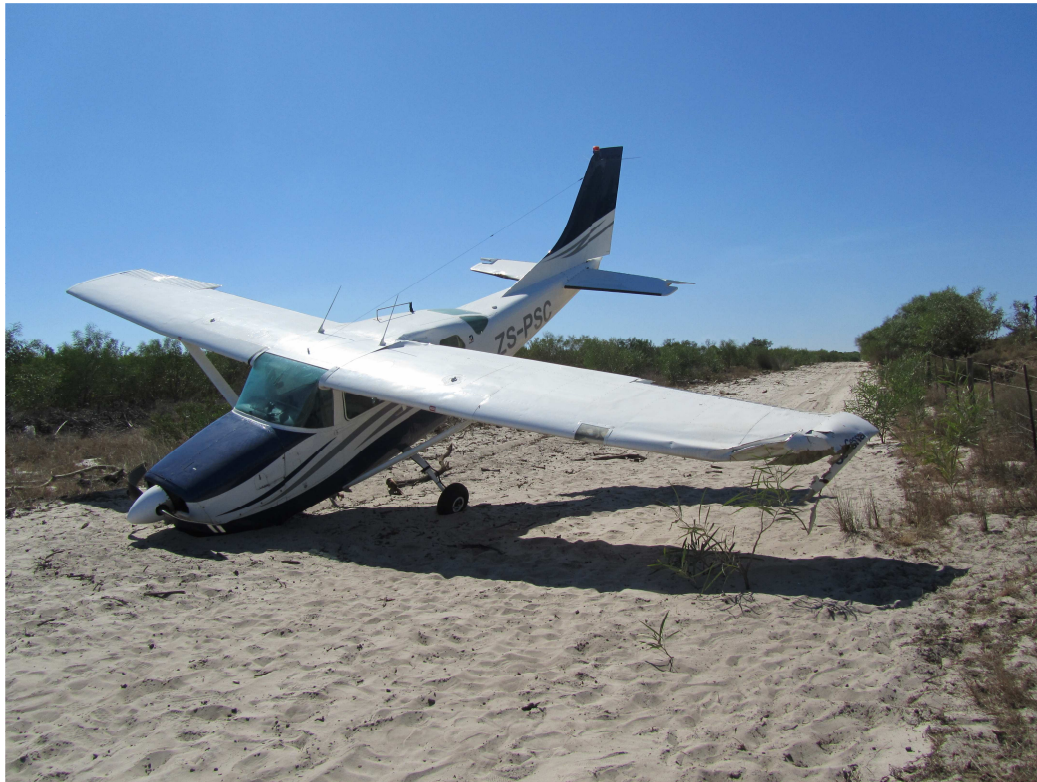
- 1.1.4 The pilot then executed a forced landing on a fire service road just outside the Delta 200 airfield. During the landing sequence the left wingtip struck the ground as the nose landing gear dug into the soft sand, resulting in substantial damage to the aircraft's left wingtip and the nose landing gear.

1.3.1 The aircraft sustained substantial damage to the nose gear, the left wing tip, the propeller as well as the bottom side of the engine cowling.

FIGURE 1 Damage to the wing tip and propeller
