AIRCRAFT ACCIDENT REPORT AND EXECUTIVE SUMMARY

Reference:	CA18/2/3/8919	
Aircraft Registration	ZS-CVA	Date of Accident	06 April 2011		Time of Accident	10:15Z
Type of Aircraft	Cessna 206 Stationair		Type of Operation	Skydive		
Pilot-in-command Licence Type	Commercial Pilot		Age	32	Licence Valid	YES
Pilot-in-command Flying Experience	Total Flying Hours		454		Hours on Type	110
Last point of departure	FADX: Delta 200, Western Cape Province					
Next point of intended landing	FADX: Delta 200, Western Cape Province					
Location of the incident site with reference to easily defined geographical points (GPS readings if possible)						
FL110 above Delta 200 (FADX) in the Western Cape Province						
Meteorological Information	Wind direction: 180°, Wind speed:10 knots, visibili ty: CAVOK					
Number of people on board	1+6 (At takeoff)	No. of people injured	1	No. of people killed	0	
Synopsis	<p>On 6 April 2011, the pilot accompanied by six parachutists departed on a skydive flight from Delta 200 (FADX) runway 20 in the Western Cape.</p> <p>The aircraft climbed to FL090 where four parachutists exited the aircraft uneventfully. The aircraft then continued its climb to FL110 so the remaining tw

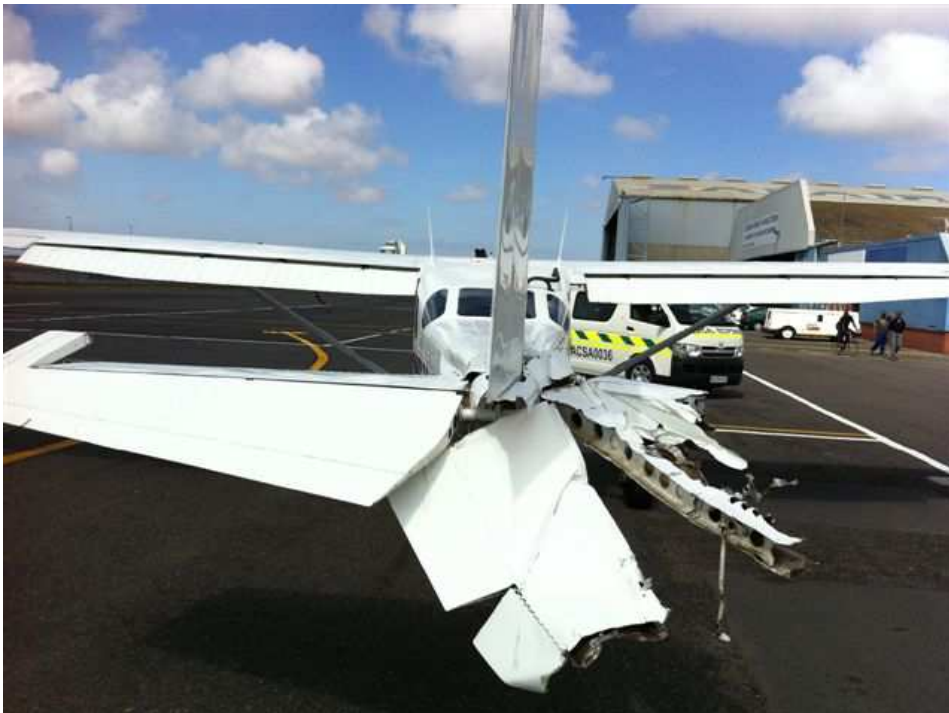
- 1.1.3 The fifth parachutist's reserve parachute deployed and resulted in the parachutist's early departure from the aircraft. The pilot looked back and noticed that the parachutist was no longer in the aircraft and the aircraft's right horizontal stabilizer and elevator were severely damaged. The last parachutist decided to remain in the aircraft.

1.3.1 The damage the aircraft sustained to the elevator and horizontal stabilizer whilst in flight was due to the parachutist. During the landing, the nose wheel and propeller were also damaged.

Figure 1: Shows the right hand vertical stabiliser severely damaged.

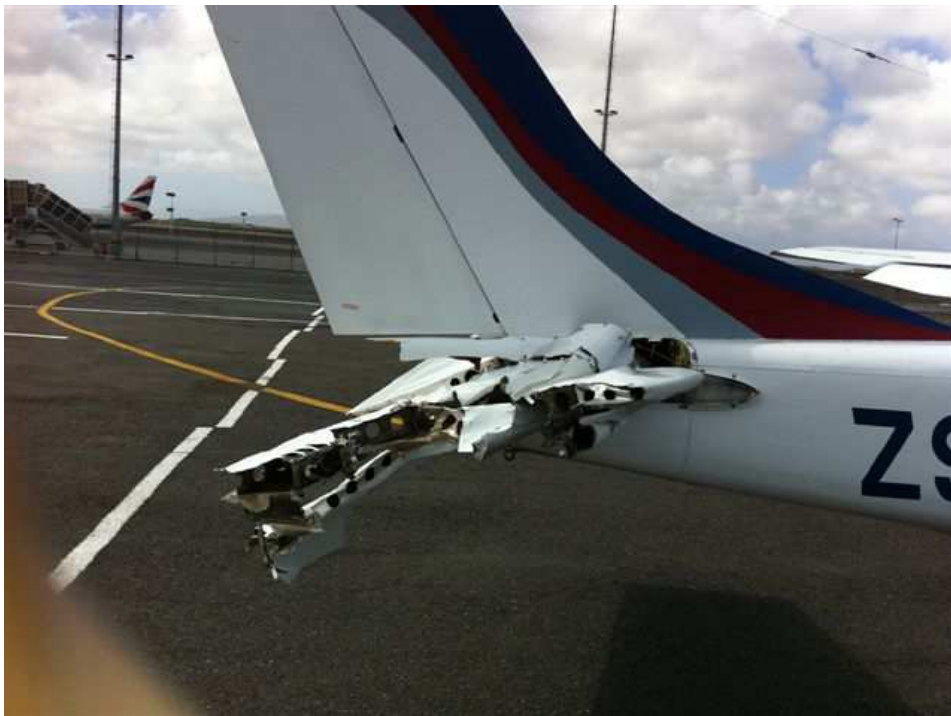
Figure 2: Side view of damaged elevator

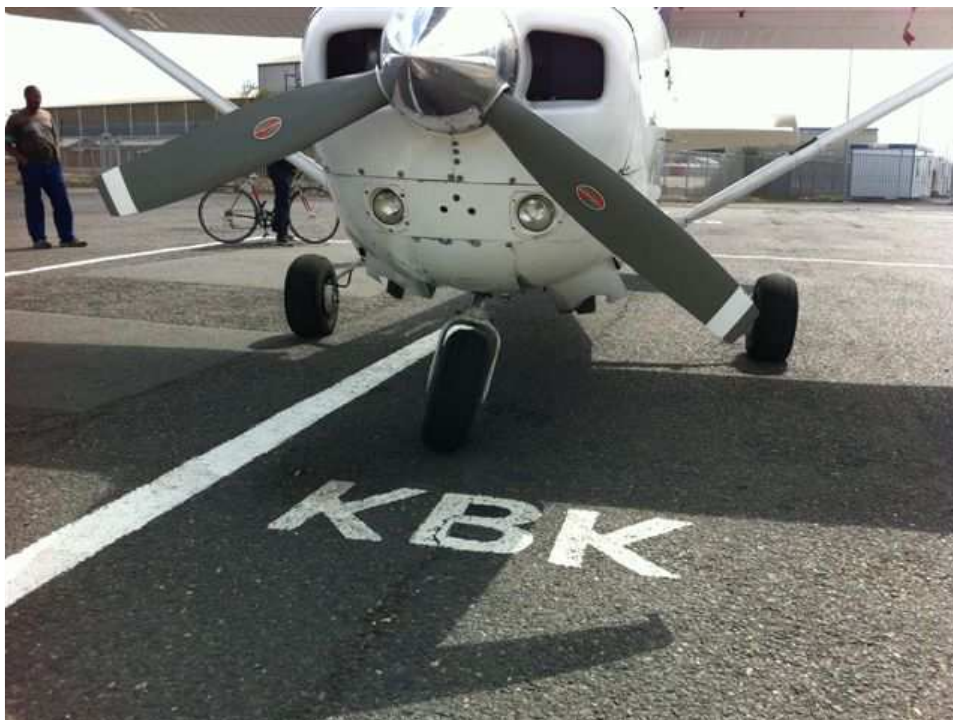
1.12.1 During the emergency landing, the aircraft bounced and landed on the nose landing gear causing damage to the nose gear and propeller.

Figure 3: Damaged nose gear and propeller

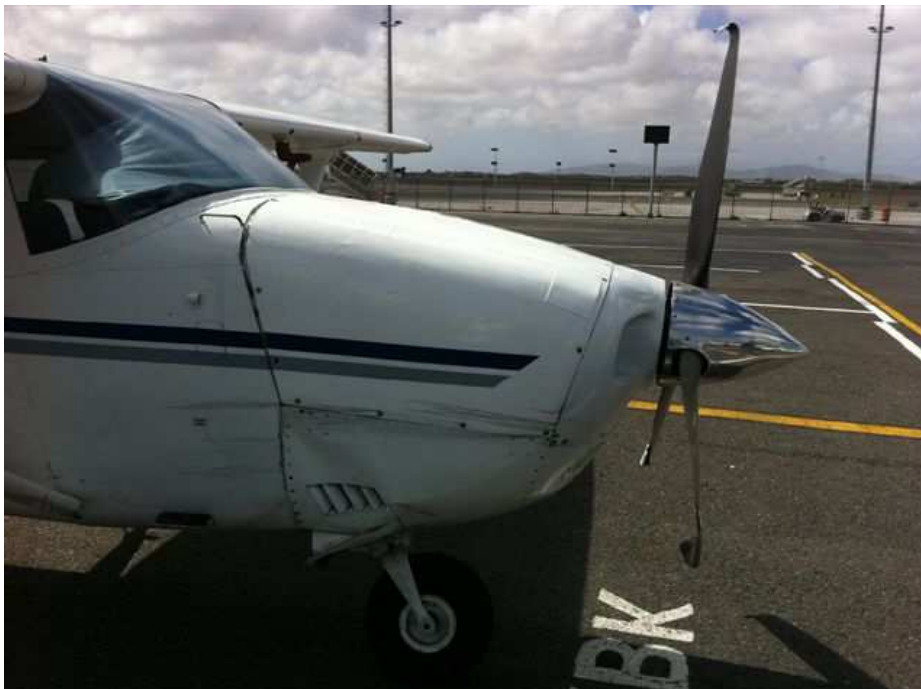
- 1.1.4 The pilot stated that because the left elevator was stuck, he declared an emergency with FACT. During the emergency landing the aircraft bounced and the propeller made contact with the runway surface. The propeller and nose wheel were damaged.

Figure 4: Side view of damaged propeller
