AIRCRAFT ACCIDENT REPORT AND EXECUTIVE SUMMARY

Reference:	CA18/2/3/8921	
Aircraft Registration	ZU-TAZ	Date of Accident	10 April 2011		Time of Accident	1335Z
Type of Aircraft	Quick-R		Type of Operation	Private		
Pilot-in-command Licence Type		Microlight	Age	50	Licence Valid	No
Pilot-in-command Flying Experience		Total Flying Hours	152.20		Hours on Type	26.80
Last point of departure		Rietfontein Private Airstrip				
Next point of intended landing		Rietfontein Private Airstrip				
Location of the accident site with reference to easily defined geographical points (GPS readings if possible)						
Rietfontein Private Airstrip						
Meteorological Information		Surface wind: calm. Temperature: 23°C. Cloud base: Nil				
Number of people on board	1 + 1	No. of people injured	1+1	No. of people killed	0	
Synopsis						
<p>On the 10 April 2011 the pilot accompanied by a passenger took off from Rietfontein airfield for a local private flight. During the take-off roll after lift off the left wing stalled and the pilot opted to land back on the runway, while on the ground the aircraft veered to the left and collided with the pole.</p> <p>The pilot and the passenger sustained minor injuries.</p> <p

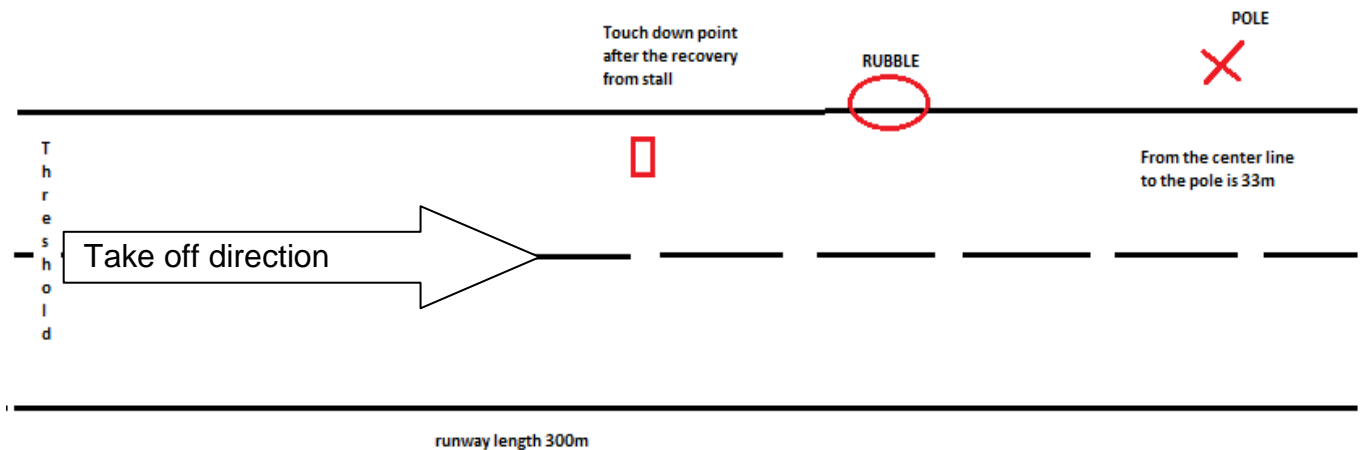
1.12.1 The aircraft took off from the private airstrip at Rietfontein. During the initial stages of take-off roll at a speed of 55mph to 60mph the pilot reported that the aircraft rolled to the left and stalled. The pilot recovered and managed to land the aircraft. During landing the pilot lost control of the aircraft and the aircraft veered off to the left of the runway before it impacted with a pole which was 33 meters from the centreline of the runway.

Figure 1 shows the layout of the Runway

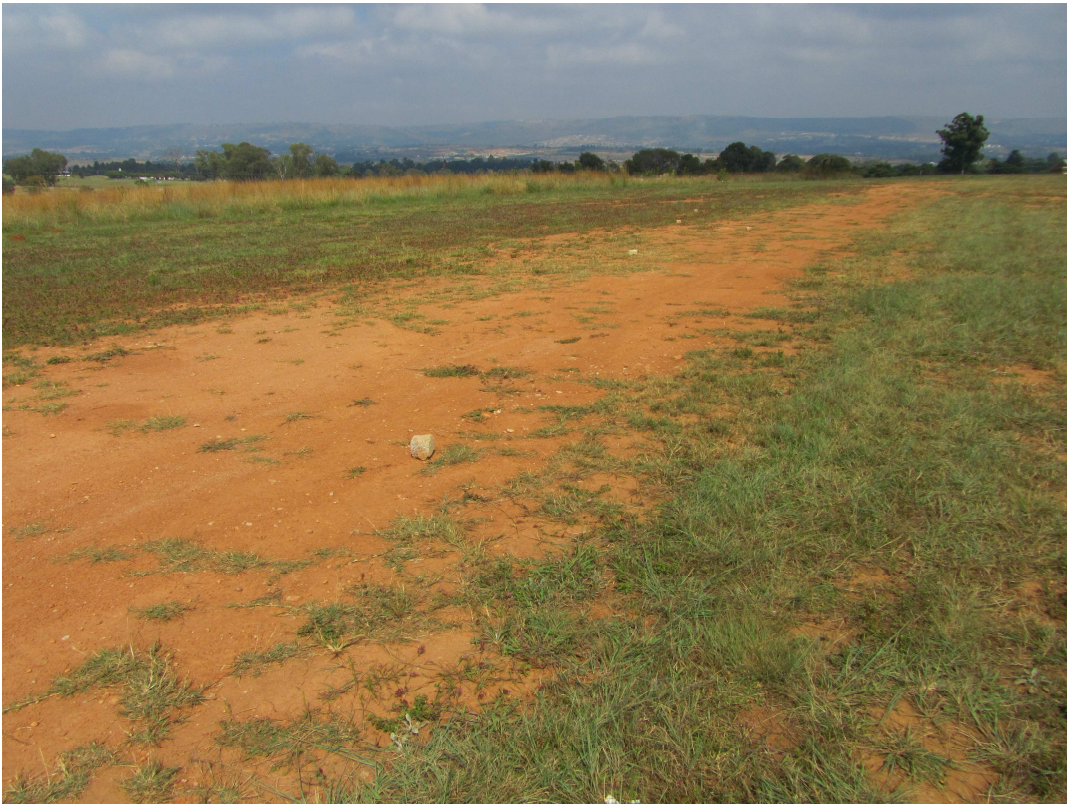
Figure 2: indicates the gravel runway
