AIRCRAFT ACCIDENT REPORT AND EXECUTIVE SUMMARY

Reference:	CA18/2/3/8923	
Aircraft Registration	ZS-PGT	Date of Accident	18 April 2011		Time of Accident	09:00Z
Type of Aircraft	Air Tractor 401		Type of Operation	Agriculture (Aerial Crop Spraying)		
Pilot-in-command Licence Type		Commercial	Age	33	Licence Valid	Yes
Pilot-in-command Flying Experience		Total Flying Hours	2458.0		Hours on Type	1841.0
Last point of departure		Monzi – FAMU (Mkuze)				
Next point of intended landing		Monzi – FAMU (Mkuze)				
Location of the accident site with reference to easily defined geographical points (GPS readings if possible)						
At a soccer field approximately 5 NM north of FAMU						
Meteorological Information		Wind: Light & Variable, Temperature: 22°C, Cloud cover: 6/8, Cloud base: 2500 ft, Dew point: 20°C, Visibility: Good.				
Number people on board	1 + 0	No. of people injured	0	No. of people killed	0	
Synopsis						
<p>The pilot flew the aircraft on an agriculture - crop spraying detail. The pilot completed five spray runs which were uneventful with the aircraft performance being satisfactorily. The pilot reported that during the sixth spray run, the aircraft suddenly developed a severe vibr

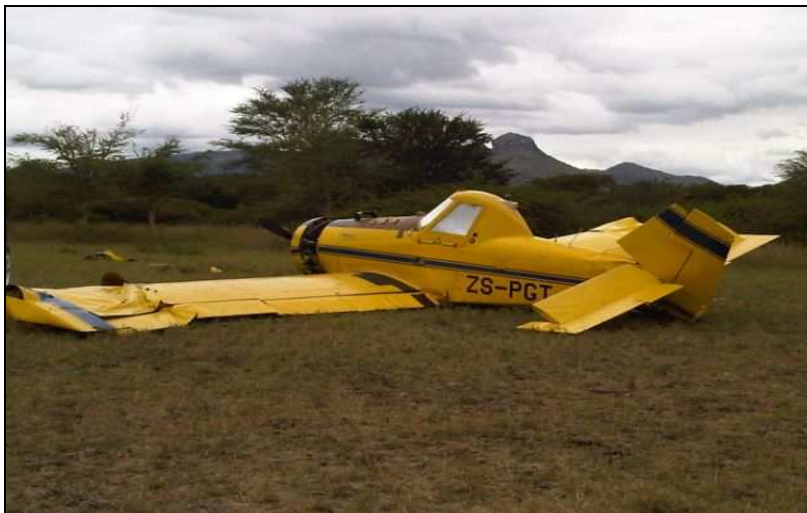
Figure 3, shows wreckage after the ground loop.

1.12.3 The aircraft had sustained substantial damage in the accident sequence. The damage caused was limited to the wings, undercarriage, tail section, propeller and engine.

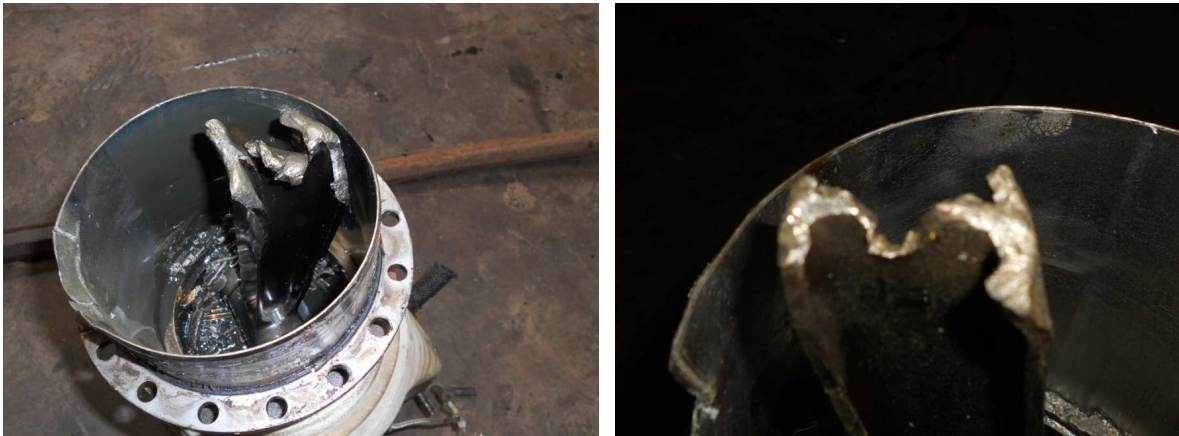
- 1.16.1.6 The history of the engine during the research is as follows: According to an Export Certificate of Airworthiness, the engine was a newly overhauled product during fitment on the aircraft. The overhaul was carried out when engine reached 10583.00 hours total time since new (TTSN). The engine was then fitted to the aircraft from 3836.16 total airframe hours from 8 May 2008. The engine operated for total of 493.08 hours after the overhaul until low compression defect.
- 1.16.1.7 Failed Engine Components and/or Parts: The engine was removed from the wreckage for examination to determine what may have caused the failure. The engine examination showed that a contained mechanical failure was sustained. The parts (#5 and #6 piston rods) failed.

Figure 2 : Evidence of the piston rods failure.

- 1.16.1.8 The identified part failed (#5 and #6 piston rods) which resulted in the engine not being able to produce the required power to maintain the intended altitude. Due to the part failure, the engine eventually stopped during the flight.

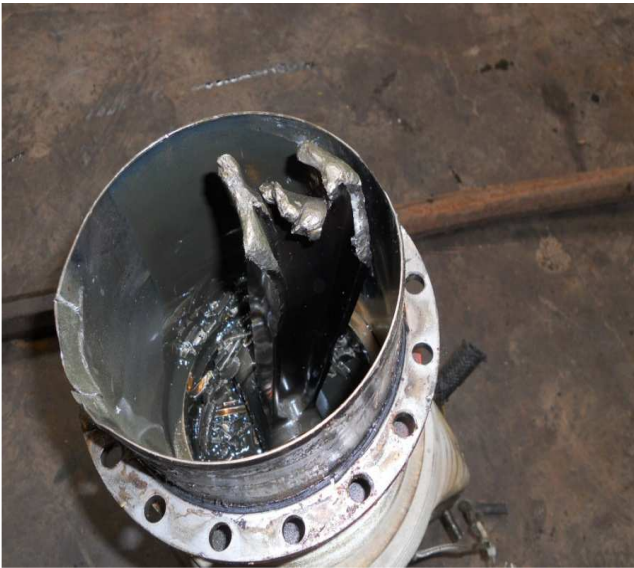
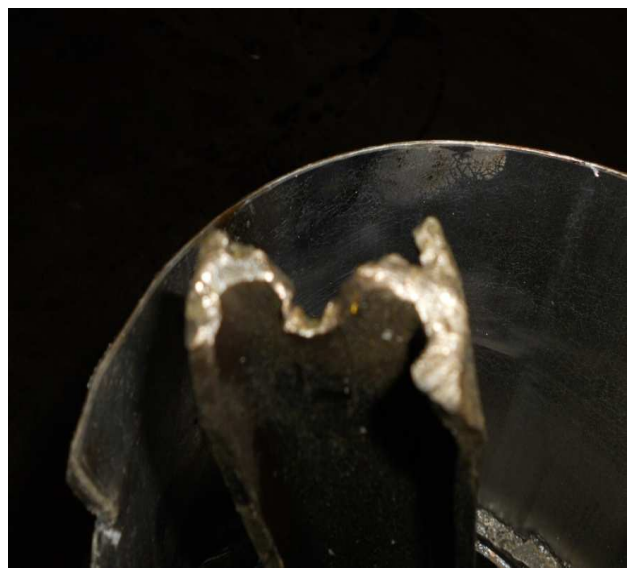
- (i) During the visual and teardown examination, the evidence found shows that both cylinders # 5 and # 6 pistons connecting rods (conrods) failed during operation. The piston conrods failed due to severe mechanical damage caused to the components and parts of the engine.

Figure 6 and 7, shows fractured master link rod on #5 & #6 cylinders.

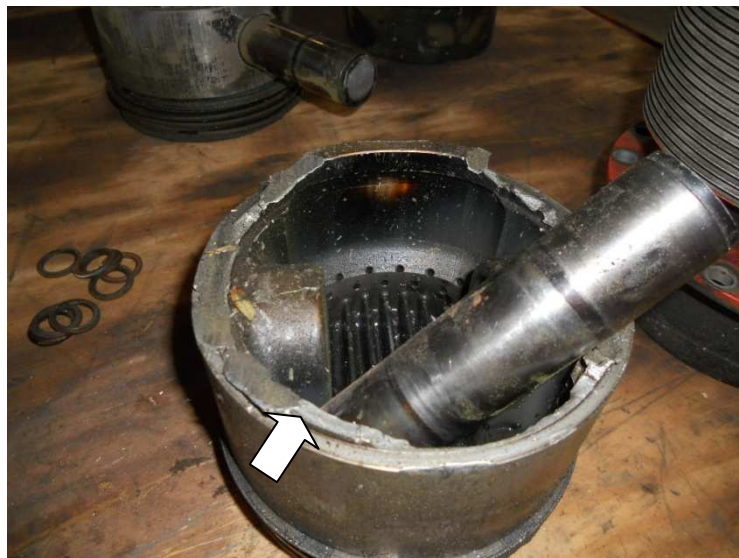
Figure 8, shows broken piston (#5 and #6) skirts.

1.16. 1.11 The engine teardown examination was concluded as follows: The master rod was the first part to fail. The reason is that the piston skirts were all damaged due to the scraper rings of each piston pulled out of the cylinder barrels. This situation can only occur during master rod failure.

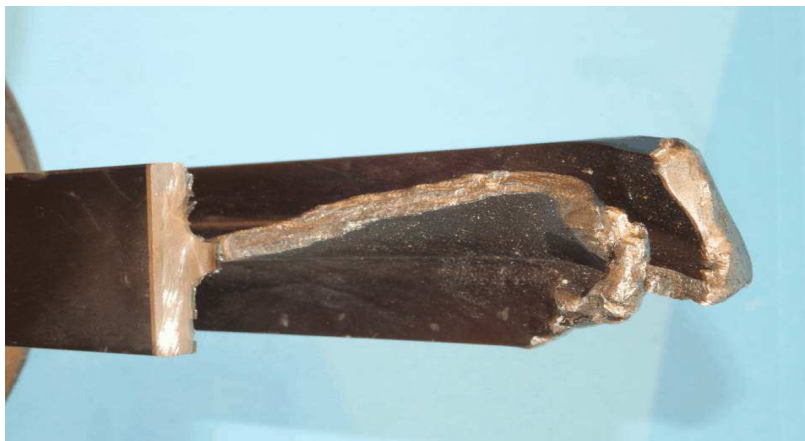
- (i) The master rod had broken adjacent to the big-end bearing housing, and the fracture surface had been almost completely obliterated following the failure. A sector of the crack extended longitudinally along the rod itself and this was carefully removed for further examination. When examined, the evidence found showed that it too was damaged beyond recognition.

Figure 11, shows longitudinal and obliterated crack surface of master rod.

1.16.2 The metallurgical report was concluded as follows: *“The master rod has failed through a fatigue mechanism initiate through wear in the bearing pins due to extended use and which should have been replaced at last overhaul”.*

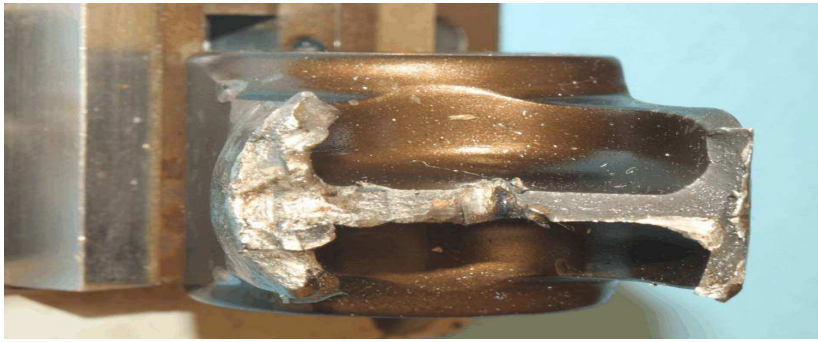
- (ii) One of the secondary connecting rods had fractured and the fracture surface appeared to be ductile. The failure was consequential to the master rod failure.

Figure 12, shows secondary connecting rod ductile features.

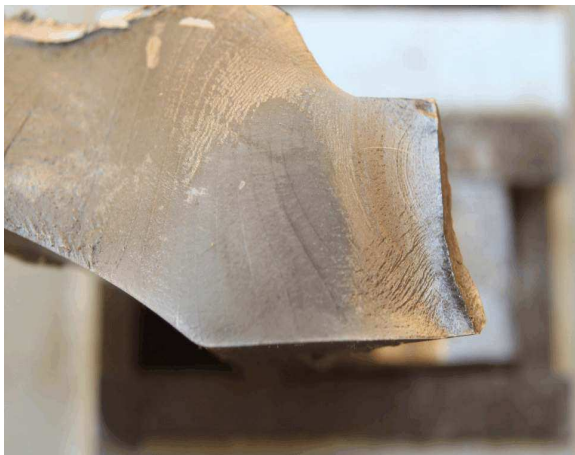
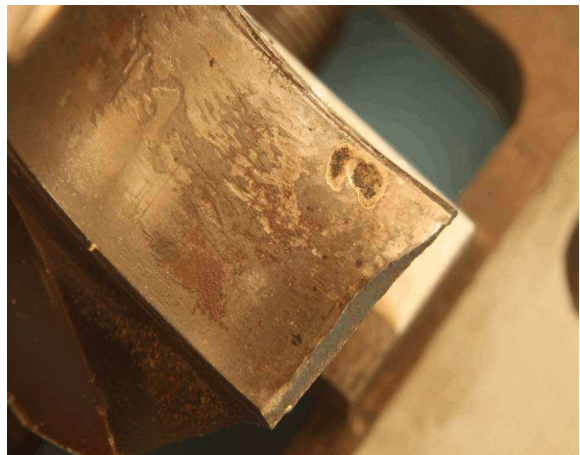
- (iii) Additional cracks were observed in the master rod in the big-end hole of #6 cylinder. The crack surface exhibited features typically of fatigue. The crack initiated within the big-end pin hole for #6 cylinder, and presence of both corrosion product deposits and scoring of the big-end hole in the axial direction with respect to the big-end pin. Examination of the pins showed a distinct step at the master rod – connecting rod interface on all the pins, and signs of fretting on at least one pin. The copper plating on the pins had been worn away one pin. It infers that the pin had been moving within the master rod during its operation.

Figure 13 and 14, shows features typical of fatigue on the secondary crack and fretting corrosion deposits and scoring on secondary rod big-end hole on master rod.

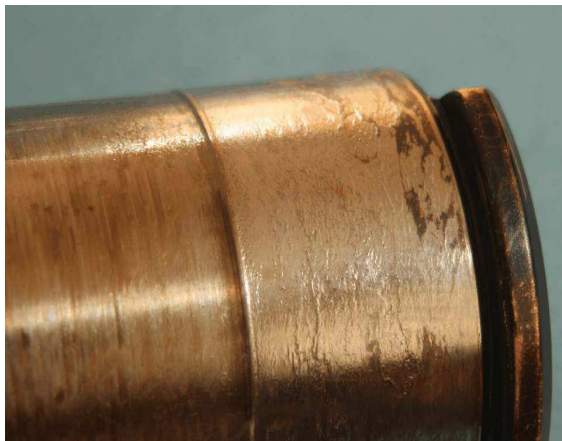
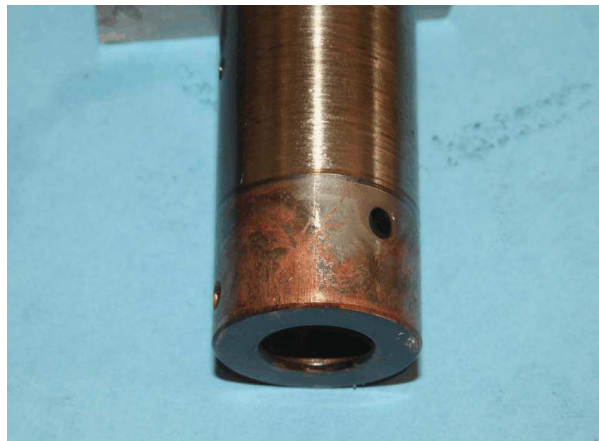
Figure 15 and 16, shows fretting damage on secondary rod big-end pin and loss of copper plating through wear on pin end.

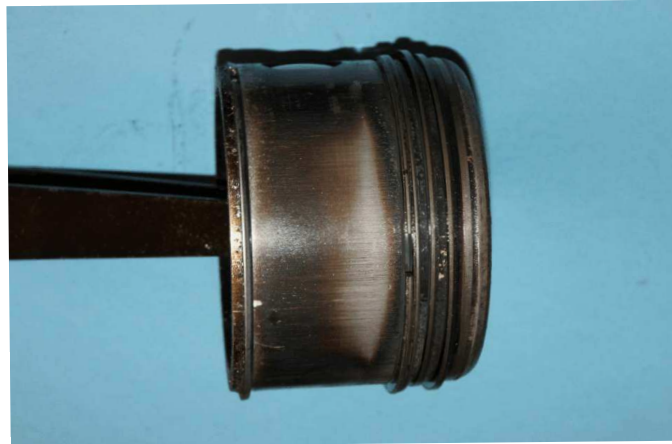
- (iv) The piston of #5 cylinder showed no signs of seizure of the skirt or wrist pin pads. The carbon layer on the crown of the piston indicated normal combustion. The rings appeared in a good condition, showing the expected wear. All the rings were loose and free to move, with the exception of the top ring which seized in its groove.

Figure 17, shows piston.
