**REPORT
OF ACCIDENT TO
PAWAN HANS HELICOPTER LTD Mi-172 HELICOPTER
VT-PHF ON 19TH APRIL 2011 AT
TAWANG, ARUNACHAL PRADESH**

**GOVERNMENT OF INDIA
MINISTRY OF CIVIL AVIATION**

**REPORT
OF ACCIDENT TO
PAWAN HANS HELICOPTER LTD
Mi-172 HELICOPTER VT-PHF
ON
19TH APRIL 2011 AT
TAWANG, ARUNACHAL PRADESH
BY
COMMITTEE OF INQUIRY
COMPRISING**

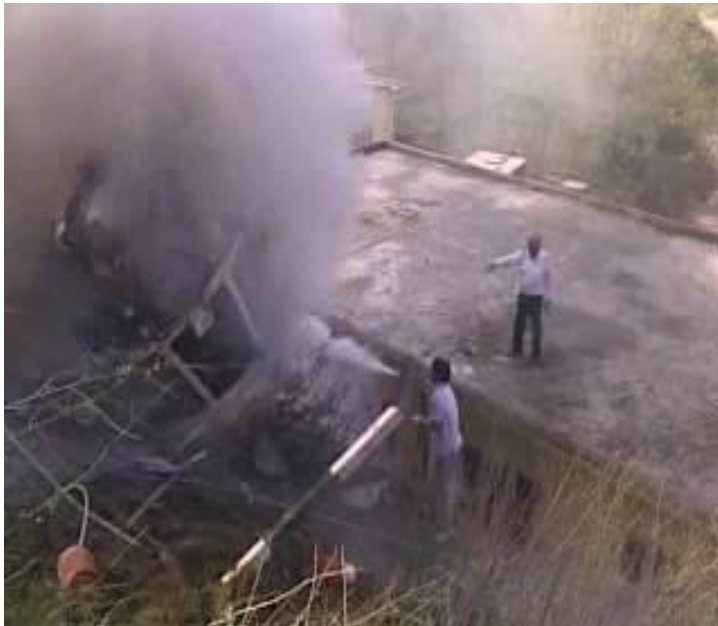
Photo : 2

Front View

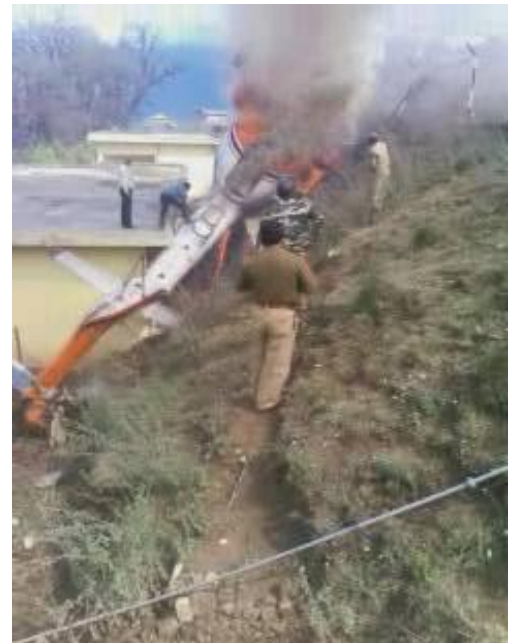
Photo : 3

Rear View

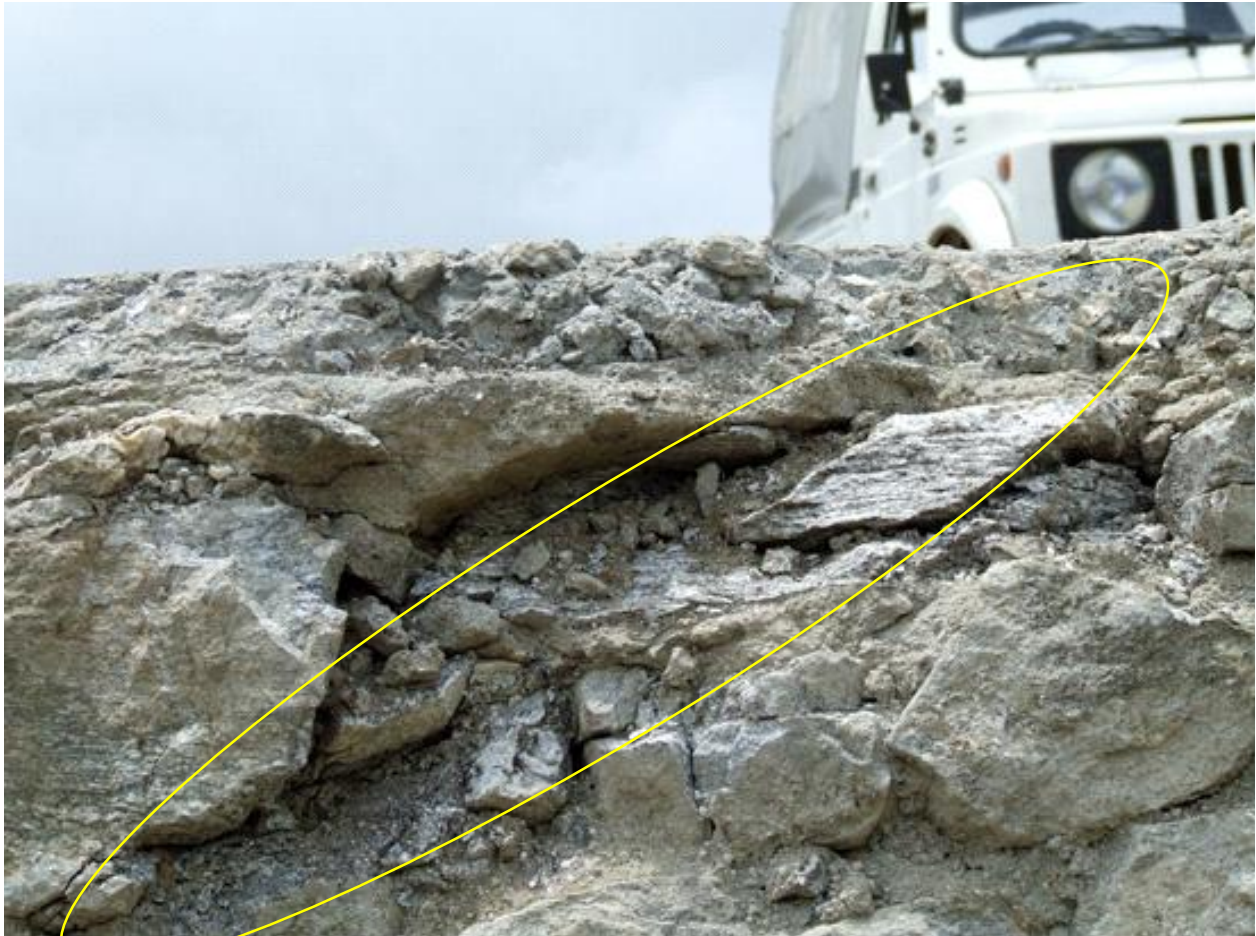
Photo:4

The rotors hit the beginning of the helipad and broke.

Rotor Hit Marks on Helipad

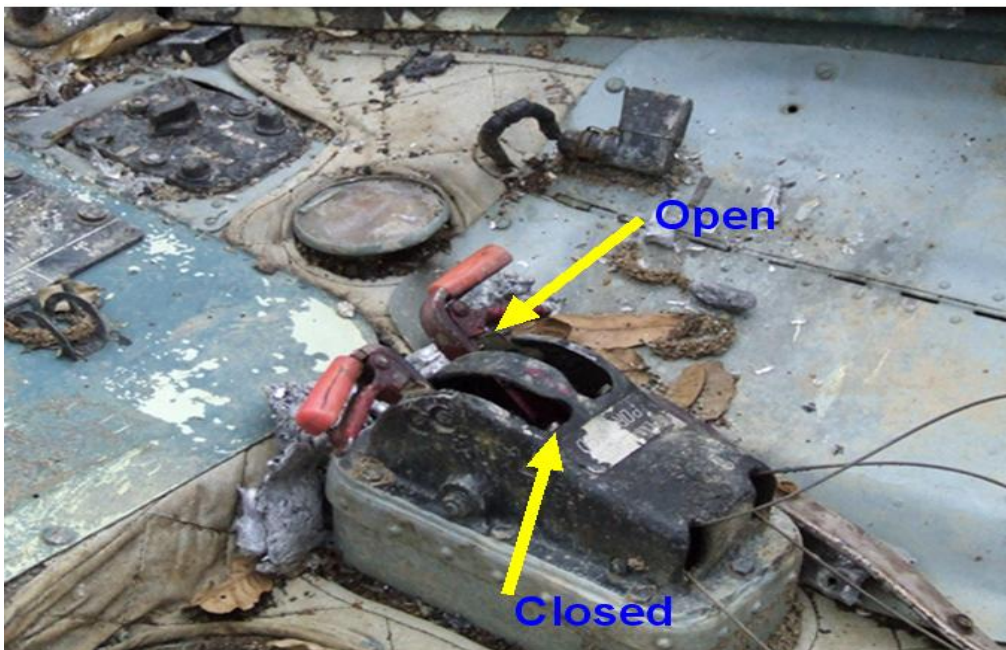
Photo : 7

HP Cocks in Open Position

All switches and CBs in the cockpit were totally burnt and could not be located. Only the HP cocks were found and they were in fully open position.

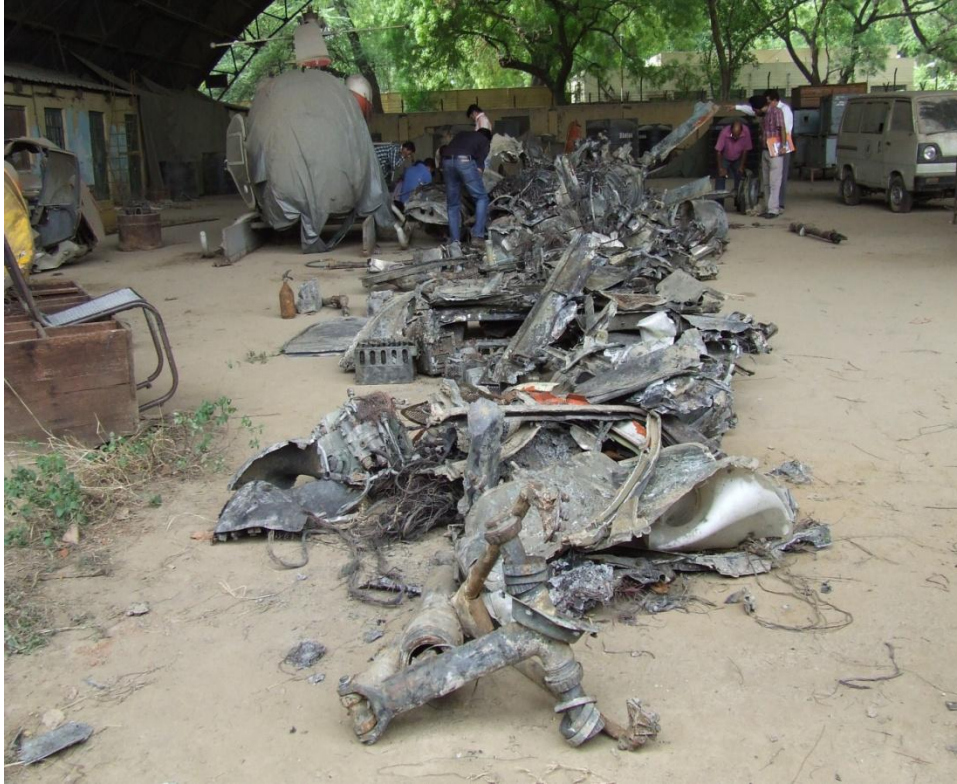
Photo : 8

The wreckage was shifted around on the day of the accident itself to help retrieve the bodies and keep the heliport active. Thus the actual correlation between the impact and the debris could not be established. Most of the helicopter had burnt after the accident within a compact area and very little was left. Only the main rotor blades had broken into pieces and had flown all

### Wreckage Relocated

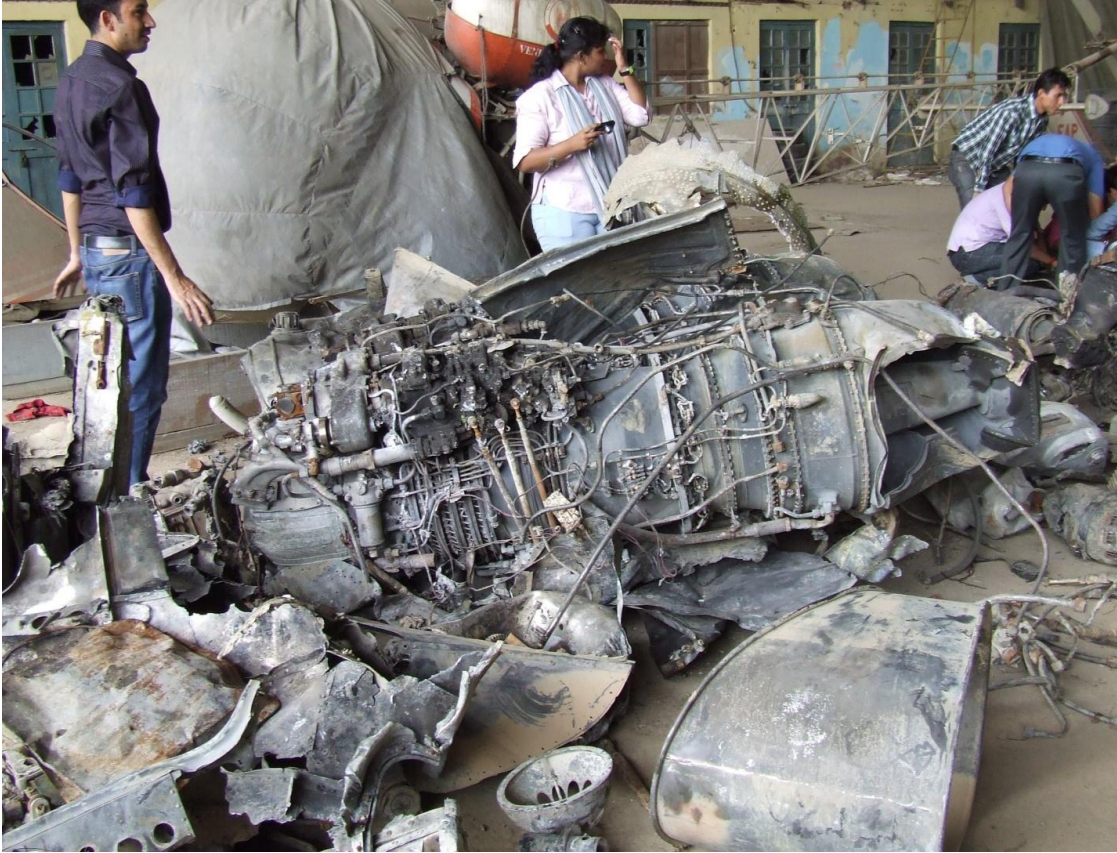
Photo : 9

Both the engines were intact with impact damage. The Fuel Control Unit of both the engines was blackened with soot. This soot mark was not seen on other parts of the engine. Portion of the Port engine exhaust was found broken.

The free turbine unit was visible and appeared un-burnt and undamaged. It was possible to rotate the left engine free turbine by hand. The outer casing of the port engine appeared undamaged. The starboard engine exhaust cowling appeared darkened and wrinkled. Compared to the extent of heat damage to other portions of the helicopter, the damage sustained by the engines appeared minimal. The free turbine of the starboard engine was not as freely rotating as the port engine.

Port Engine

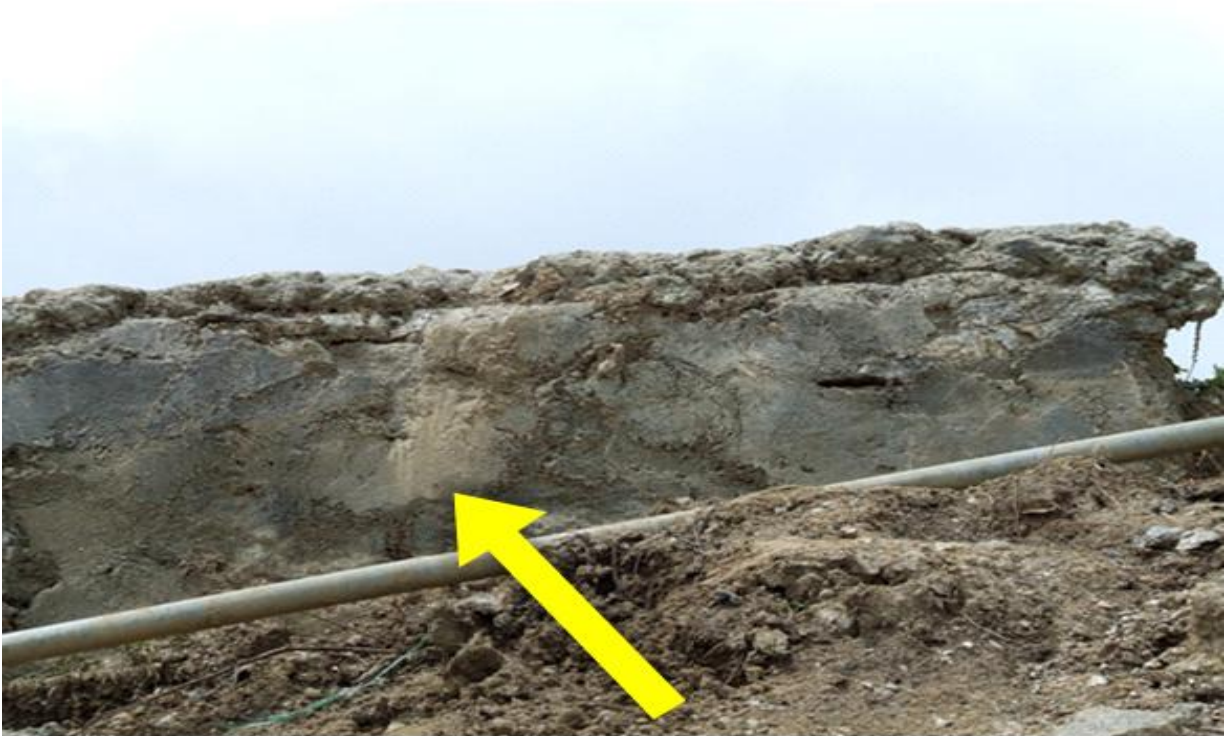
Photo : 10

Eyewitnesses had seen the left undercarriage impacting on the edge before the helipad. They were able to pin point the location. Even 20 days after the

accident, the tyre marks on the ledge still remained. There were no reports of the right wheel impacting the ground. The port wheel being closer to the Facilitation Building would have been more clearly visible to the eyewitnesses on ground. Also the helicopter body could have prevented a clear line of sight from the building to the starboard wheel.

Tyre Marks

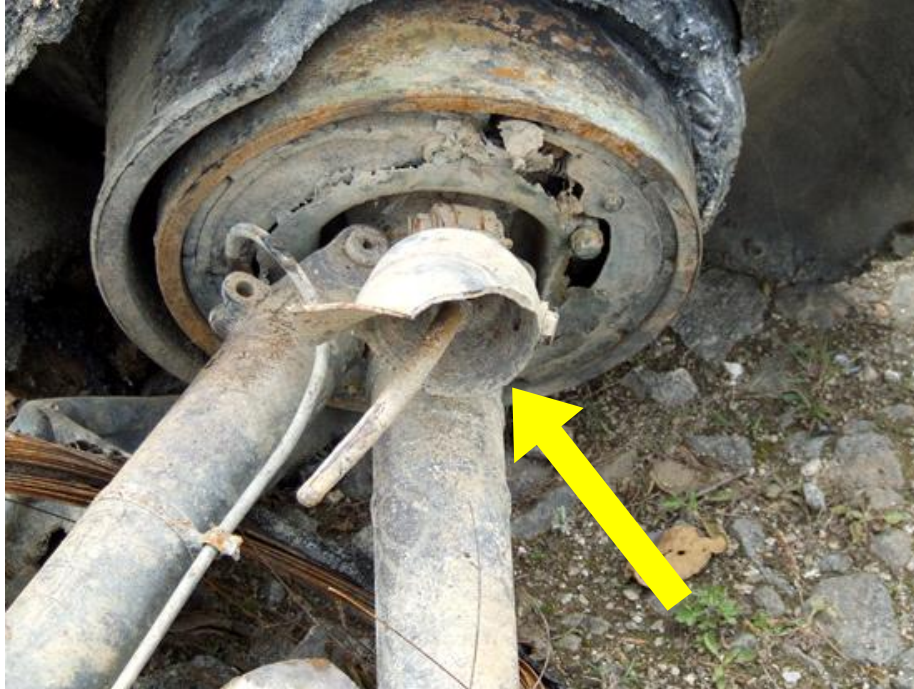
Photo : 11

The left wheel Oleo-pneumatic shock absorber had completely sheared off from the top and bottom. It was lying detached from the main body of the helicopter. Rest of the port wheel was intact but with the tyre burnt.

Damage to Left Landing Gear

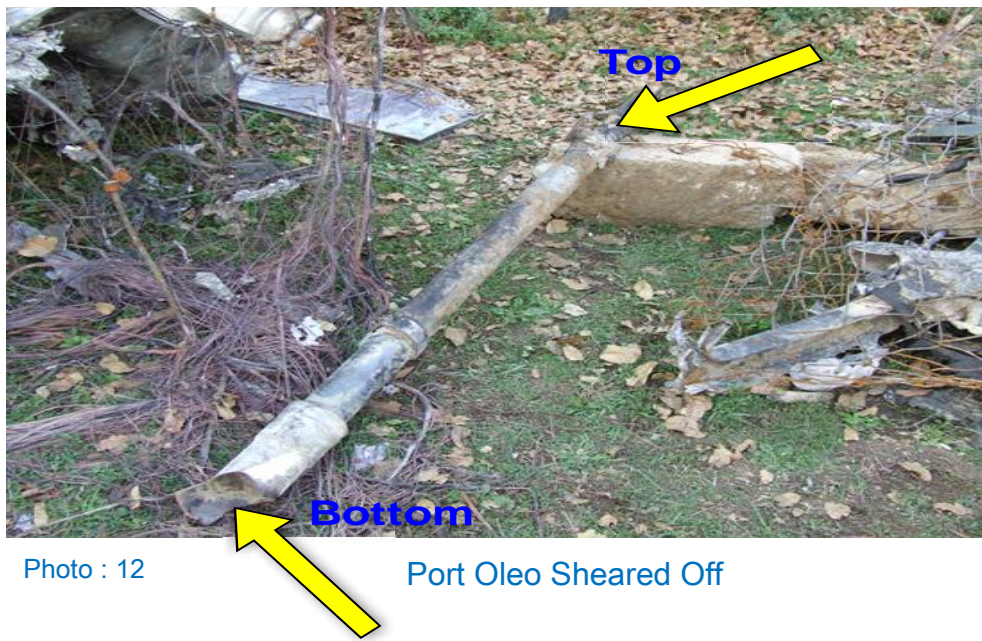
Photo : 12

Port Oleo Sheared Off

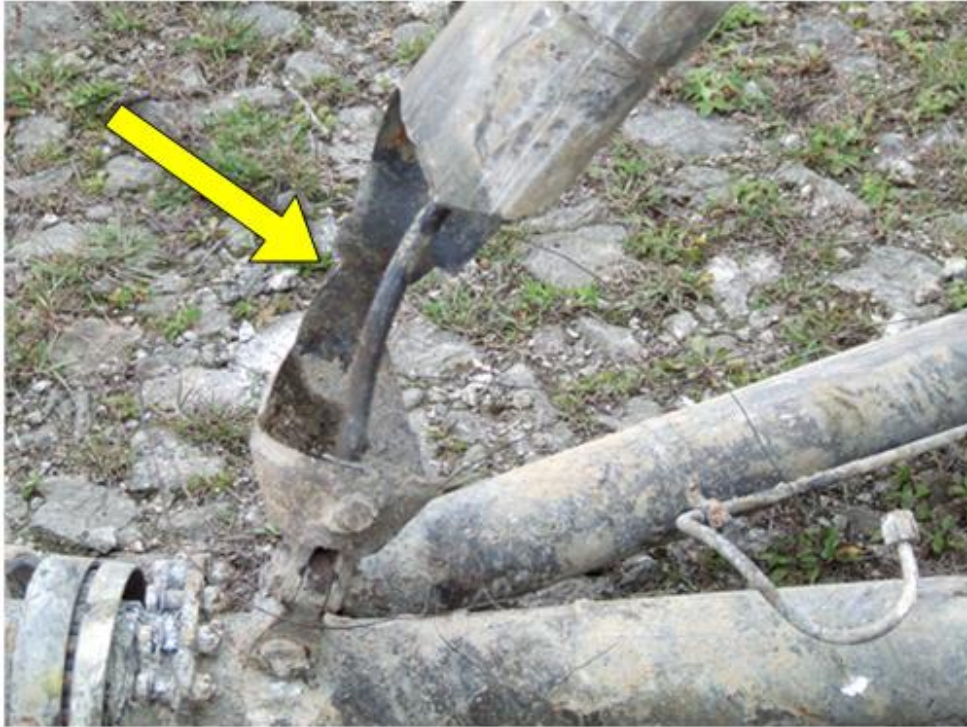
Photo : 13

The starboard oleo leg also had substantial damage at the lower side. The starboard radius rod was cracked and dented at the leading edge (forward portion).

Damage to Starboard Oleo

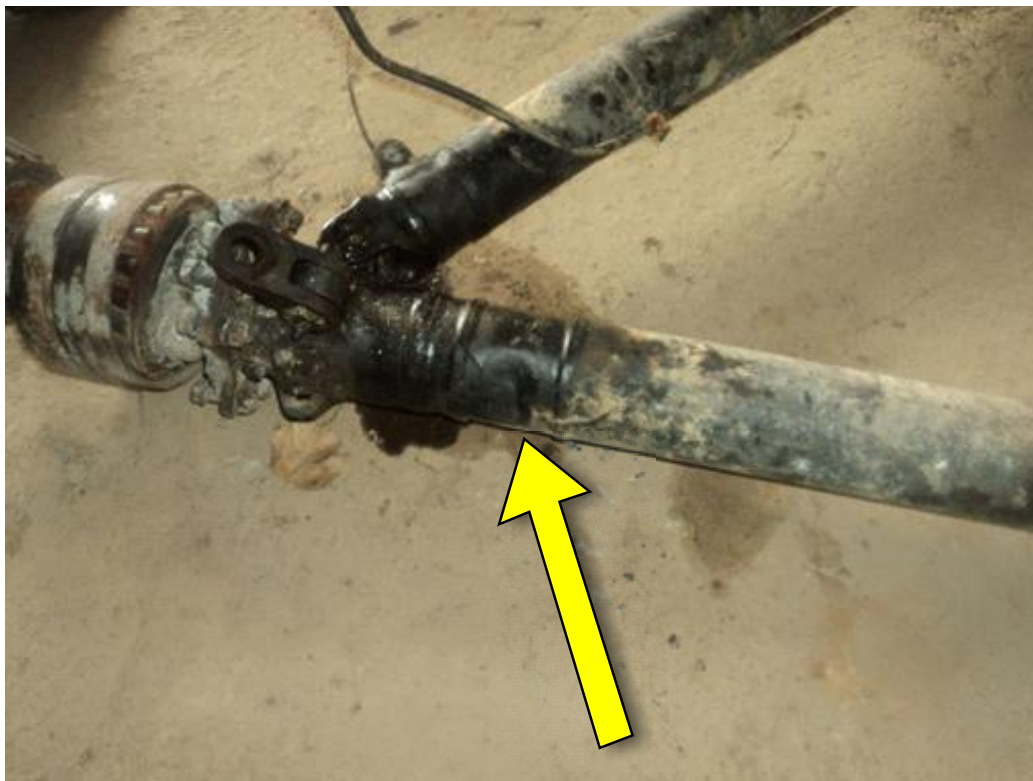
Photo : 14

Damage to Starboard Radius Rod

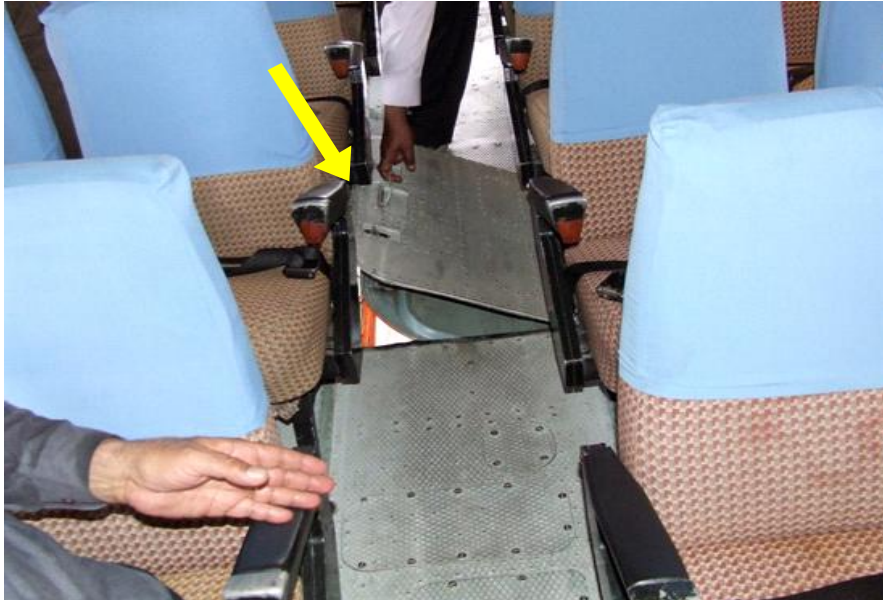
Photo : 19      Cargo Sling Hatch-Possible Additional  
Emergency Exit (Can be opened only when the  
seat hand rest is removed)

In this particular accident, this hatch would not have helped much. However, this could be of use in an emergency. Technicians in the IAF/BSF, routinely use it for servicing Mi 17-1V (the military version of Mi-172) under the belly.
