<b>AIRCRAFT ACCIDENT REPORT AND EXECUTIVE SUMMARY</b>
---

Reference:	CA18/2/3/8930	
<b>Aircraft Registration</b>	ZS-KSZ	<b>Date of Accident</b>	28 May 2011		<b>Time of Accident</b>	0901Z
<b>Type of Aircraft</b>	Cessna R182		<b>Type of Operation</b>	Private (Air Race)		
<b>Pilot-in-command Licence Type</b>	Private	<b>Age</b>	68	<b>Licence Valid</b>	Yes	
<b>Pilot-in-command Flying Experience</b>	Total Flying Hours	1 924		Hours on Type	Unknown	
<b>Last point of departure</b>	Mafikeng Aerodrome, Mafikeng, Northwest Province					
<b>Next point of intended landing</b>	Mafikeng Aerodrome, Mafikeng, Northwest Province					
<b>Location of the accident site with reference to easily defined geographical points (GPS readings if possible)</b>						
At Blokkloof Farm, Koster, Northwest Province (GPS: S25°42.689 E026°50.348 at 4553 feet elevation)						
<b>Meteorological Information</b>	Temperature: 17°C; Dew point: -03°C; Wind: 360°08k nots; Cloud cover: None; Visibility: 10km

## AIRCRAFT ACCIDENT REPORT

**Name of Owner/Operator** : Wally Brink Property Investments  
**Manufacturer** : Cessna Aircraft Company  
**Model** : R182  
**Nationality** : South African  
**Registration Marks** : ZS-K

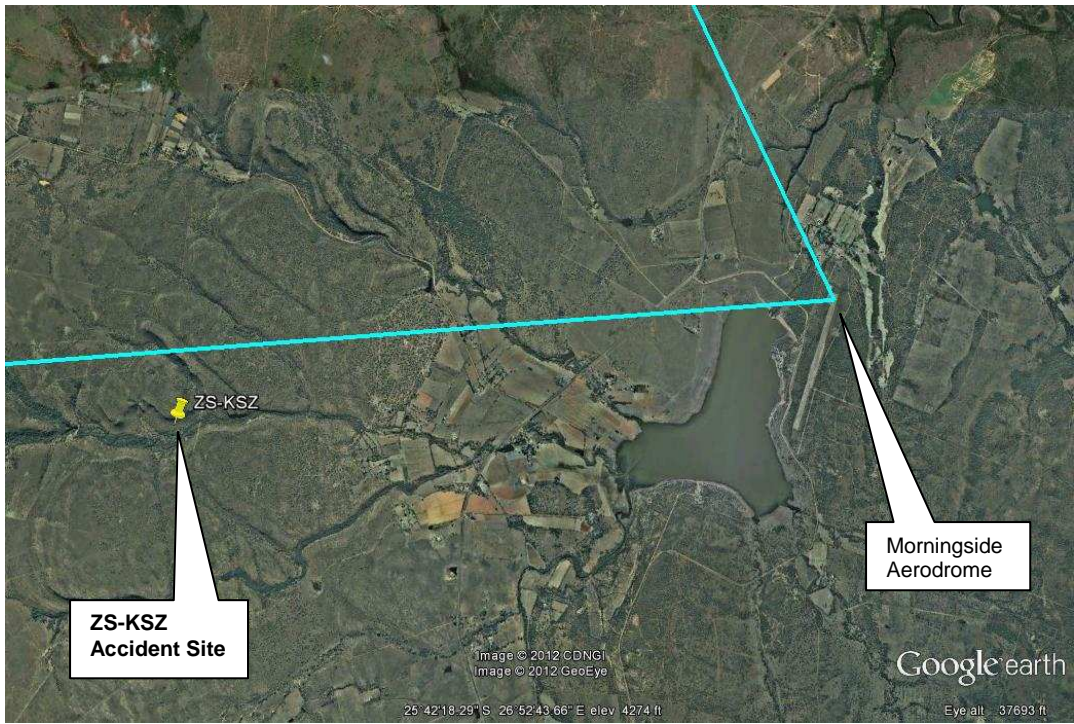
**Photo 2:** Google Earth photo of the accident site and race path.

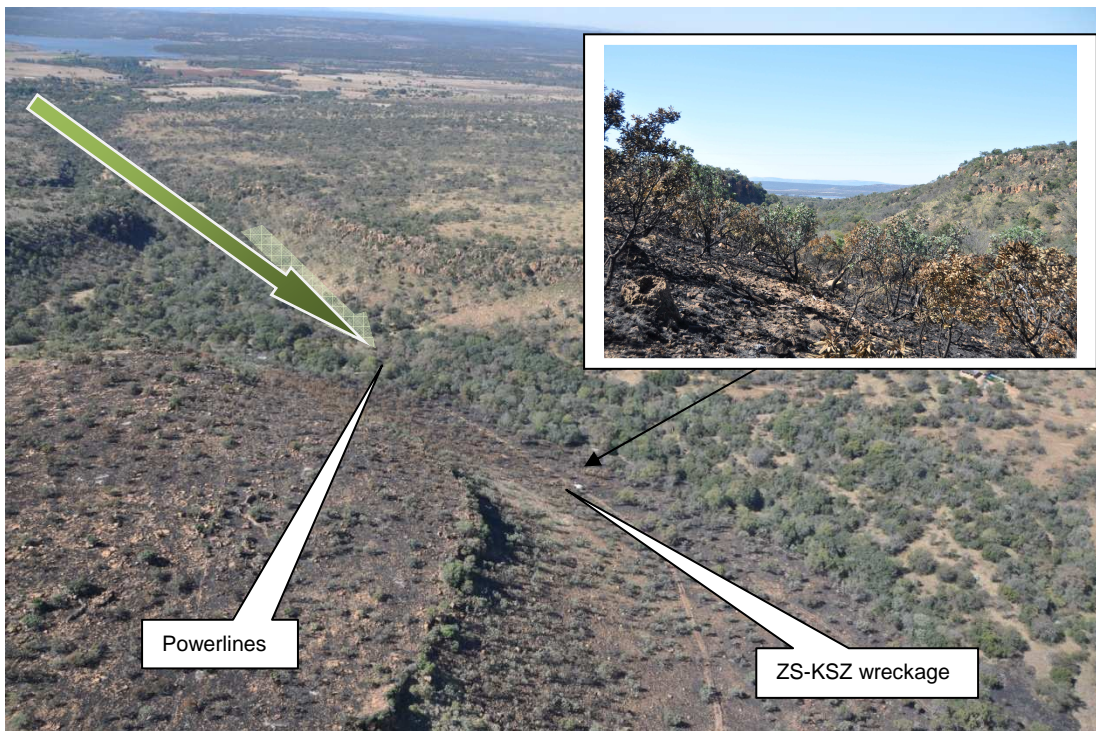
**Photo 3:** Estimated path of ZS-KSZ thru the valley. **Inset:** View of valley.

1.12.1 During the "President's Trophy Air Race" ZS-KSZ flew low through the valley and impacted high tension wires. The aircraft then pitched up, entered into a spiral dive and impacted the side of the valley. A post-impact fire ensued which then destroyed the aircraft wreckage.

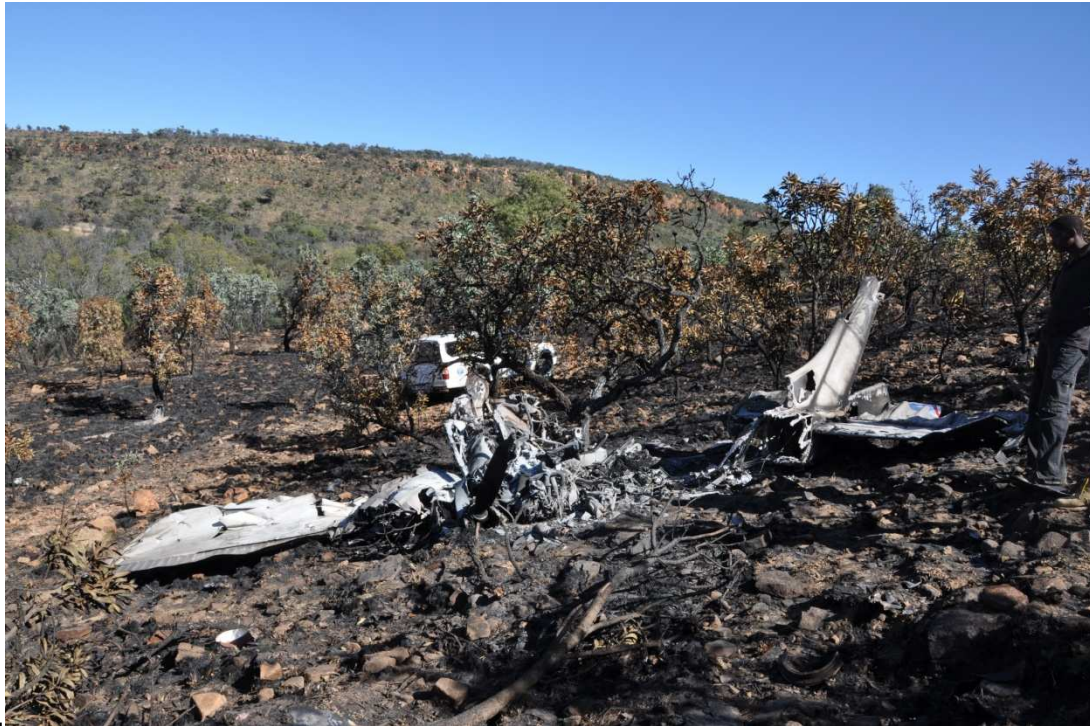
1.3.1 The aircraft was destroyed by the impact forces and the post-impact fire.

**Photo 4:** A view of the aircraft wreckage.

1.12.2 Evidence at the wreckage site showed signs that the aircraft bounced after the initial impact. The aircraft then broke into two significant parts; the left wing and the rest of the airframe. The engine was mangled and destroyed by the impact forces and post-impact fire. The propeller exhibited damage indicative of the engine producing power at impact.

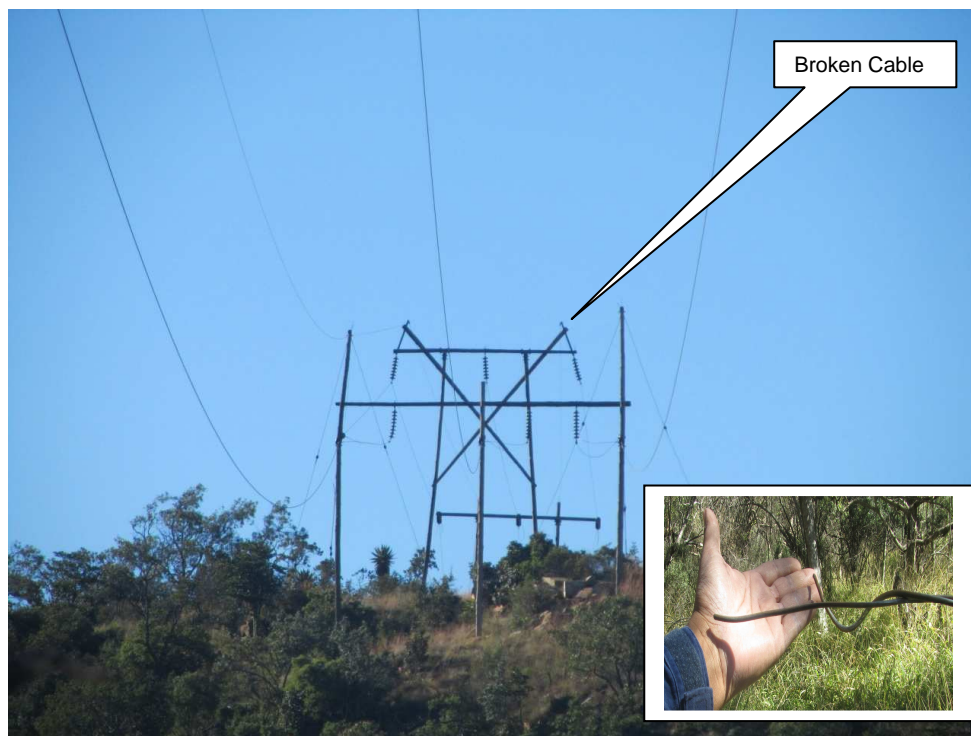
1.4.2 The high tension wire (earth wire) sustained damage after the aircraft impacted it.

**Photo 5:** High tension wires and pylons. **Inset:** Broken earth wire.

- a) The aircraft had collided with one of two earth wires that were 47.5 metres (155.8 feet) above the ground. The high tension wires consisted of three lower high tension wires and two upper earth high tension wires.

- b) The height of the high tension wires were measured from the ground:
  - Height of main high tension wires was 43.5 metres (142.7 feet) AGL
  - Height of earth high tension wire was 47.5 metres (155.8 feet) AGL

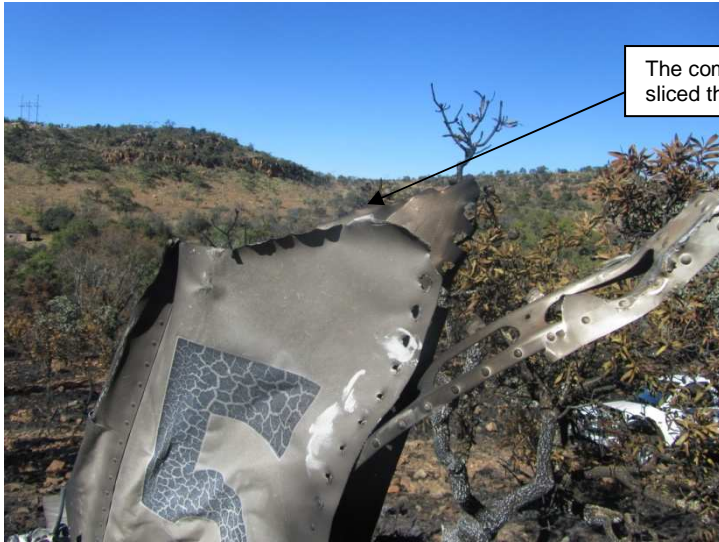
1.12.4 During the impact sequence the high tension wire severed the vertical stabilizer approximately 140 cm from the top. It then severed the rudder and ripped it from the vertical stabilizer. The rudder was located below the broken high tension wire approximately 242 meters (794 feet) from the main wreckage.

**Photo 7:** The vertical stabilizer

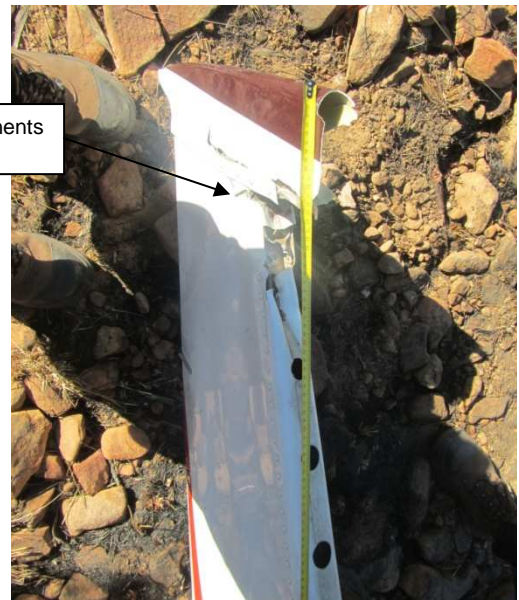
**Photo 8:** The rudder

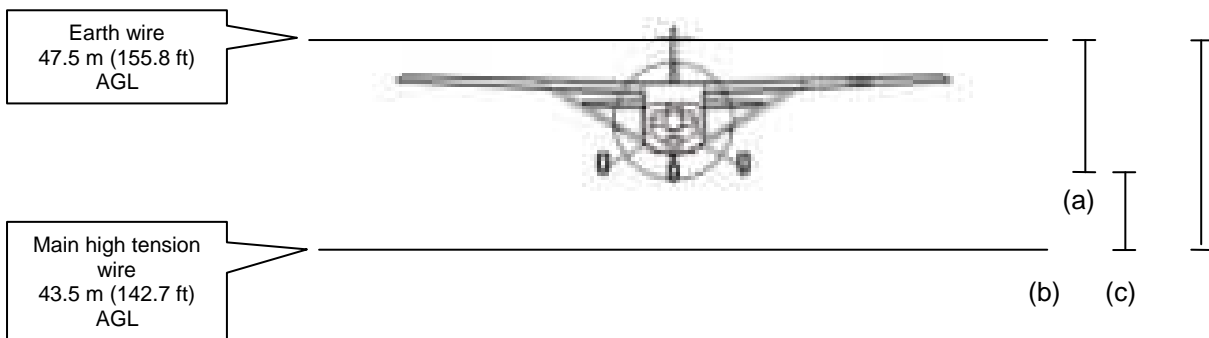
- c) As the height of ZS-KSG was 2.82 meters (9.3 feet) and the vertical stabilizer was found sliced approximately 140 cm from the top by the high tension wire. It then sliced into the rudder and ripped the rudder from the vertical stabilizer. It was calculated that the aircraft was at a height of 44.82 m AGL (147 feet) when it impacted the earth wire. See the sketch below:

- (a) Earth wire to Aircraft landing gear – 2.68 m
- (b) Aircraft landing gear to Main high tension wire – 1.32 m
- (c) Earth wire and Main high tension wire – 4 m

Consequently the aircraft was at a height of 44.82 m (147 feet) AGL when it impacted the earth wire.
