<b>AIRCRAFT ACCIDENT REPORT AND EXECUTIVE SUMMARY</b>
---

Reference:	CA18/2/3/8933	
<b>Aircraft Registration</b>	ZU-CNB	<b>Date of Accident</b>	06 June 2011		<b>Time of Accident</b>	1345Z
<b>Type of Aircraft</b>	Windlass Aquilla-Microlight		<b>Type of Operation</b>	Private		
<b>Pilot-in-command Licence Type</b>		Microlight	<b>Age</b>	40	<b>Licence Valid</b>	Yes
<b>Pilot-in-command Flying Experience</b>		Total Flying Hours	346.8		Hours on Type	346.8
<b>Last point of departure</b>		Micro-land aerodrome (Gauteng province).				
<b>Next point of intended landing</b>		Bapsfontein aerodrome (Gauteng province).				
<b>Location of the accident site with reference to easily defined geographical points (GPS readings if possible)</b>						
Endicot farm near Springs at GPS coordinates determined to be S26°17' .82" E028°35' .74".						
<b>Meteorological Information</b>	Surface wind; 10 kts, Temperature; 18°C, Partly cloudy conditions prevailed.					
<b>Number of people on board</b>	1 + 1	<b>No. of people injured</b>	1	<b>No. of people killed</b>	0

**Name of Owner/Operator** : Carshagen W  
**Manufacturer** : Solo Wings CC  
**Model** : Windlass Aquilla  
**Nationality** : South African  
**Reg

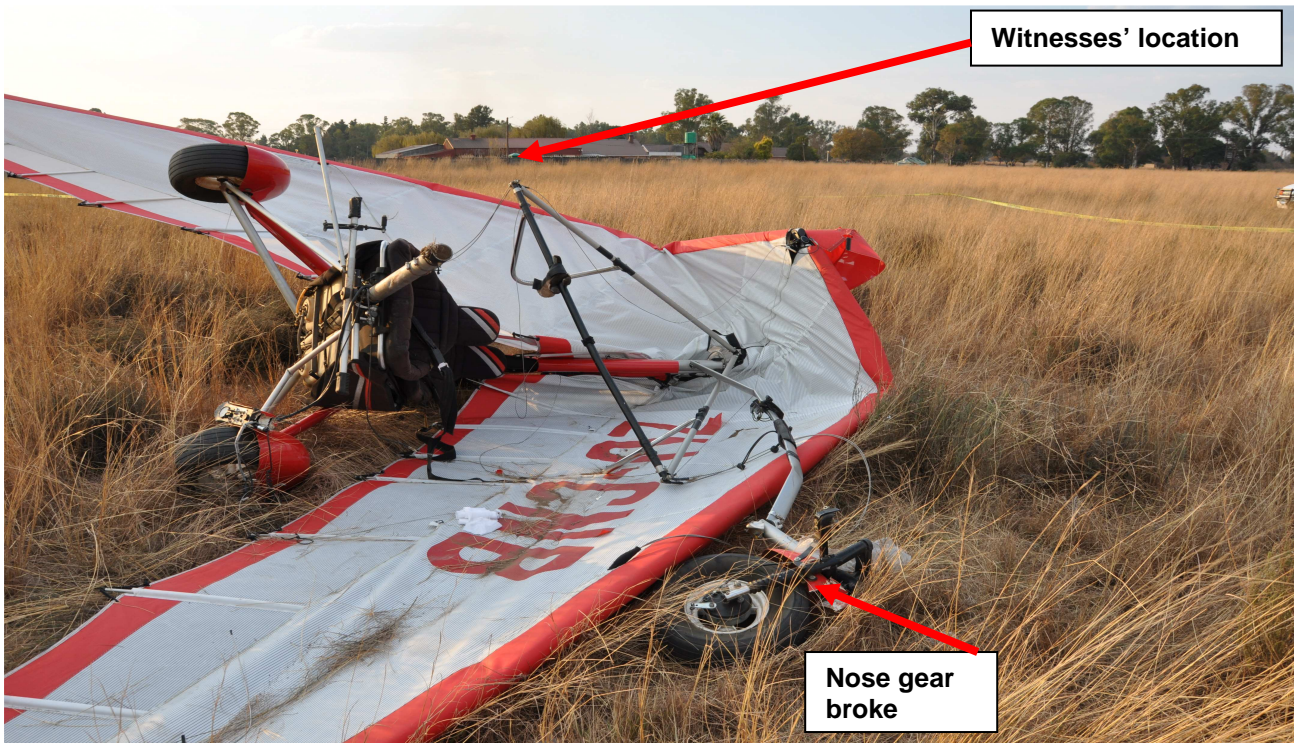
- 1.1.4 The pilot immediately looked for a suitable place in order to execute a forced landing. According to the pilot, the wind was very strong and the aircraft drifted over the area he intended to land on. He kept control of the forced landing but in the event he failed to clear the telephone wires spanned across an open area at Endicott farm and collided with the wires rendering ground impact inevitable.

Figure 1: View of the accident site and the terrain.

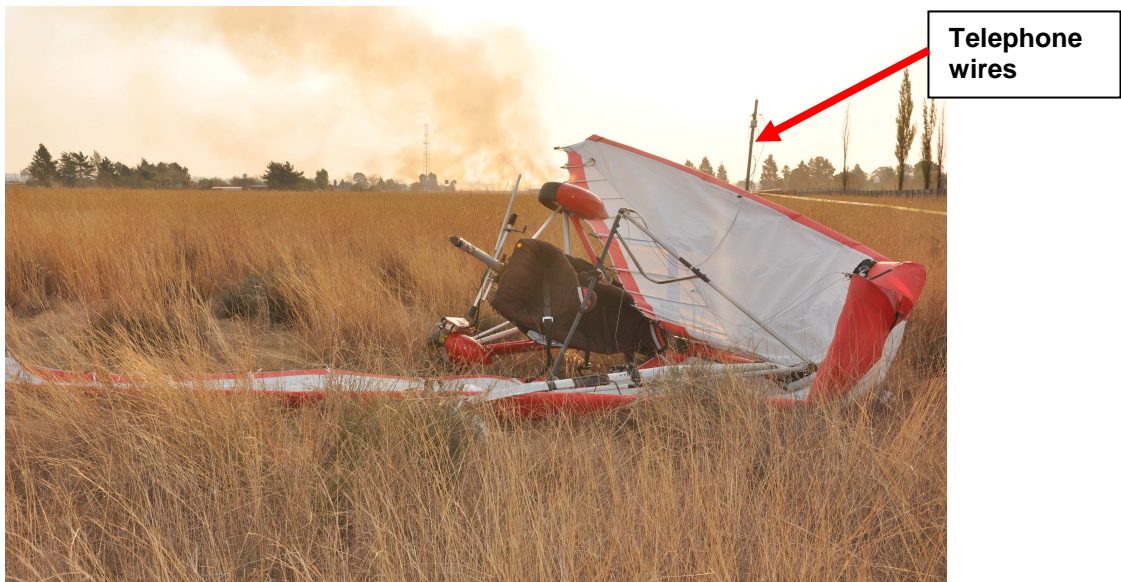
1.4.1 Damage was limited to the telephone wires spanned across the open field at Endicott farm.

Figure 2: View of damaged telephone wires from a distance.

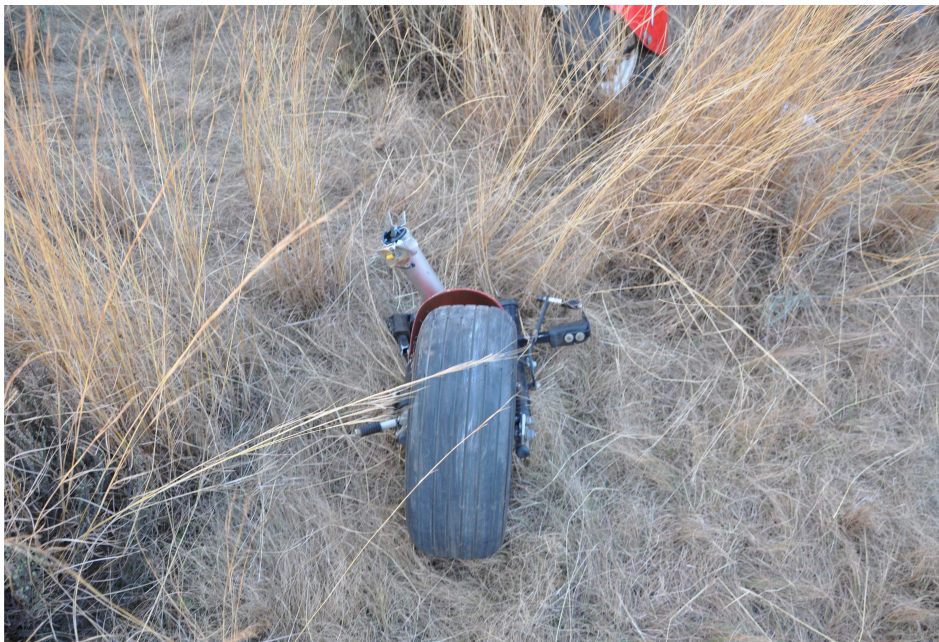
1.12.1 The aircraft collided with telephone wires spanned across an open grass area at Endicot farm rendering ground impact inevitable. The aircraft then impacted the ground in a steep nose down attitude and was in a Westerly direction. Trapeze bar cables were substantially damaged by the impact and a two bladed wooden propeller showed signs of not been producing power prior to impact. Both wings and undercarriage were substantially damaged. Below is a photo of a broken nose gear.

**Figure 4: View of a nose landing gear.**

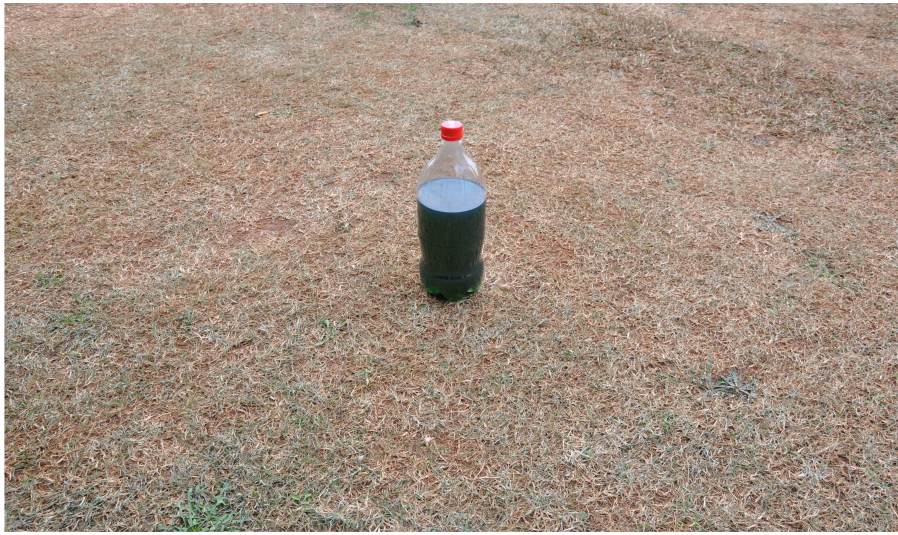
1.16.2 The photo below showed the amount of fuel drained from the fuel tank ( $\pm$  1 litre).

**Figure 5: Fuel drained from the aircraft.**

3.2.1 Unsuccessful landing due to collision with wires following fuel exhaustion.
