<b>AIRCRAFT ACCIDENT REPORT AND EXECUTIVE SUMMARY</b>
---

Reference:	CA18/2/3/8935	
<b>Aircraft Registration</b>	ZU-RFR	<b>Date of Accident</b>	18 June 2011		<b>Time of Accident</b>	0830Z
<b>Type of Aircraft</b>	Magni Gyro 24 - Orion		<b>Type of Operation</b>	Private		
<b>Pilot-in-command Licence Type</b>		Gyroplane Pilot	<b>Age</b>	54	<b>Licence Valid</b>	NO
<b>Pilot-in-command Flying Experience</b>		Total Flying Hours	133.4 as per the last licence renewal on file		Hours on Type	unknown
<b>Last point of departure</b>		FAAL (All Days Aerodrome) - Limpopo				
<b>Next point of intended landing</b>		FAAL (All Days Aerodrome) - Limpopo				
<b>Location of the accident site with reference to easily defined geographical points (GPS readings if possible)</b>						
The gravel road close to All Days Aerodrome (GPS Position: S22°39,402' E29°03,335')						
<b>Meteorological Information</b>						
<b>Number of people on board</b>	1+1	<b>No. of people injured</b>	0	<b>No. of people killed</b>	2

## AIRCRAFT ACCIDENT REPORT

**Name of Owner/Operator** : Llewellyn Parker  
**Manufacturer** : Magni Gyro  
**Model** : M-24 Orion  
**Nationality** : South African  
**Registration Marks** : ZU-RFR  
*

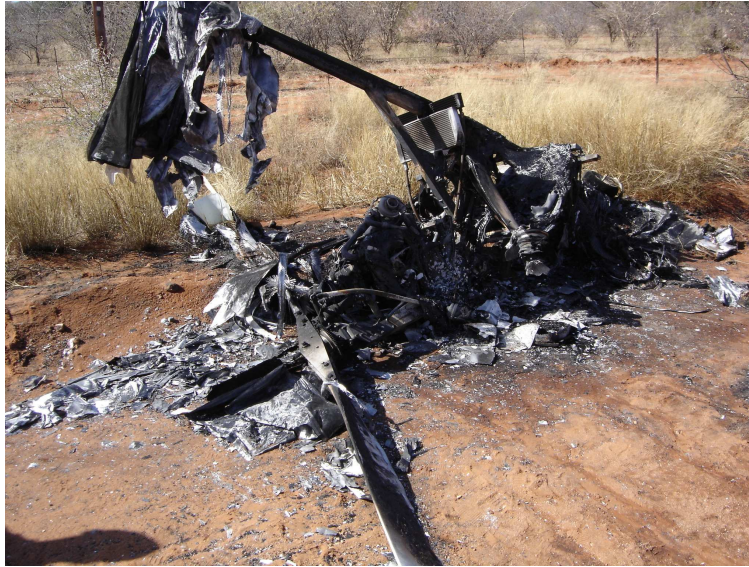
1.3.1 The aircraft was destroyed by the post impact fire.

Fig. 1 – Aircraft consumed by the fire

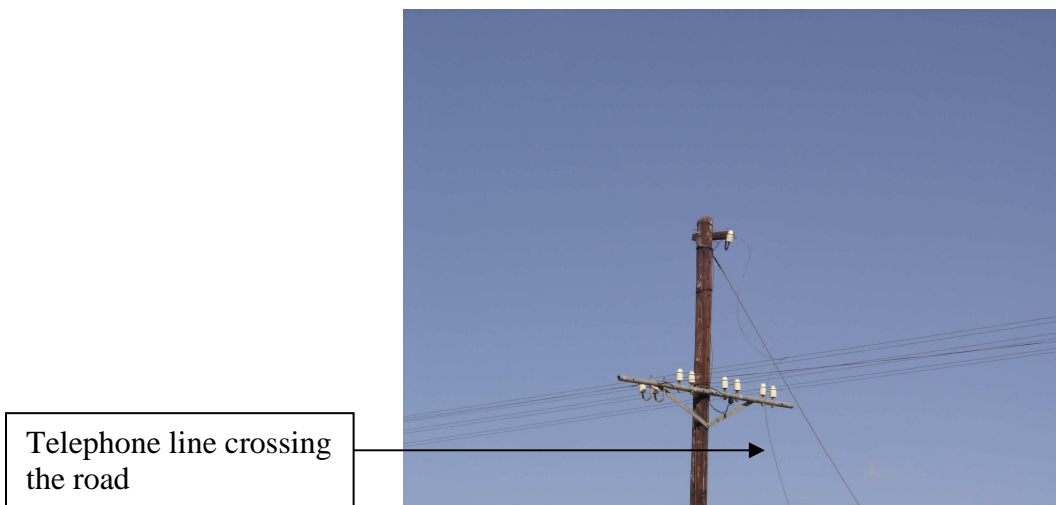
1.4.1 Aircraft collided with the telephone lines crossing the gravel road.

Fig. 2 – Telephone lines

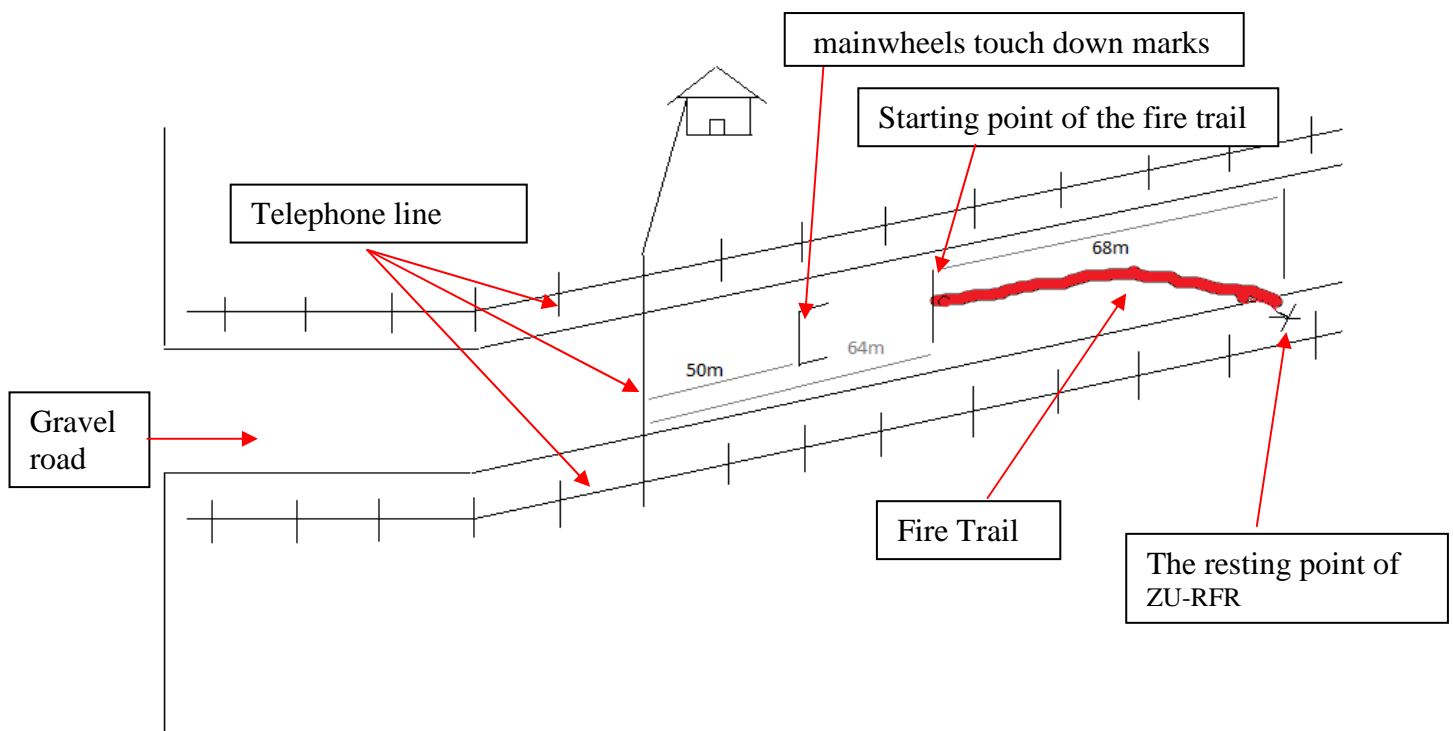
Fig. 4

1.12.2 The aircraft touched down 50m after colliding with the telephone lines crossing the gravel road. See fig. 4

1.12.3 Windshield pieces were found around the telephone line as per fig. 4 and the pieces had marks of cable scraping. See fig.4

1.12.4 The fire trail started 14m after the touch down marks and the trail continued for 68m until the aircraft came to rest. See fig.4
