AIRCRAFT ACCIDENT REPORT AND EXECUTIVE SUMMARY

Reference:	CA18/2/3/8940	
Aircraft Registration	ZS-HDK	Date of Accident	1 July 2011		Time of Accident	1120Z
Type of Aircraft	Eurocopter AS350B3 (Helicopter)		Type of Operation	Aerial Survey		
Pilot-in-command Licence Type		Commercial	Age	36	Licence Valid	Yes
Pilot-in-command Flying Experience		Total Flying Hours	410.5		Hours on Type	297.1
Last point of departure		Sishen Aerodrome (FASS), (Northern Cape province)				
Next point of intended landing		Sishen Aerodrome (FASS), (Northern Cape province)				
Location of the accident site with reference to easily defined geographical points (GPS readings if possible)						
To the left of Runway 35 at Sishen Aerodrome (GPS co-ordinates: South 27°39'00" East 23°00'00")						
Meteorological Information		Wind direction: 350°Magnetic, Wind speed: 5 knots, Visibility: 10000m, Temperature 23°C, Cloud cover: Clear sky.				
Number of people on board	2 + 1	No. of people injured	0	No. of people killed	0

Name of Owner : Delmon Mining and Civils (Pty) Ltd
Operator : Delmon Mining and Civils (Pty) Ltd
Manufacturer : Eurocopter
Model : AS350B3
Nationality : South African
Registration Marks : ZS-HDK
Place :

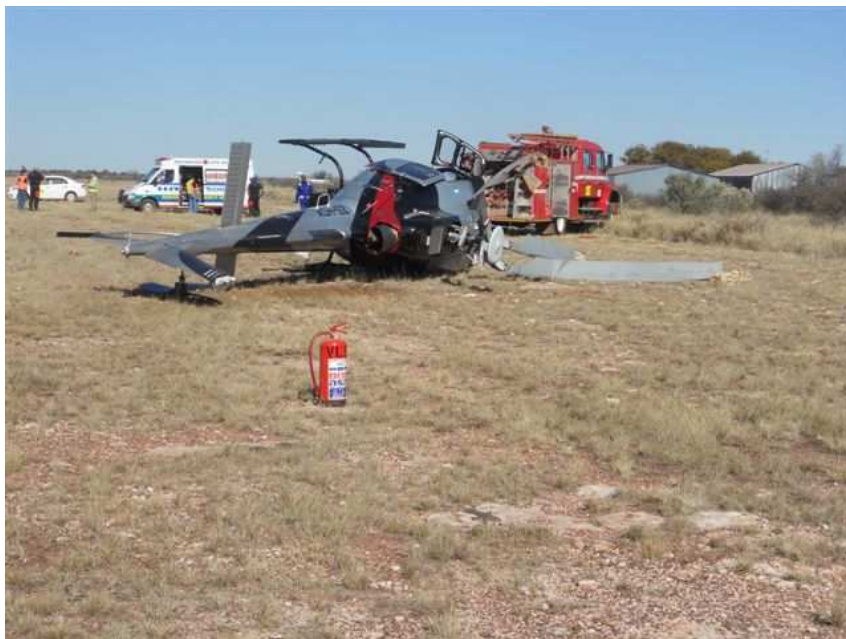
1.3.1 The helicopter sustained substantial damage by the impact forces.

Figure 1. A view of the helicopter as it came to rest next to the runway.

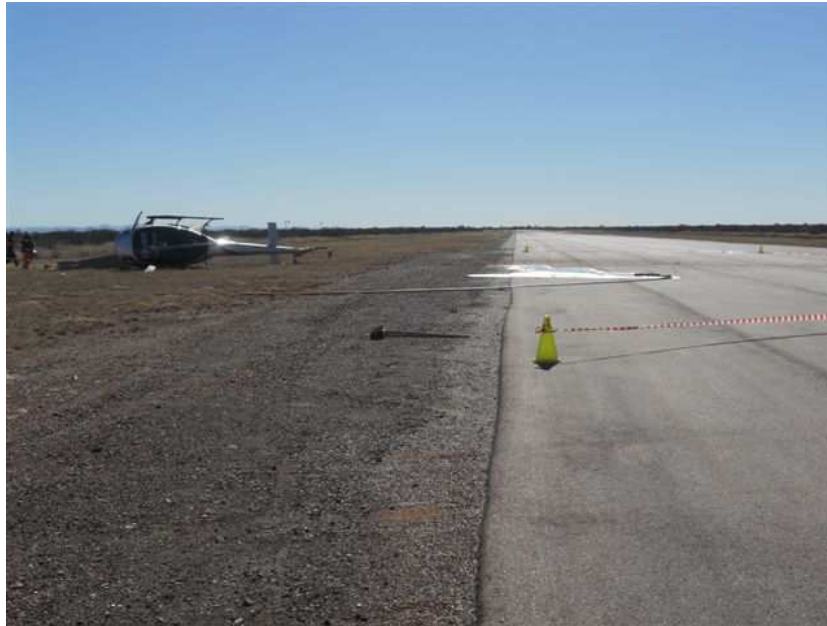
The final impact point was to the left of Runway 35 at Sishen Aerodrome. The helicopter came to rest facing in south-westerly direction, determined to be 240° Magnetic. (See Fig 2)

Figure 2. Helicopter as it came to rest to the left side of Runway 35.

During impact the helicopter had a nose down and bank angle to the right. The degree of bank angle and nose down attitude is unknown.

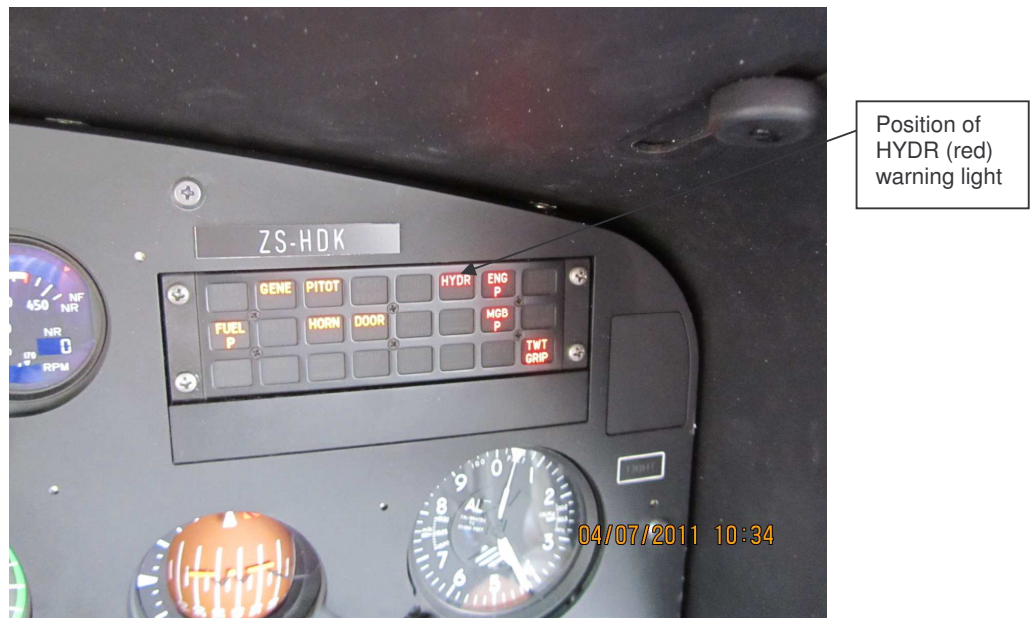
Figure 3. Position of the “HYDR” warning light on instrument panel.

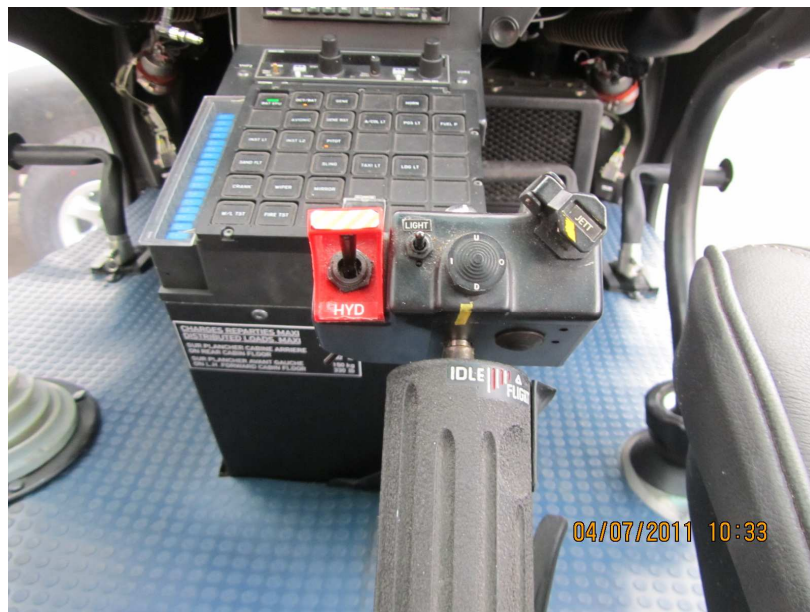
Figure 4. Position of the master “HYD” switch on the collective pitch lever.

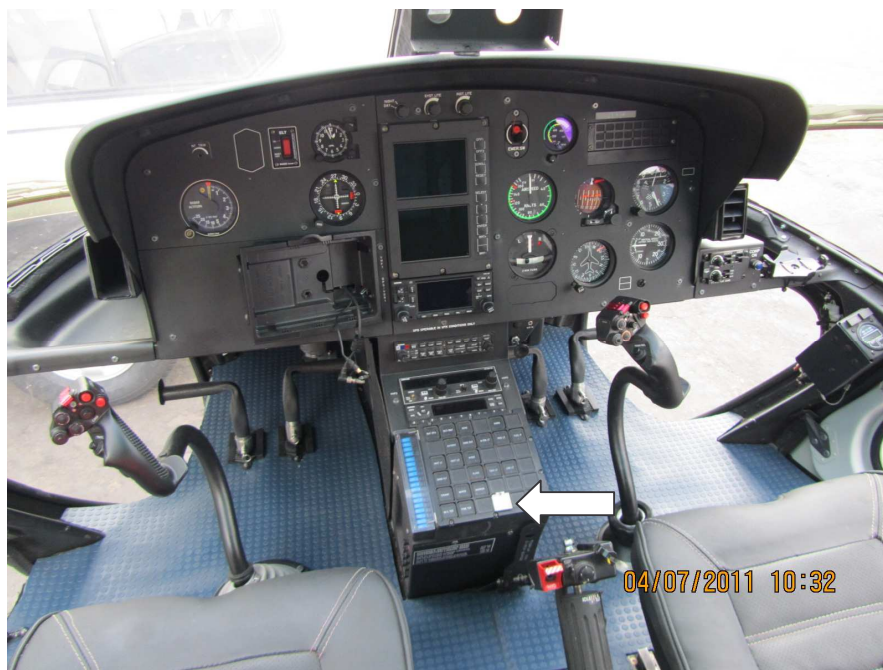
Figure 5. Position of the “ACCU TST” switch on the systems control panel.

was deactivated by the pilot-not-flying in flight to simulate a hydraulic failure. The “ACCU TST” switch, unlike the HYD mater switch located on the collective pitch lever was never switched back on before an attempt was made to land the helicopter in close proximity to the ground. This resulted in an incomplete re-activation of the hydraulic system before performing a normal landing. As the PF increased collective pitch, close to the ground the helicopter started to yaw to the left a yaw rate that neither pilots was able to address/stop. The deactivation of the “ACCU TST” switch had caused the tail rotor load compensating servo to stay depressurised during this phase of flight resulting in no hydraulic power assistance to the tail rotor to counteract the torque / helicopters gyroscopic effect.
