AIRCRAFT ACCIDENT REPORT AND EXECUTIVE SUMMARY

Reference:	CA18/2/3/8950	
Aircraft Registration	ZS-FPK	Date of Accident	30 July 2011		Time of Accident	0800Z
Type of Aircraft	Cessna 177A		Type of Operation		Training	
Pilot-in-command Licence Type		Airline Transport	Age	23	Licence Valid	Yes
Pilot-in-command Flying Experience		Total Flying Hours	1 594.5		Hours on Type	Unknown
Last point of departure		Brits Aerodrome (FABS), North West				
Next point of intended landing		Grand Central Aerodrome (FAGC), Gauteng Province				
Location of the accident site with reference to easily defined geographical points (GPS readings if possible)						
Magaliesburg ridge (GPS co-ordinates: S25°41.770' E027°54.890') at 5 000 ft						
Meteorological Information		Surface wind 130° at 3 kt, temperature 15 °C, cloud base nil				
Number of people on board	1 + 1	No. of people injured	0	No. of people killed	2	
Synopsis		<p>A flight instructor accompanied by a pilot under training, who held a valid Airline Transport Pilot licence, took off from Grand Central Aerodrome (FAGC) on a patten training flight (for an instructor's rating) under the auspices of an aviation training organisation (ATO). After take-off fr

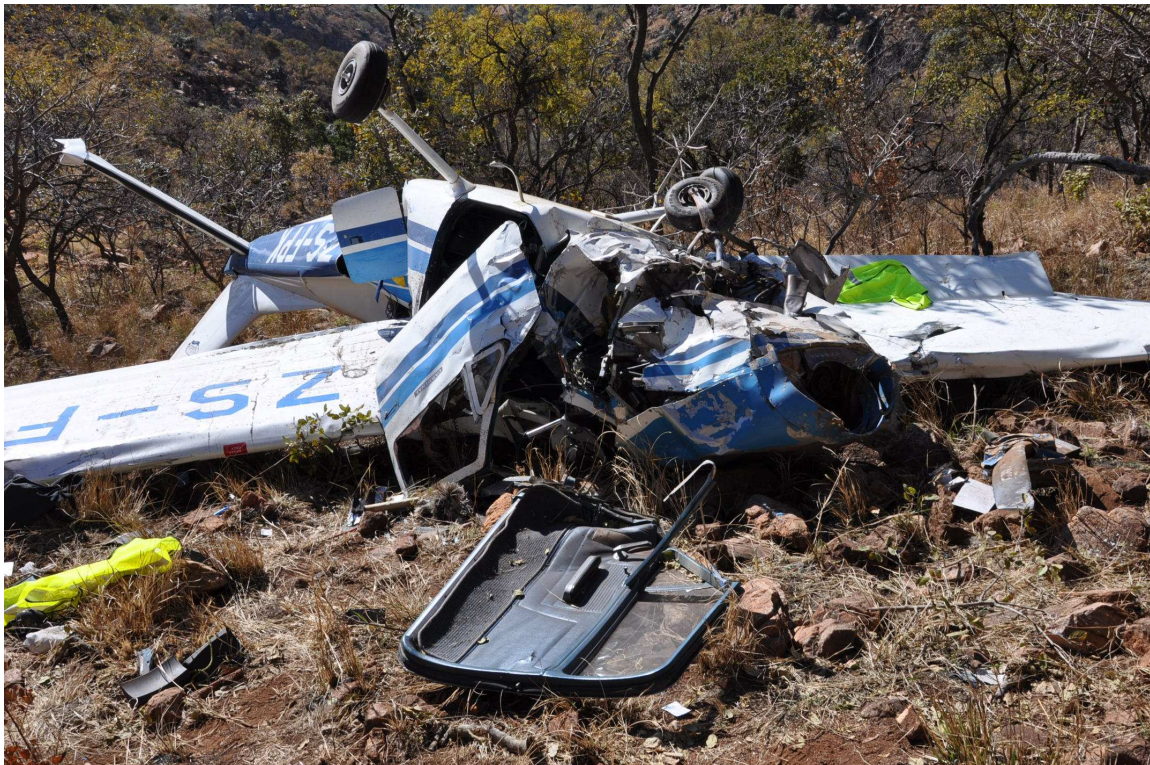
1.3.1 The aircraft was destroyed during the accident sequence.

Figure 1: The wreckage of the aircraft

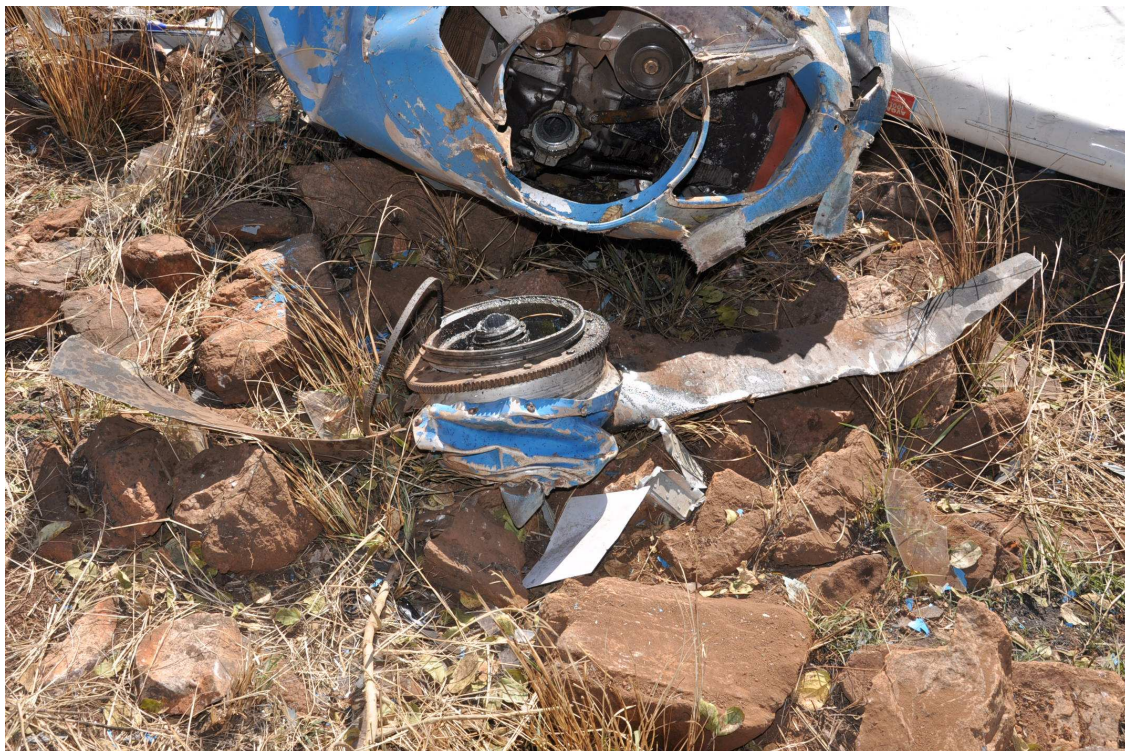
Figure 2: The propeller separated from the aircraft

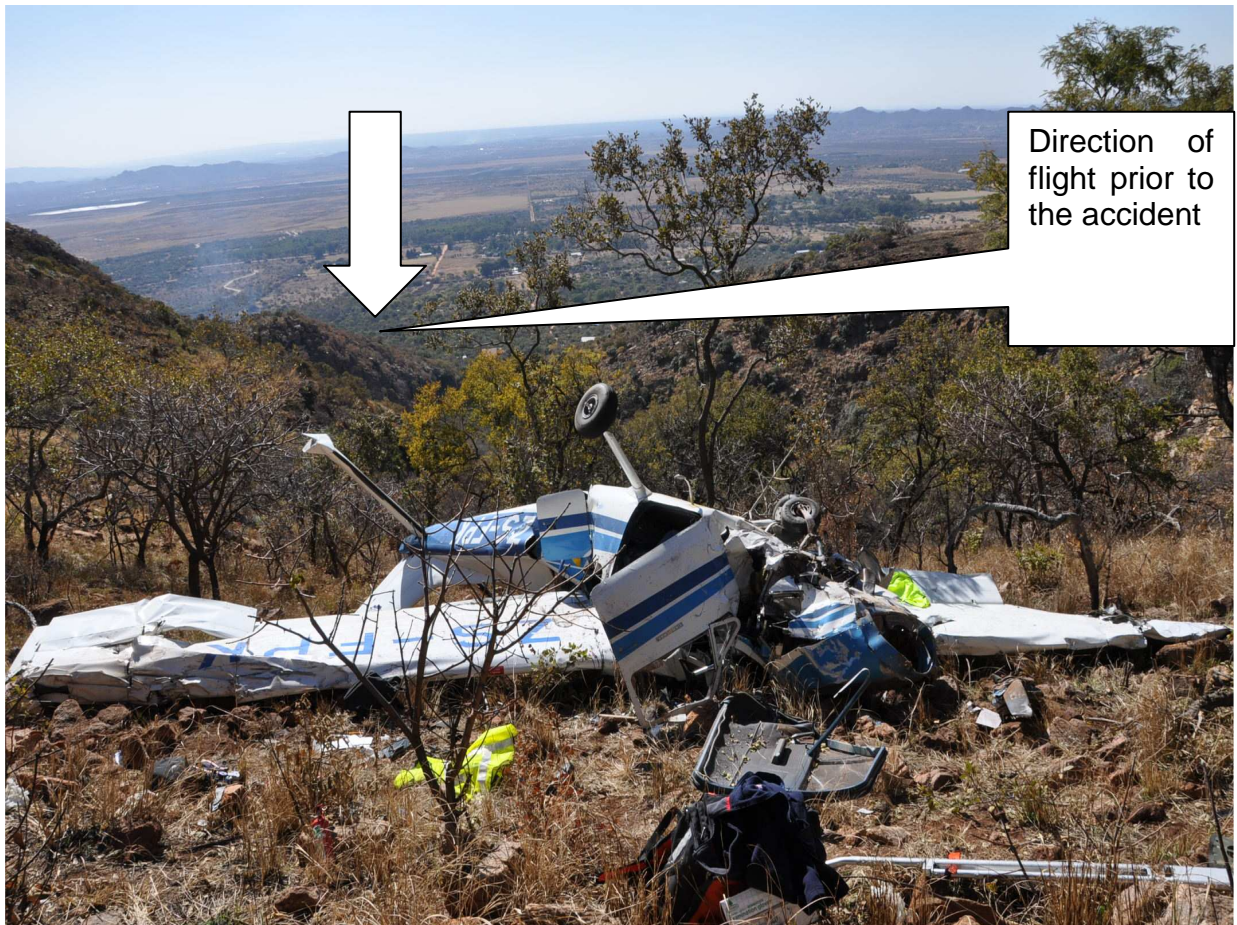
1.12.1 Prior to the accident the aircraft was flying in a southerly direction at a low altitude. It appears that the aircraft impacted a tree with the left-hand wing before it impacted with the ground and flipped over. The onsite investigation revealed no anomalies with the control surfaces or control cables.

Direction of flight prior to the accident

Figure 3: The wreckage of the aircraft

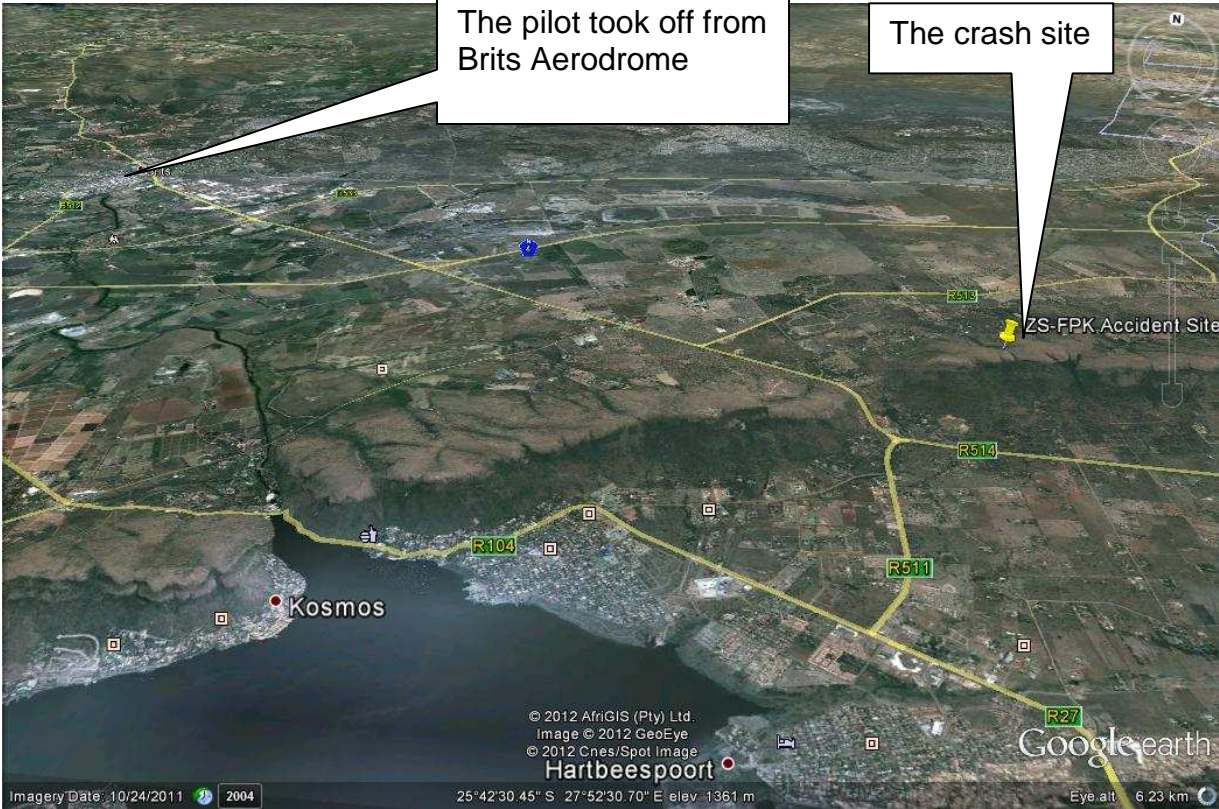
The pilot took off from Brits Aerodrome

The crash site

Figure 4: The crash site in relation to Brits Aerodrome
