AIRCRAFT ACCIDENT REPORT AND EXECUTIVE SUMMARY

Reference	CA18/2/3/8956	
Aircraft Registration	ZS-WYC	Date of Accident	09 August 2011		Time of accident	1530Z
Type of Aircraft	Atlas C4M (KUDU)		Type of Operation	Private		
Pilot-in-command Licence Type		Commercial	Age	31	Licence Valid	Yes
Pilot-in-command Flying Experience		Total Flying Hours	860.7		Hours on Type	139.3
Last point of departure		The Ranch private aerodrome:FAPP, (Limpopo province).				
Next point of intended landing		Rustenburg aerodrome: FARG, (North West province).				
Location of the accident site with reference to easily defined geographical points (GPS readings if possible)						
On a farm next to Rustenburg aerodrome at GPS co-ordinates determined to be: S 25°33.169' E 027°08.145' at an elevation of 3 892 feet AGL.						
Meteorological Information	Surface wind 340°, temperature 20°C, visibility +10 km.					
Number of people on board	1 + 2	No. of people injured	0	No. of people killed	0

AIRCRAFT INCIDENT REPORT

Name of Owner/Operator : Angels Way Trust
Manufacturer : Atlas Aircraft Corporation
Model : Atlas C4M Kudu
Nationality : South African
Registration Marks : ZS-WYC
Place : On a farm next to Rustenburg aerod

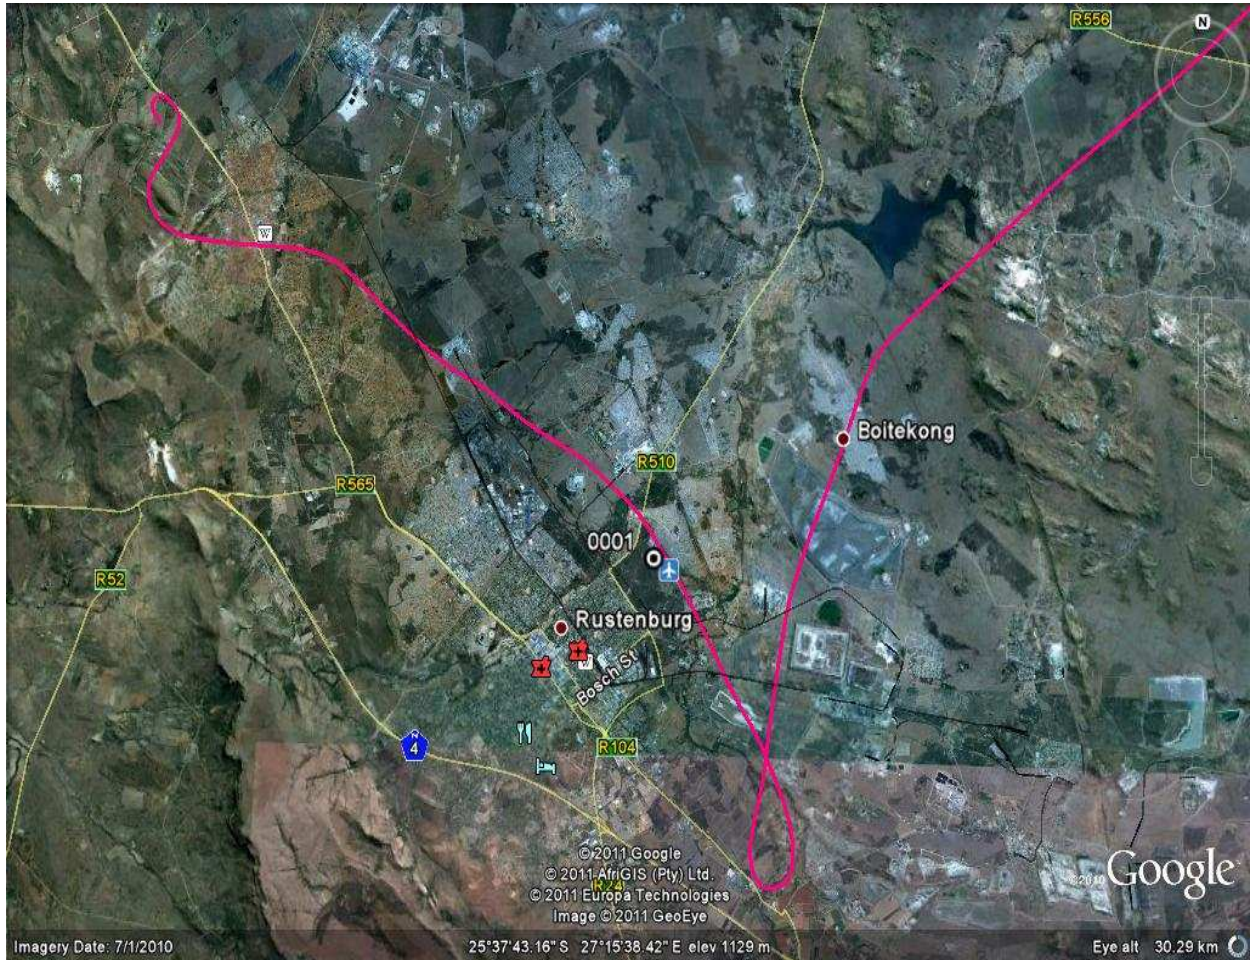
Figure 1: ZS-WYC flight path from the Ranch in pink.

- 1.8.1 The aircraft was fitted with standard navigation equipment for the aircraft type as approved at the time of certification.
- 1.8.2 The aircraft was also fitted with Gamin global positioning system (GPS). The GPS data was down loaded as it cab seen on figure 1.

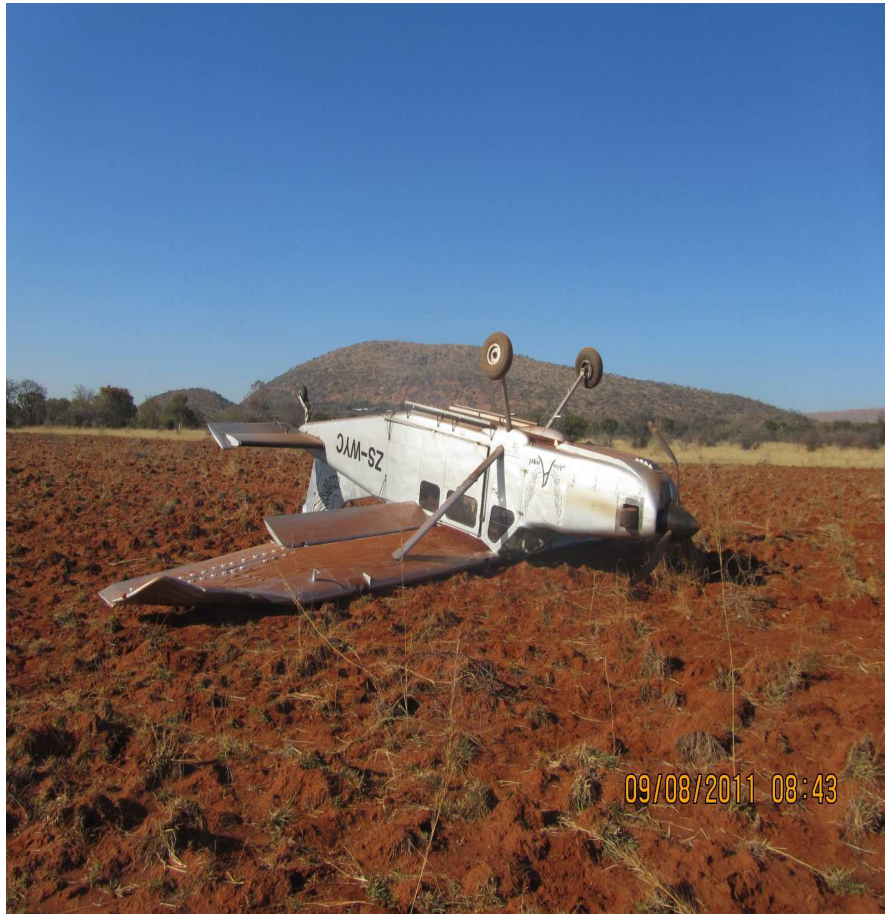
1.3.1 The aircraft was substantially damaged.

Figure 2: View of the aircraft at the accident site.

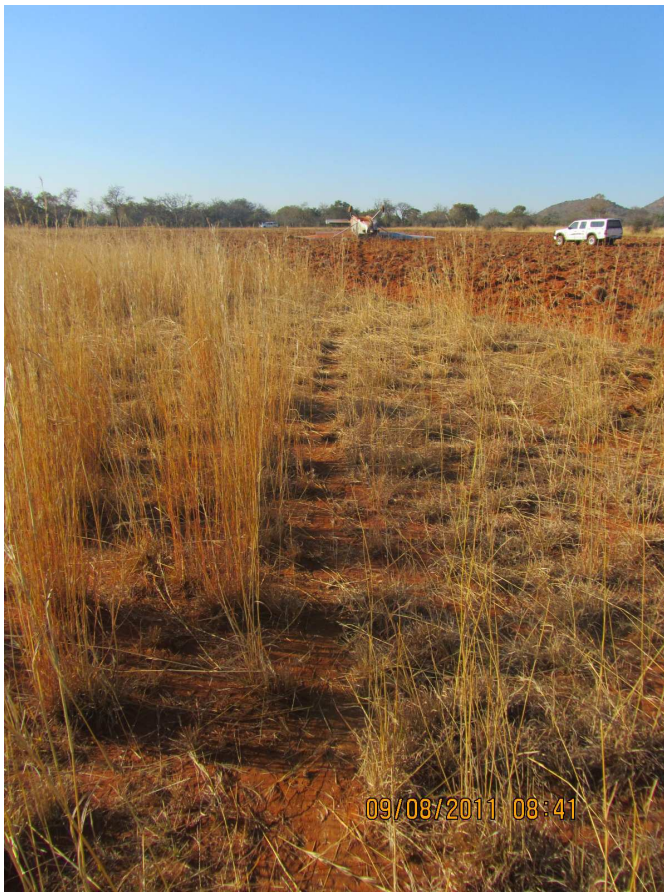
Figure 3: First point of impact and final position of the wreckage.

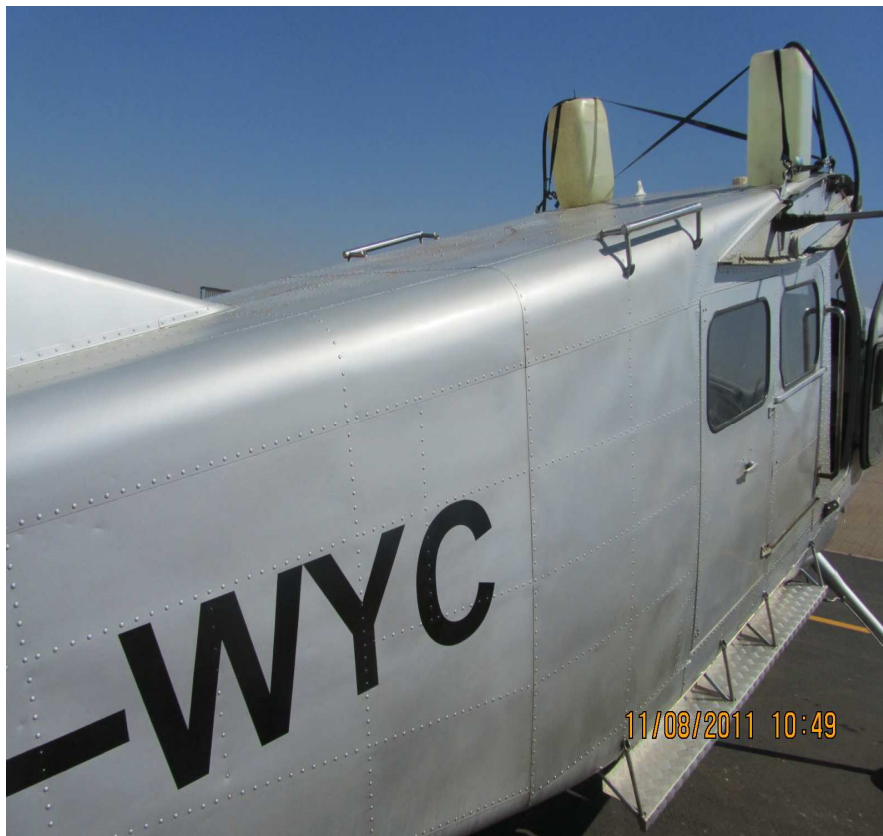
- 1.6.4 At Wonderboom a damaged propeller was removed and a serviceable one was fitted as per aircraft maintenance manual. Aviation gasoline (Jet A1) was gravity fed from the two containers (Left and Right) as it can be seen on the picture below and engine run was carried out.

Figure 4: View of the aircraft on the run up bay.

- 1.6.5 The engine was started. Fuel was selected and all parameters were met. The engine operated normally, and power was increased in stages until it was evident that it was capable of operating at full power.
