# CIVIL AIRCRAFT FACTUAL INCIDENT REPORT

CAV/INC/BOP/11

AIRCRAFT: CESSNA 208B CARAVAN

REGISTRATION: 5Y-BOP

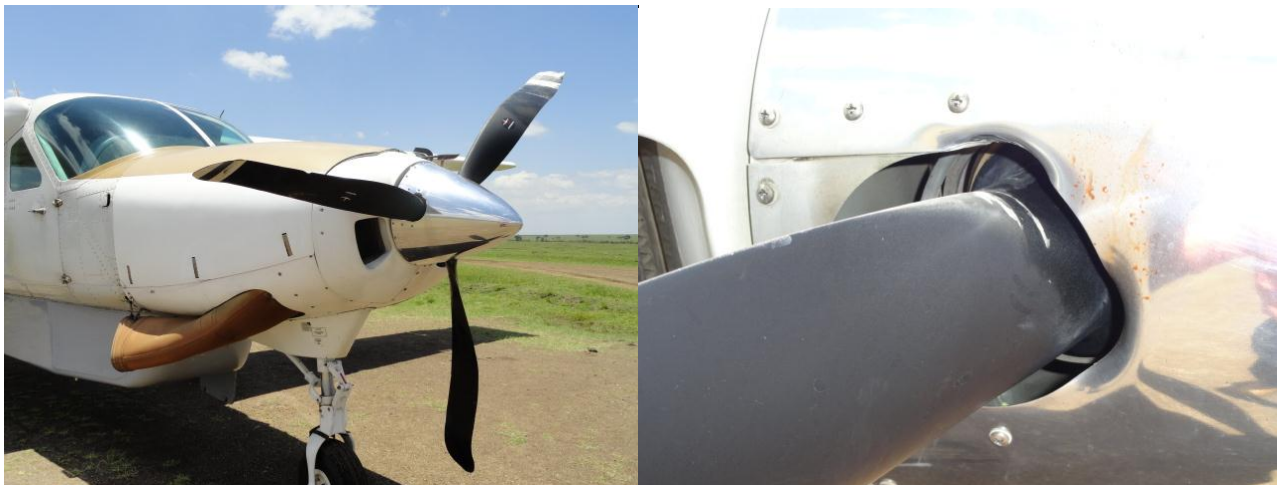
## 1.3. Damage to Aircraft

The propeller blades were bent as a result of impact with the animal. The propeller hub was also damaged and back plate broken. The starter fan belt was dislodged as a result of the impact.

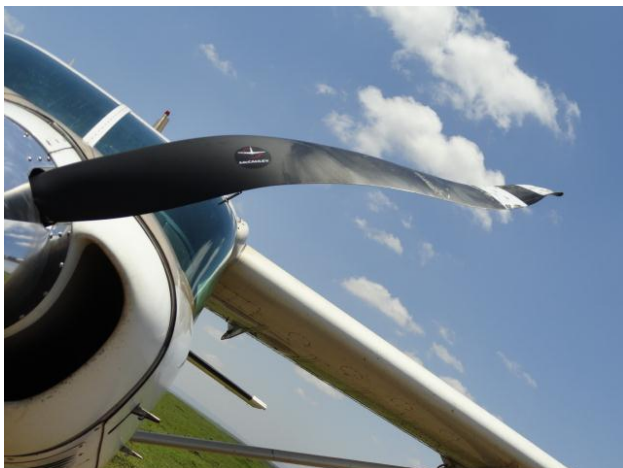
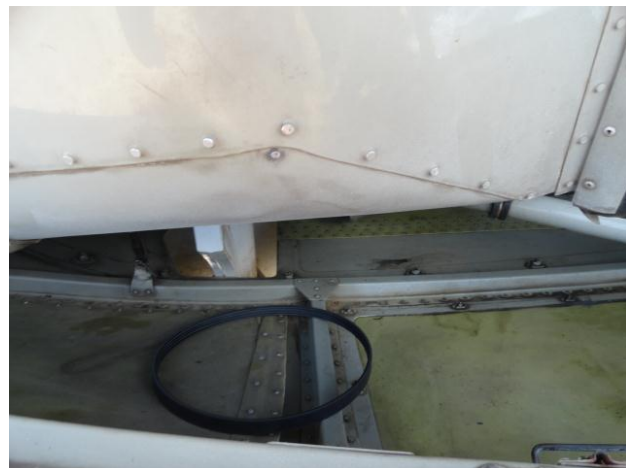
The aircraft structure remained intact after the incident except for the bending of propeller blades as a result of the animal strike. The propeller hub was damaged and the back plate broken. The starter fan belt was also dislodged.

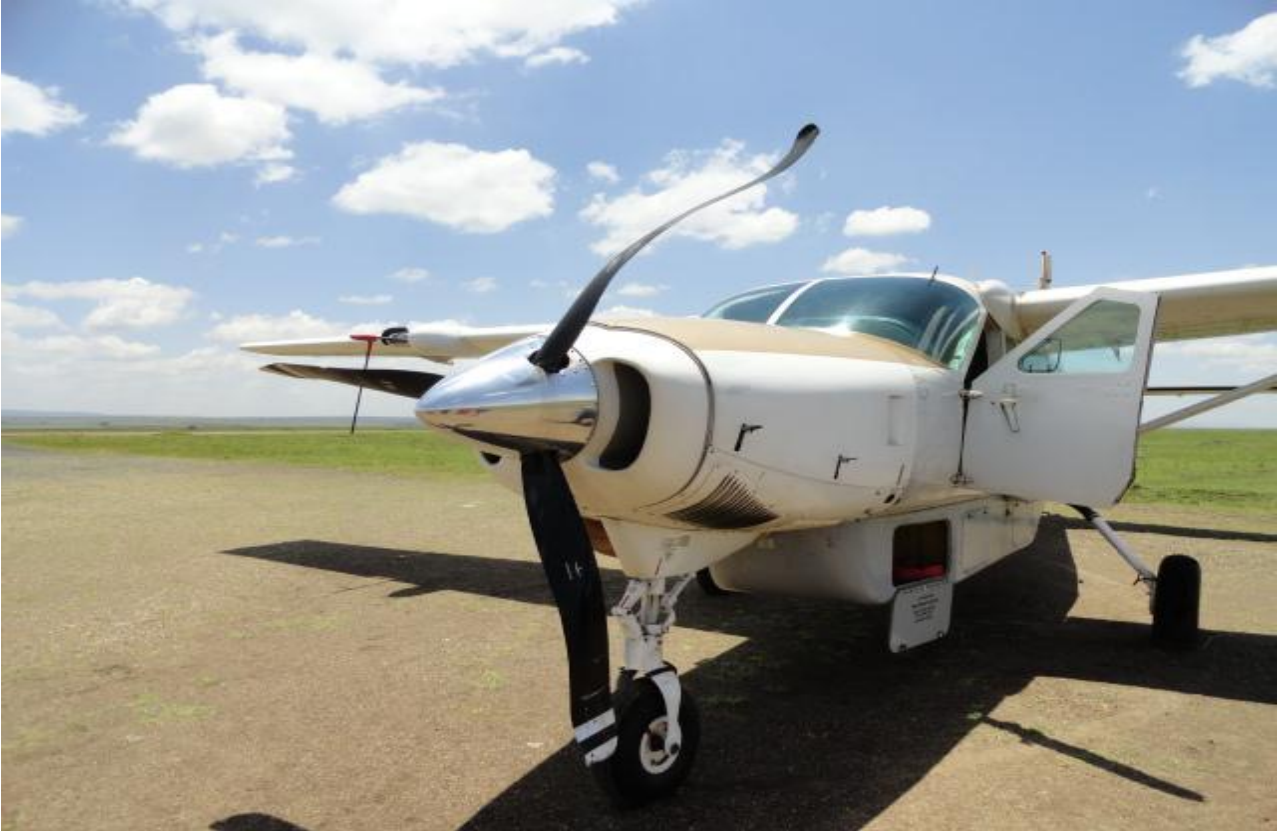
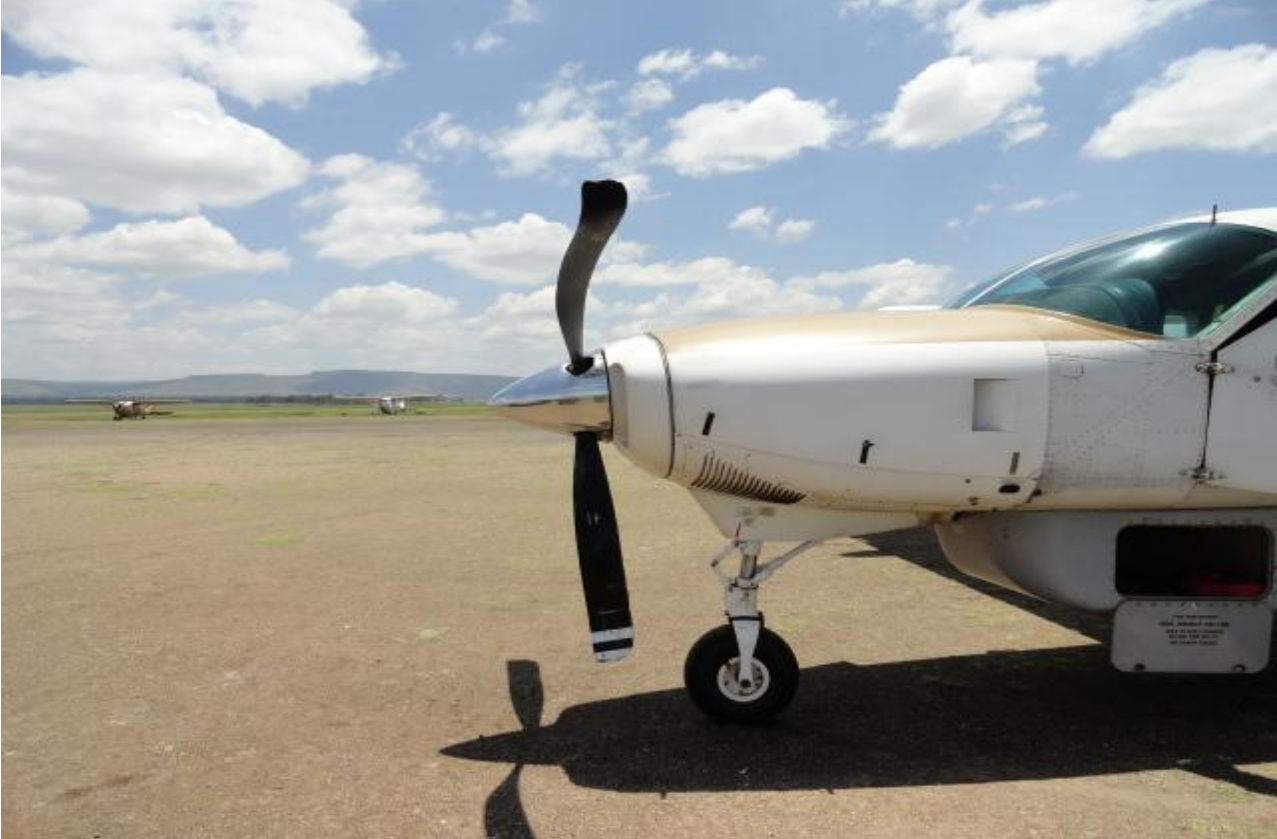
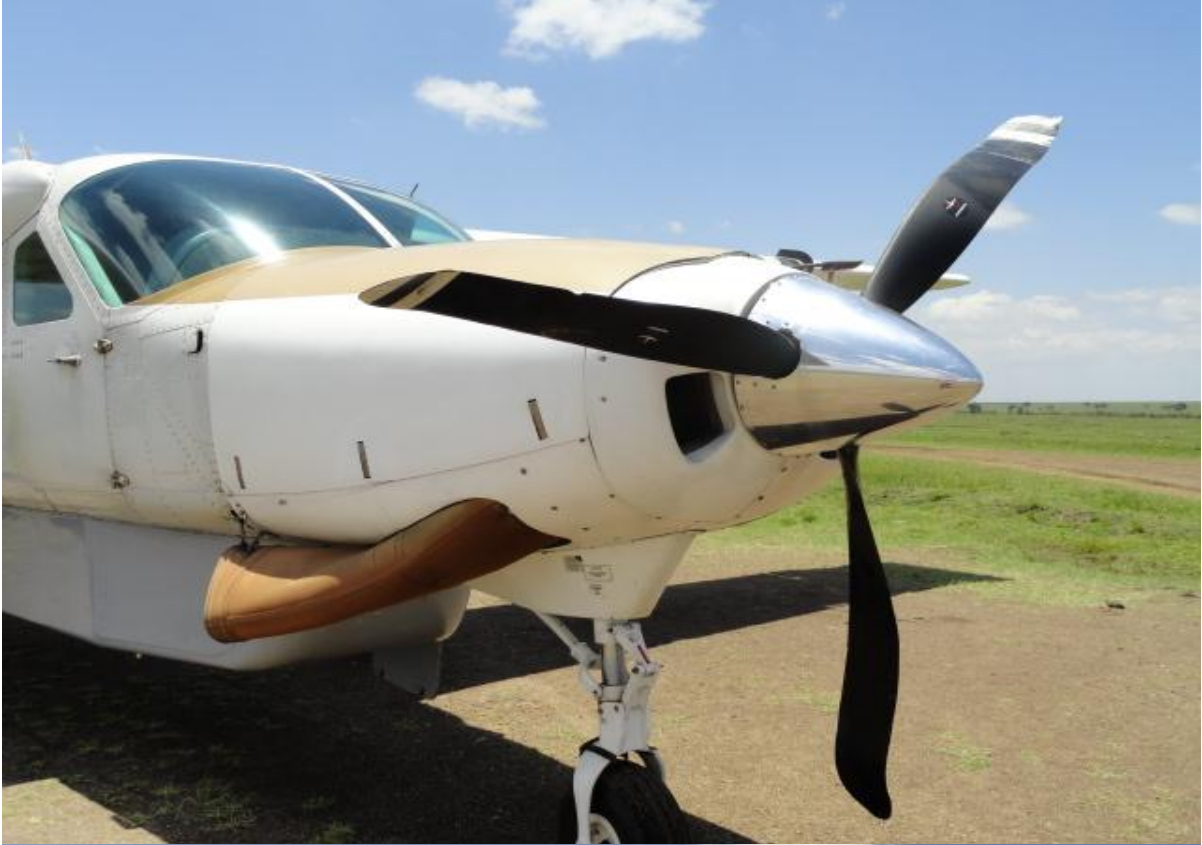
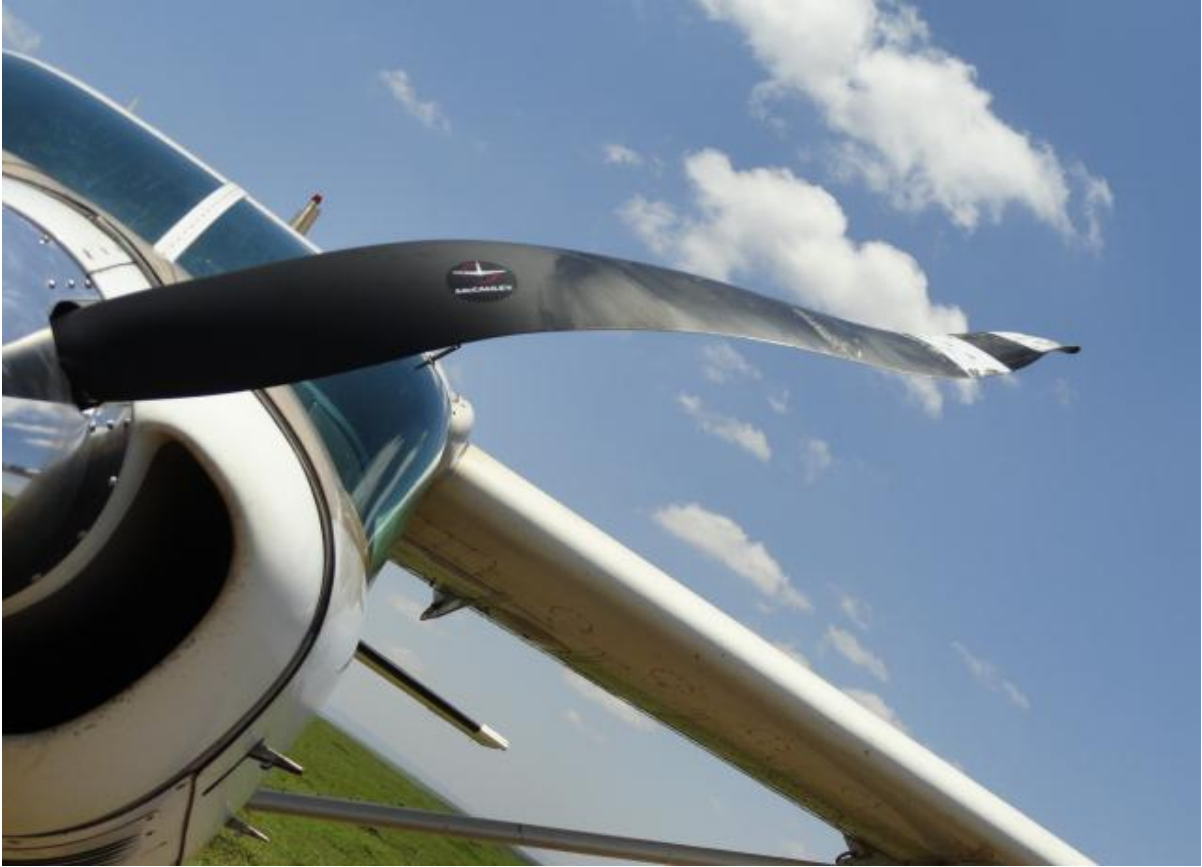
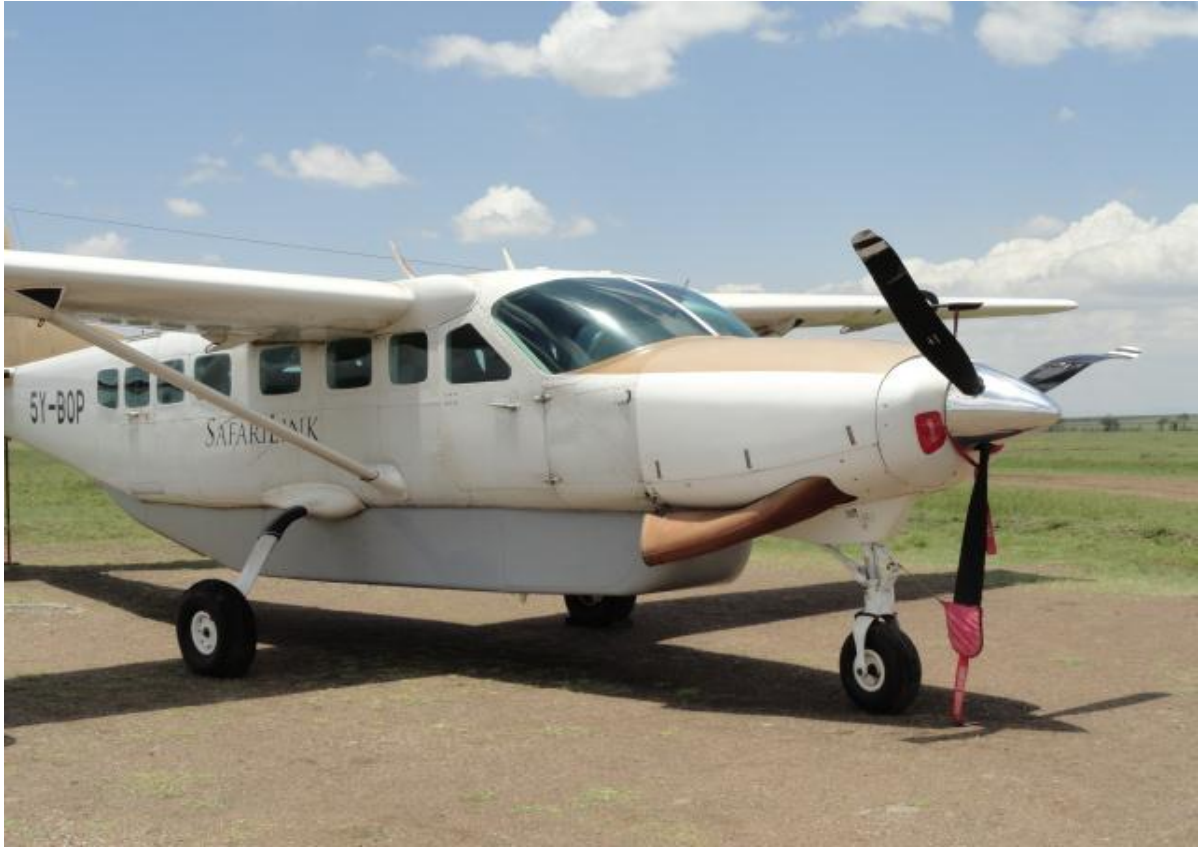
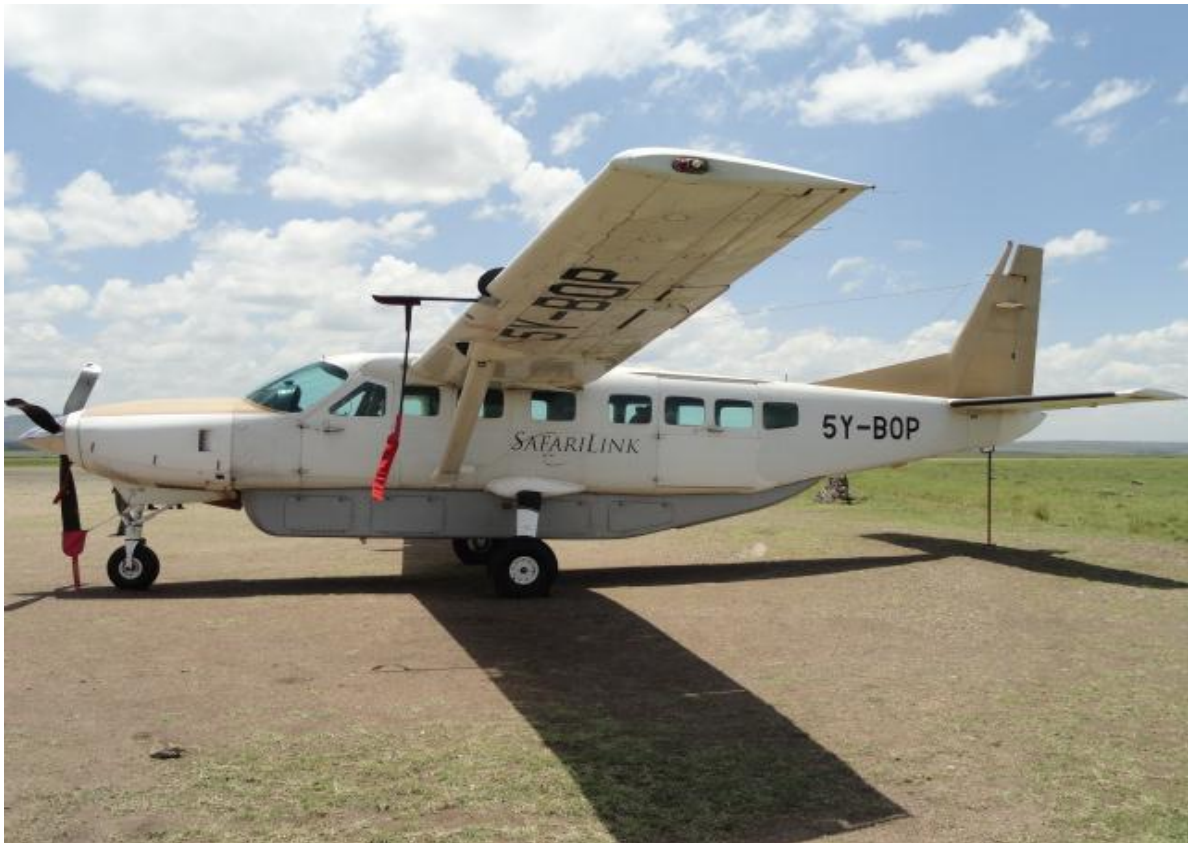
**Aircraft Photographs**

The propeller strike location was determined to be approximately 300 feet from the threshold of runway 27. Blood stains and animal remains were strewn over the propeller spinner and the underside of the left wing.
