Occurrence Investigation

AIRCRAFT ACCIDENT REPORT AND EXECUTIVE SUMMARY

Reference:	CA18/2/3/8974	
Aircraft Registration	ZS-SRX	Date of Accident	15 October 2011		Time of Accident	0530Z
Type of Aircraft	AT- 401B (Air Tractor)		Type of Operation		Agricultural	
Pilot-in-command Licence Type		Commercial	Age	33	Licence Valid	Yes
Pilot-in-command Flying Experience		Total Flying Hours	3236		Hours on Type	1200
Last point of departure		Private field in the Riversdale area in the Western Cape				
Next point of intended landing		Private field in the Riversdale area in the Western Cape				
Location of the accident site with reference to easily defined geographical points (GPS readings if possible)						
In a wheat field in the Riversdale area at GPS position S34 07.96 E21 09.633						
Meteorological Information		Surface Wind: South-Easterly at 5 kt; Visibility: 10 km; Temperature: 16°C				
Number of people on board	1 + 0	No. of people injured	0	No. of people killed	0	
Synopsis

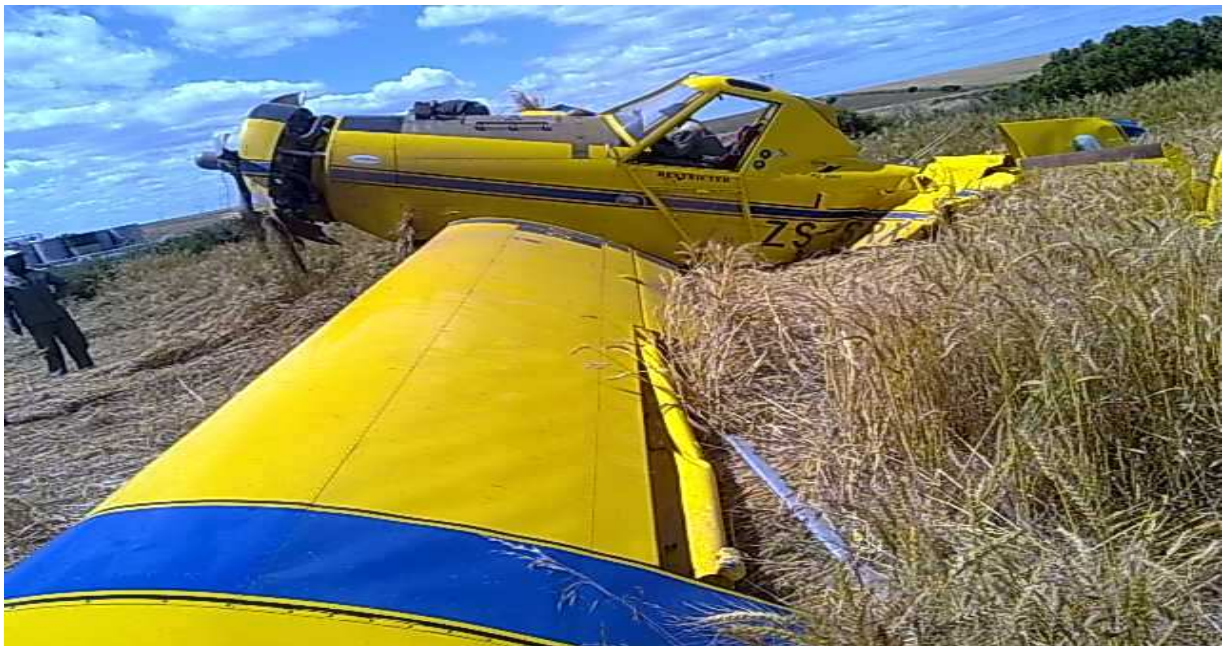
1.3.1 The aircraft sustained substantial damage.

Figure1, shows the damage caused to the aircraft.

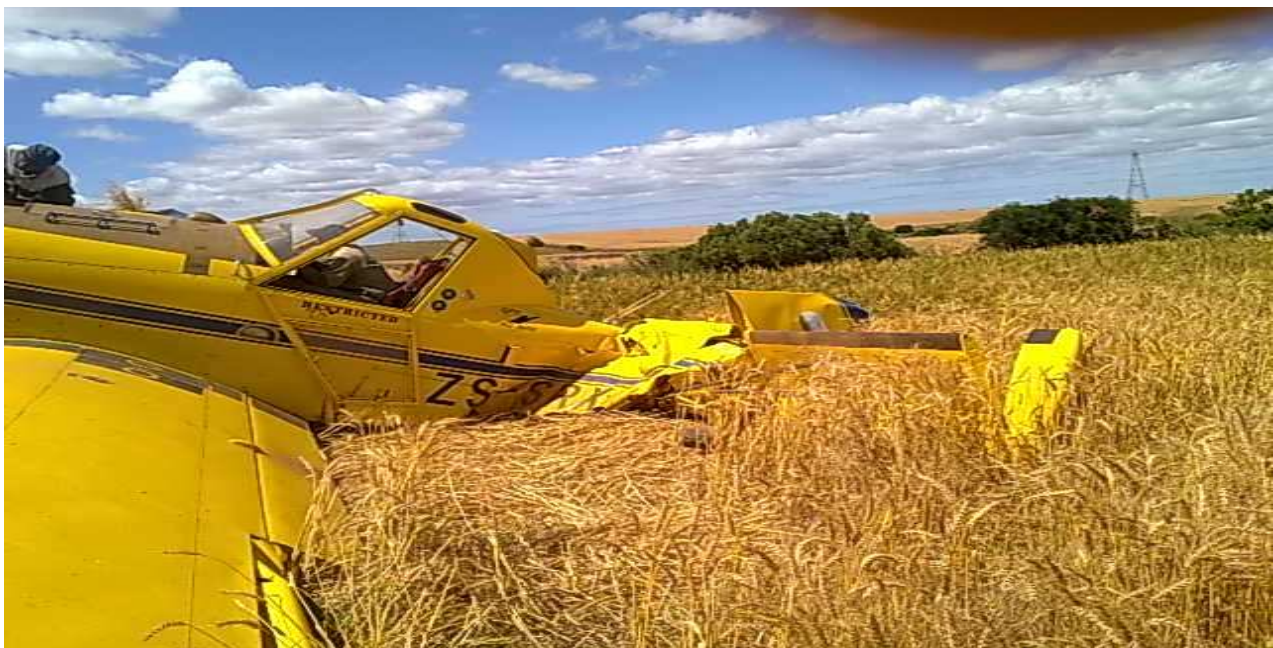
1.12.1 After collision with the power lines, the aircraft's nose abruptly pitched down and struck the ground approximately 20 m from the power lines and the left undercarriage broke off. The aircraft's left wing struck the ground, swung around at least 180 degrees and then came to rest approximately 100 m from the power lines.

Figure 3, shows the point of rest of the aircraft after impact.
