AIRCRAFT INCIDENT REPORT AND EXECUTIVE SUMMARY

Reference:	CA18/3/2/0876	
Aircraft Registration	ZS-ACS	Date of Incident	16 November 2011		Time of Incident	1717Z
Type of Aircraft	King Air 200		Type of Operation	Training		
Pilot-in-command Licence Type	Air Transport		Age	52	Licence Valid	Yes
Pilot-in-command Flying Experience	Total Flying Hours		10723		Hours on Type	862.30
Last point of departure	Wonderboom Aerodrome (FAWB) in Gauteng					
Next point of intended landing	Wonderboom Aerodrome (FAWB) in Gauteng					
Location of the incident site with reference to easily defined geographical points (GPS readings if possible)						
Runway 11 at Wonderboom Aerodrome						
Meteorological Information	Surface Wind: 320/05 Visibility: 10km Temperature: 27°C					
Number of people on board	2+1	No. of people injured	0	No. of people killed	0	
Synopsis	<p>The aircraft took-off uneventfully from Wonderboom Aerodrome on a local training flight in the General Flying Area with the intention to land back at Wonderboom Aerodrome. During the training exercises, the right hand main landing gear failed to extend. After unsuccessful attempts to extend the landing gear, the aircraft landed on Runway 11 with t

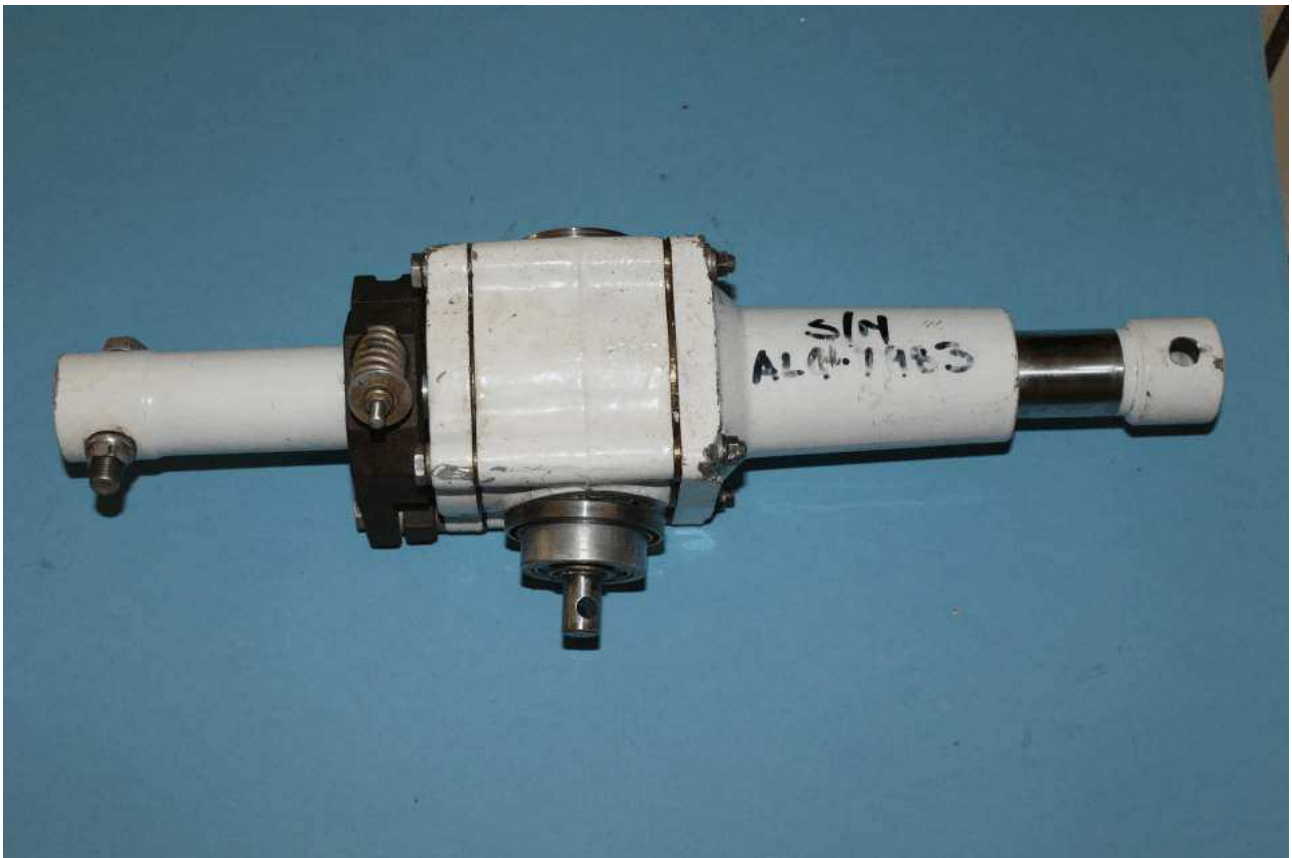
1.16.1 The aircraft was recovered to an AMO (Aircraft Maintenance Organisation) where the aircraft was put on jacks and retraction tests were done in order to check the operation of the landing gear system. It was discovered that the right hand main landing gear actuator had failed internally (see picture below).

Figure 2 showing the right hand main landing gear actuator before disassembly

- 2.4 Retraction tests performed by the AMO in the presence of the Investigator-In-Charge revealed that the right hand main landing gear failed to extend due to internal damage caused to the right hand main landing gear actuator.
- 2.5 The landing gear hydraulic system configuration of the Beech King Air 200 is such that should the actuator cease to function, extension of the landing gear would not have been possible. Failure of this component would produce a “lock-up” and disable any attempt (normal or emergency) by the pilot to retract or extend the gear.
- 2.6 Due to the fact that the right hand main landing actuator was defective, it was not possible to extend the right hand main landing gear with both the normal and emergency system.

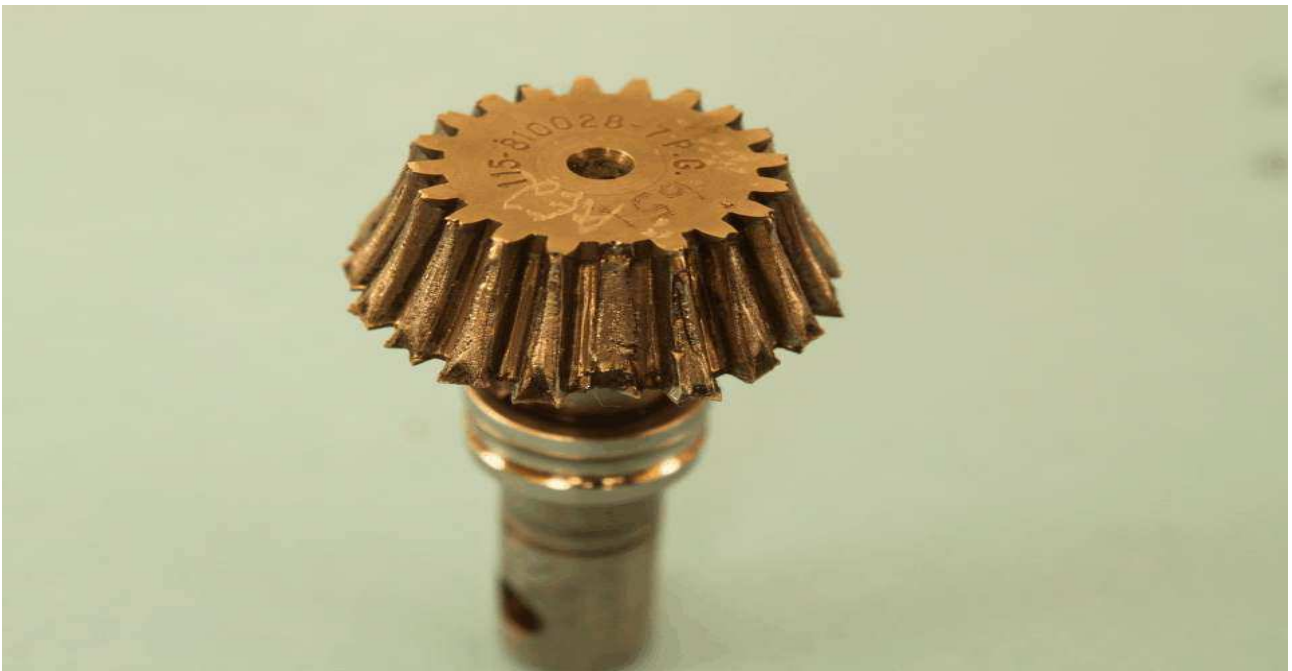
1.16.2 The right hand main landing gear actuator was submitted for metallurgical examination and it was found that the two bevel gears in the actuator showed extensive wear on the teeth and some of the teeth were missing as shown below:

Figure 2 showing the extensive wear of teeth and missing tooth on the small drive gear.

1.16.4 It was concluded from the metallurgical examination that the actuator failed to extend the undercarriage as a result of extensive wear and tooth breakage in both the bevel gears where failure would have occurred when a fragment became trapped between the gears, preventing them from meshing and causing the undercarriage drive motor to trip on overload.

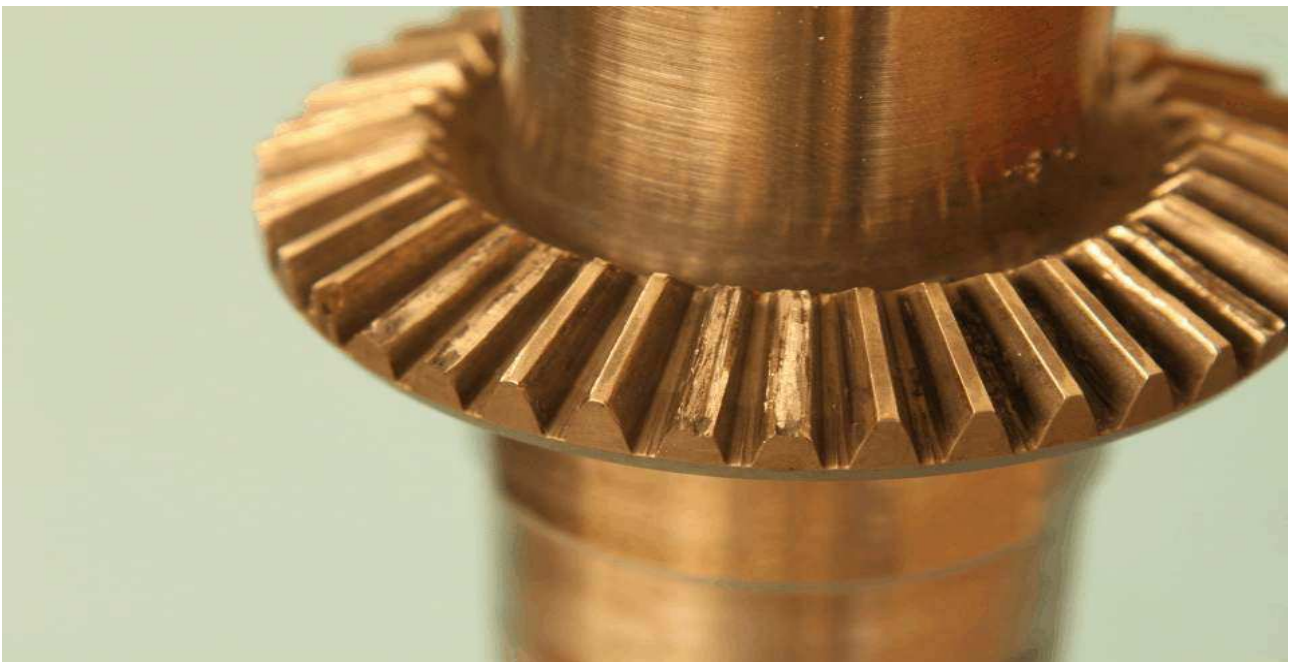
Figure 3 showing wear of teeth and missing teeth on large drive gear
