AIRCRAFT ACCIDENT REPORT AND EXECUTIVE SUMMARY

Reference:	CA18/2/3/8981	
Aircraft Registration	ZU-YJK	Date of Accident	20 November 2011		Time of Accident	0920Z
Type of Aircraft	Vans RV-7 A		Type of Operation		Private	
Pilot-in-command Licence Type		Private	Age	70	Licence Valid	Yes
Pilot-in-command Flying Experience		Total Flying Hours	111.0		Hours on Type	63.6
Last point of departure		Brits Aerodrome (FABS), North West Province				
Next point of intended landing		Brits Aerodrome (FABS), North West Province				
Location of the accident site with reference to easily defined geographical points (GPS readings if possible)						
3 Berge Caravan Park, Brits area (GPS co-ordinates: S25°34'59" E022°45'40") at an elevation of 3 900 f t						
Meteorological Information		Wind speed 6 kt, wind direction 040M, visibility 1 0 km, temperature 23°C, cloud cover scattered at 3 000 ft				
Number of people on board	1 + 0	No. of people injured	0	No. of people killed	1

AIRCRAFT ACCIDENT REPORT

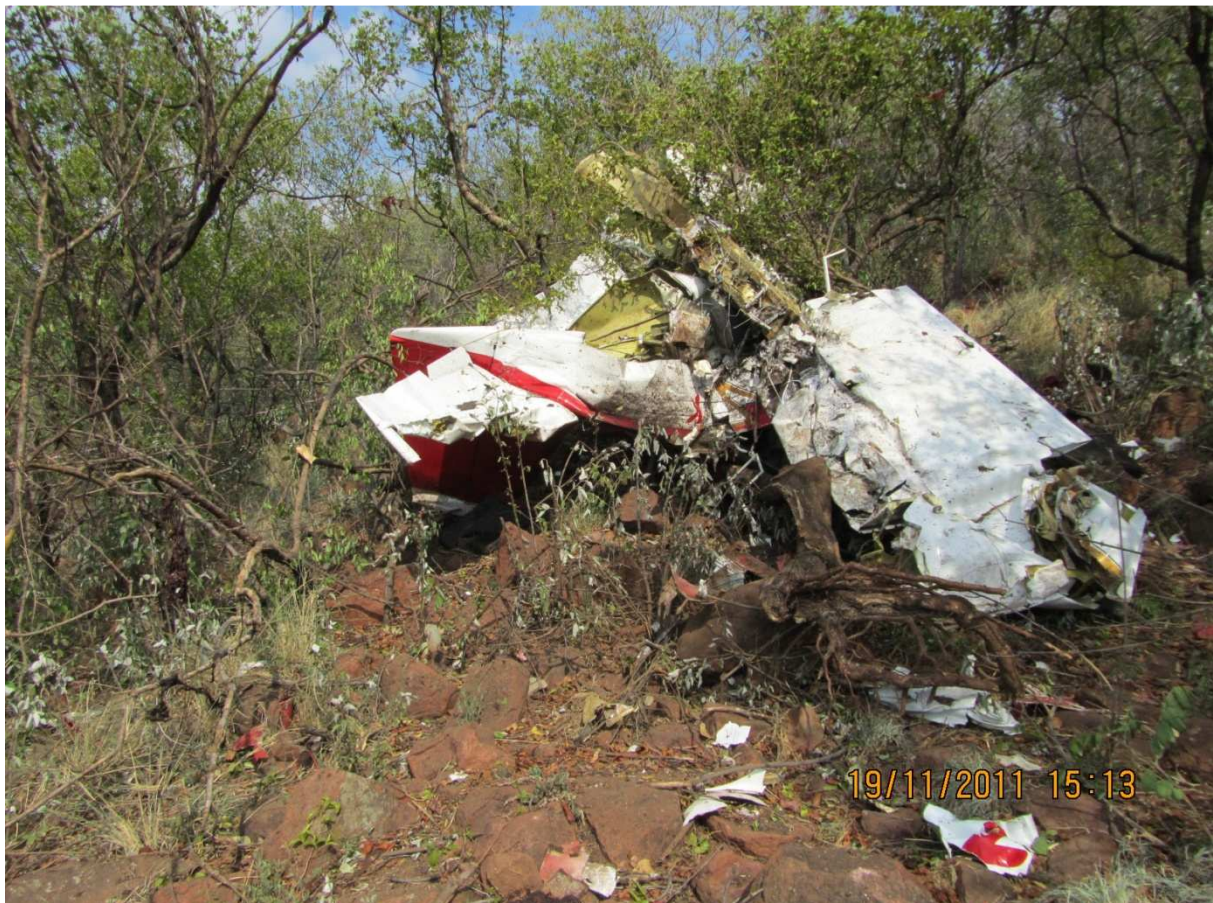
- 1.3.1 The aircraft was destroyed during the impact sequence.

Figure 1 The aircraft wreckage

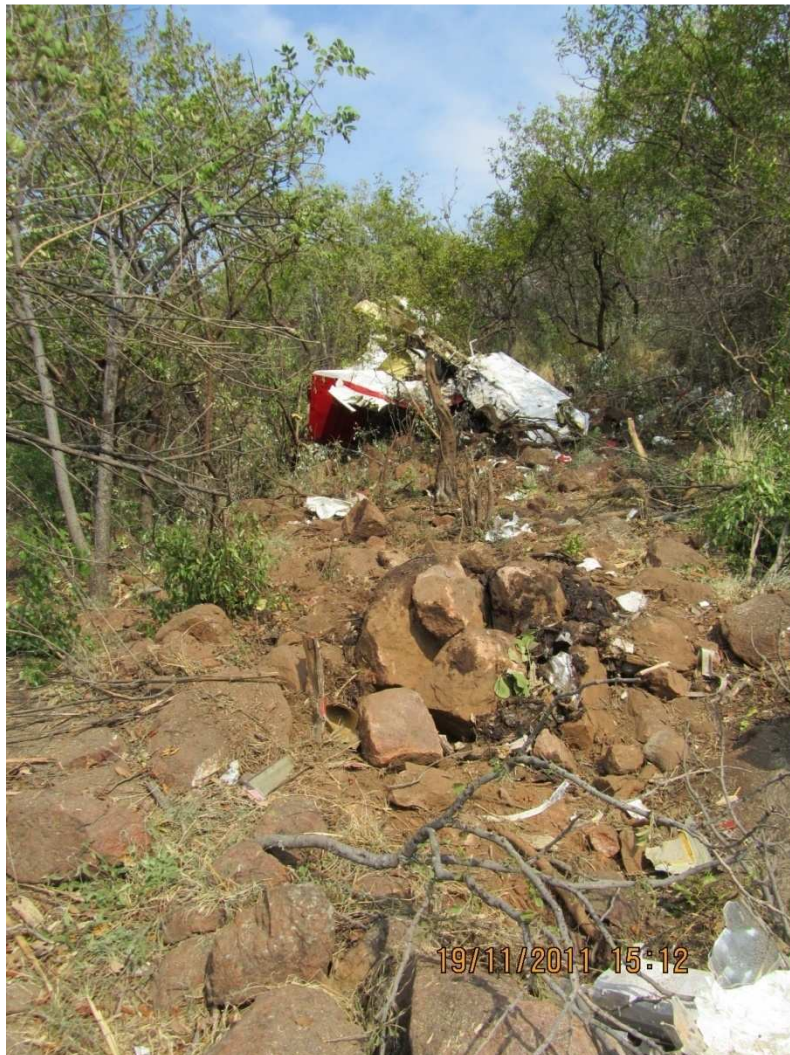
1.4.1 Minor damage was caused to the surrounding vegetation.

Figure 2 Minor damage to surrounding vegetation

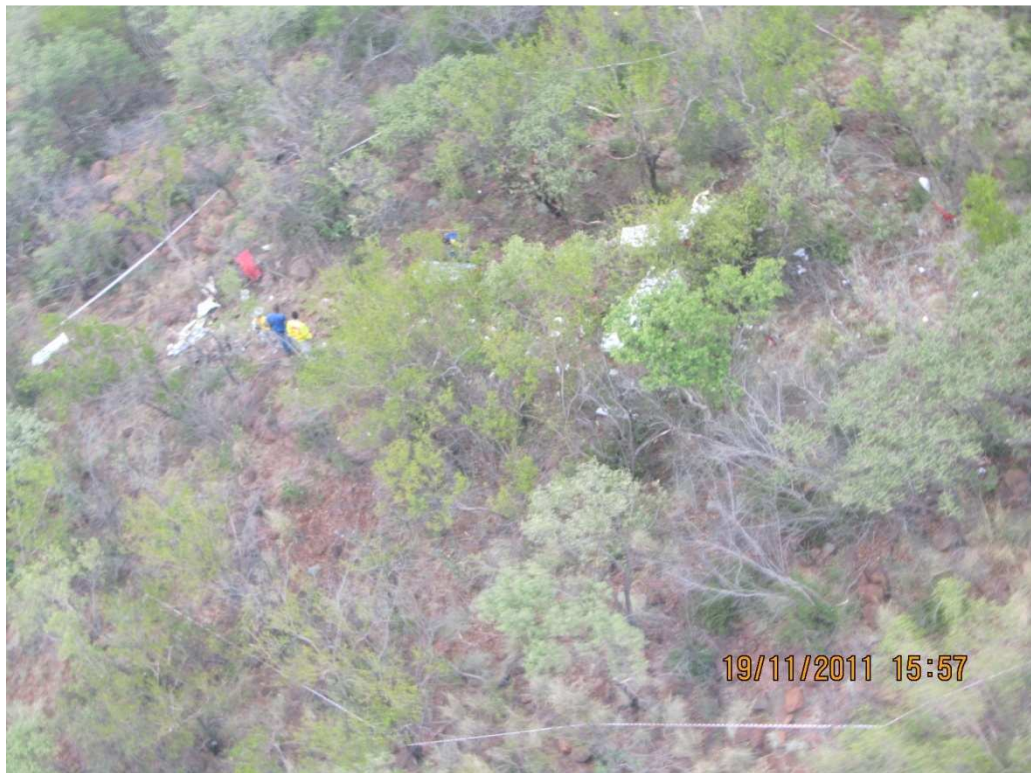
Debris was scattered in a radius of 25 m on high ground at a height of 3 900 ft.

Figure 3 Debris path

The aircraft impacted with rocky terrain and slid uphill for a further 11 m before coming to rest against a tree.
