ACCIDENT REPORT

HELICOPTER AS350B2 REGISTRATION 5Y-HLI

ACCIDENT SUMMARY REPORT

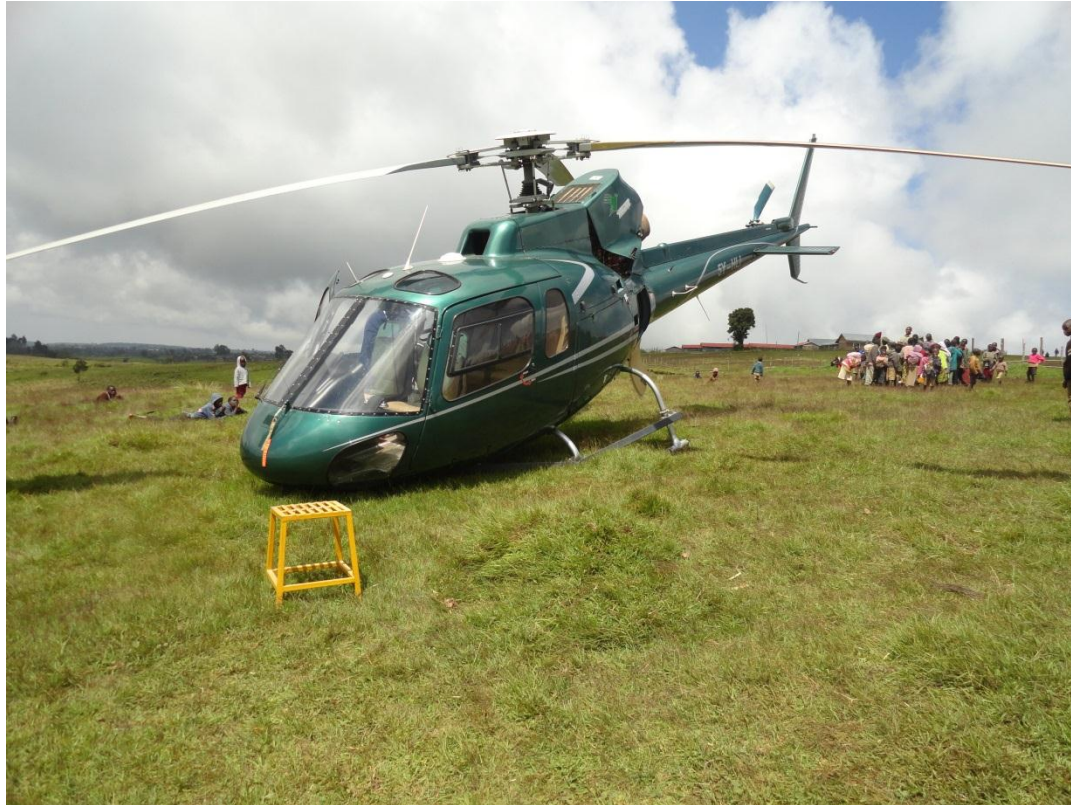
1.3 Damage to aircraft

The helicopter suffered damage on the left skid as a result of the hard sideward impact with uneven ground surface during the landing. The left front cross tube was bent inwards damaging the lower Canopy Cowling.

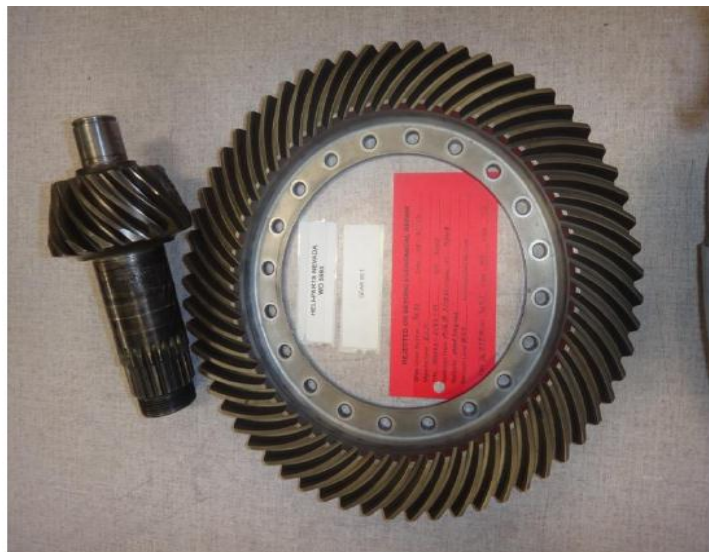
Pinion and Gear Wheel

The Gearbox Reduction Gear was removed and examined as per the maintenance manual procedures due to over torque (defect) that had occurred. There were no sign or evidence of failure or defect that may have occurred prior to the accident.

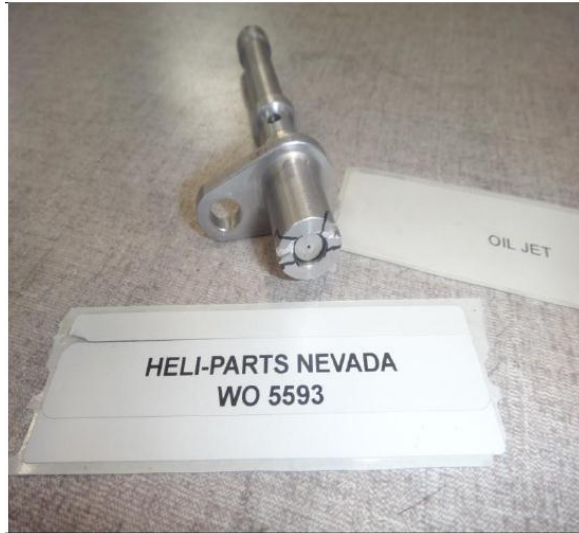
Oil Jet

The Oil jet was found worn out. The Upper Housing was found with enlarged bolt holes which exceeded the allowed dimensional limits.

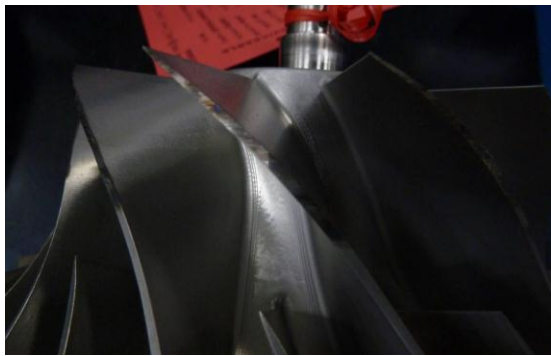
There was evident rub beyond allowable limits on the Centrifugal Compressor blade tips. Through rub damage was evident on the Centrifugal Compressor cover.

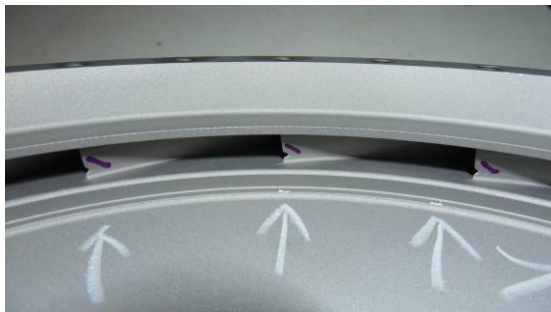
The engine Diffuser Assembly had evidence of erosion beyond allowable limits

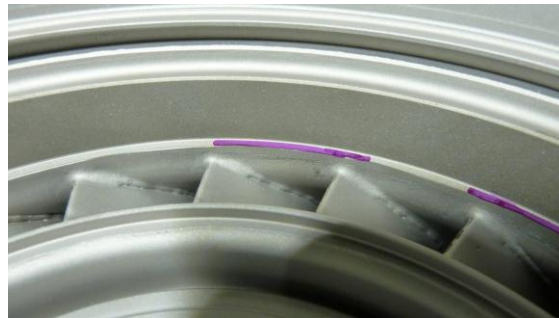
The 1st Stage Nozzle Guide Vane had evident Crazing and cracks
