## AIRCRAFT ACCIDENT REPORT AND EXECUTIVE SUMMARY

Reference:	CA18/2/3/8993	
<b>Aircraft Registration</b>	ZS-PLR	<b>Date of Accident</b>	18 December 2011	<b>Time of Accident</b>	0750Z	
<b>Type of Aircraft</b>	Cessna 206		<b>Type of Operation</b>	Private		
<b>Pilot-in-command Licence Type</b>		Commercial	<b>Age</b>	52	<b>Licence Valid</b>	Yes
<b>Pilot-in-command Flying Experience</b>		Total Flying Hours	2284		Hours on Type	1689
<b>Last point of departure</b>		Secunda Aerodrome (FASC) (Mpumalanga)				
<b>Next point of intended landing</b>		Kimberley (FAKM) ( Northern Cape)				
<b>Location of the accident site with reference to easily defined geographical points (GPS readings if possible)</b>						
On a corn field near Parys in the Free State Province						
<b>Meteorological Information</b>		Surface wind: 315° 10 knots, temperature: 24°, v isibility: CAVOK				
<b>Number of people on board</b>	1+1	<b>No. of people injured</b>	0	<b>No. of people killed</b>	0

**Name of Owner/Operator** : Lojanama Aviation CC  
**Manufacturer** : Cessna  
**Model** : U206D  
**Nationality** : South African  
**Registration Marks** : ZS-PLR  
**Place** : Parys  
**Date** : 18 December 2011  
**Time** : 07

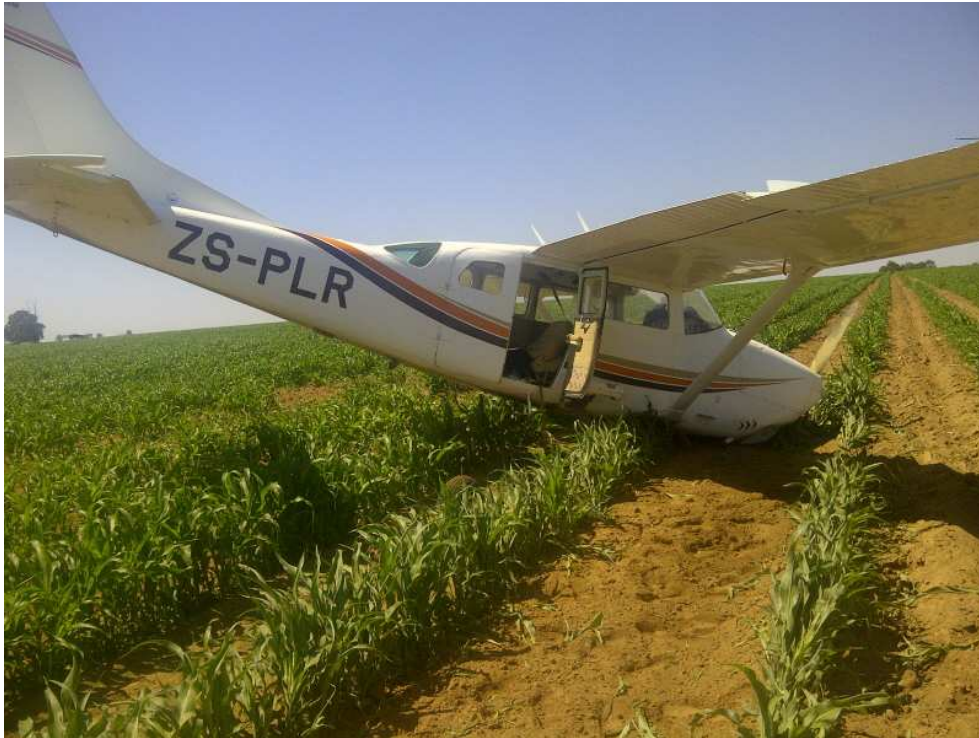
1.3.1 The aircraft sustained substantial damage to the nose gear, the left wing tip, the propeller as well bottom side of the engine cowling.

1.12.1 The accident happened on a corn field. The aircraft landed at relatively high speed, the nose gear dug into soft ground and broke off, before it came to rest in a nose down attitude.

1.12.2 The aircraft sustained substantial damage to the undercarriage and the engine cowling.

Photo 1: Showing the aircraft after it came to rest

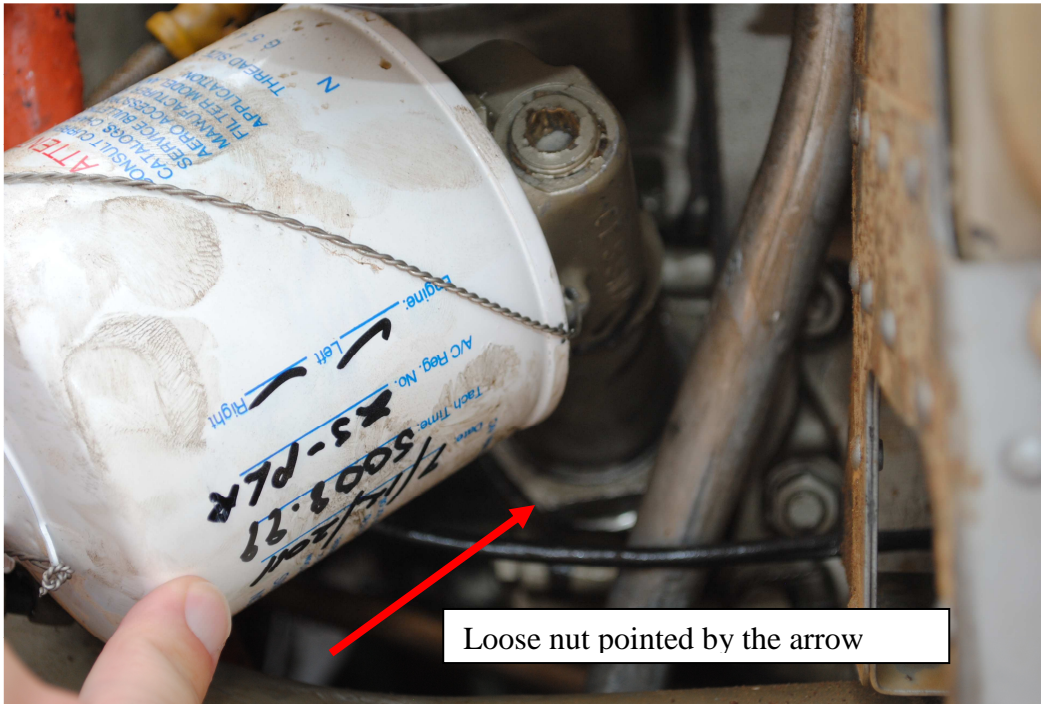
- 1.16.1 The aircraft was recovered to an approved maintenance facility for further investigation. The engine was removed from the airframe to determine the cause of failure.
- 1.16.2 During the examination it was discovered that the engine seized in flight. The cause of the engine seizure was established to be loss of oil. Further investigation to why the engine lost oil, it was discovered that the oil filter arm gland nut was loose. This nut was found loose even though it was wire locked. This gave the indication that the nut might have been improperly tightened before the wire locking was done.

**Photo 2: Showing the oil filter**

- 2.2 The aircraft was recovered to an approved maintenance facility. The engine was removed from the airframe. During the engine examination, it was discovered that the engine had seized. The cause was attributed to a complete engine oil loss in flight. The source of the oil leak from the engine was traced to an oil filter arm gland nut which was found loose.

- 2.3 Although the locking wire was found intact, there is a possibility that the oil filter arm gland nut was not properly tightened before the wire locking was done.

- 3.1.1 The pilot was a holder of a valid private pilot licence.
- 3.1.2 The aircraft had a valid airworthiness certificate.
- 3.1.3 Weather conditions were reported to be fine; it was not a factor in this accident.
- 3.1.4 The accident happened in daylight conditions.
- 3.1.5 Post accident examination of engine system revealed that the engine failed due to a complete engine oil loss.
- 3.1.6 The engine oil leak was caused by a loose oil filter arm gland nut.
