AIRCRAFT ACCIDENT REPORT AND EXECUTIVE SUMMARY

Reference:	CA18/2/3/9000	
Aircraft Registration	ZU-BPC	Date of Accident	6 January 2012		Time of Accident	0800Z
Type of Aircraft	Thunderbird MK V		Type of Operation		Private	
Pilot-in-command Licence Type		Microlight Pilot	Age	54	Licence Valid	Yes
Pilot-in-command Flying Experience		Total Flying Hours	195.24		Hours on Type	195.24
Last point of departure		Eagles Creek Airfield - Gauteng Province				
Next point of intended landing		Eagles Creek Airfield – Gauteng Province				
Location of the accident site with reference to easily defined geographical points (GPS readings if possible)						
On grass runway at Eagles Creek Airfield.						
Meteorological Information		Wind direction: Calm, Wind speed: Calm, Temperature: 24°C, Cloud cover: clear skies, Cloud base: clear skies, Visibility: Good.				
Number of people on board	1 + 0	No. of people injured	0	No. of people killed	0	
Synopsis						
<p>The owner/pilot flew the aircraft on a private flight from Eagles Creek Airfield with the intention to fly to the general flying area. After take-off, during climb out, the engine suddenly stopped. The pilot attempted to restart the engine, but he was

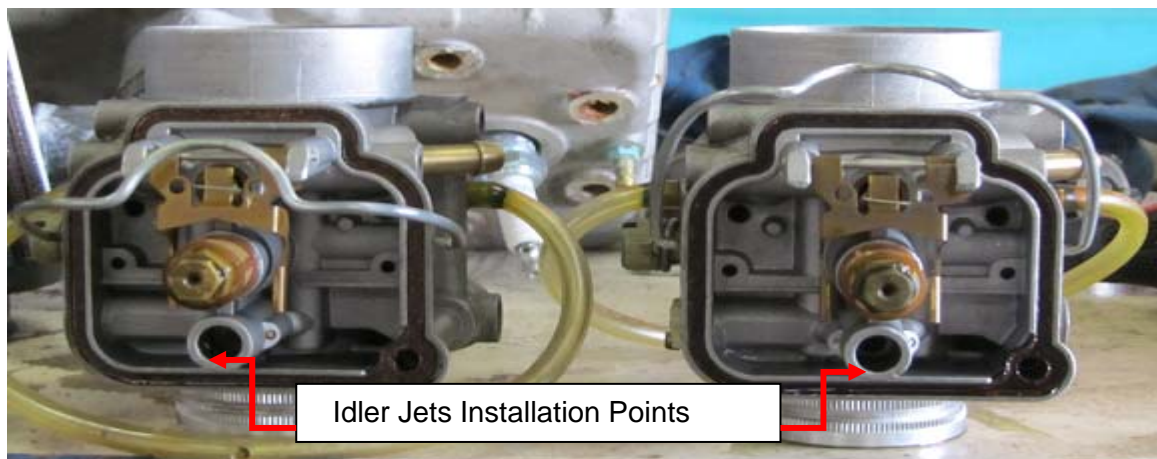
1.16.2 Engine Carburetors: According to the Rotax Maintenance Schedule, the carburetors had to be completely serviced at 150 hours and again at 300 hours. It does not appear as though the owner complied with the requirements of the maintenance schedule. The evidence found shows that the carburetors fitted on the aircraft was serviced when the engine was overhauled at 296 hours on 7 May 2009.

Figure 1, shows the carburetors of the aircraft.

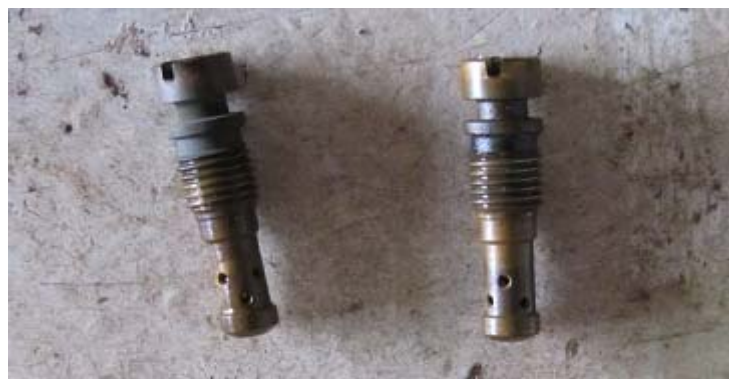
Figure 2, shows the idler jets removed from the carburettor.

- 2.5 The two brass needle jets were then removed from the carburettors and examined. The aim was to determine if the jets throats (small hole) were clear of being clogged. The proof found showed that the jets were indeed clogged with an unidentified substance. The result was that the fuel could not be drawn into the engine through the clogged jets. As such, internal combustion was virtually impossible as the jets could not supply fuel for the combustion to be sustained. Thus, if not enough fuel gets to the engine, the symptom will be poor running and no power available when the throttle is being opened. In this case, there was a loss of engine power and eventually the engine stopped. The evidence of this can be seen by the piston that seized inside the engine.

Note: It is recommended that the idle jets should not be cleaned and reused after it was found blocked by sludge, but replaced with new jets.

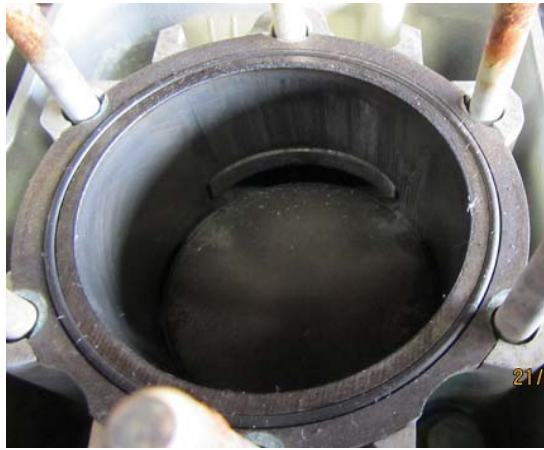
Figure 3, shows the piston that seized.

- (iv) The engine cylinders were also examined during the investigation. One of the pistons inside the engine failed. There were scoring marks on the shoulder of the cylinder which was caused by the piston rings.

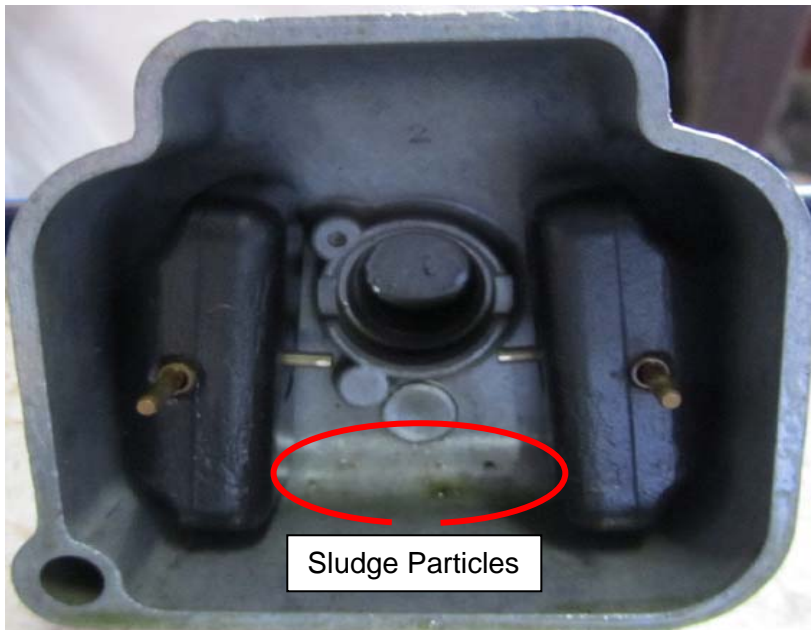
1.16.3 The fuel was checked during the investigation and evidence was found of small particles of contamination inside the fuel system. The small particles appeared to be some sort of sludge. In order to understand how sludge forms in fuel, the following information is available:

Figure 4, shows carburettor bowl with small particles of sludge inside.

- 2.6 The fuel that was inside the bowls was examined with the aim to identify the substance that clogged the jets. The evidence found showed that the fuel was contaminated. Though not conclusively determined during the investigation, the contamination may have been sludge that formed. Ordinarily, the sludge will form by blending and mixing fuel oils of different types; either at the refinery or in the consumers tank. The sludge forms due to reactions of moisture, heat and oxidation. Initially the sludge is very small, thus it can be drawn into small spaces or through small holes easily. But over time the sludge grows in size and may cause blockages, the same way like it did with the needle jets being clogged.

2.7 In order to prevent engine failures of this nature, it is important to ensure that the fuel used is free of contamination and filtered if required. The fuel should be checked during each pre-flight inspection to determine if contamination exists. It is important to ensure that the fuel used which is stored in drums is free from contamination prior to refuelling the aircraft. The fuel used should be of good quality and within prescribed usage time intervals. The conclusion is if all the above precautions are adhered to, accidents of this nature where contaminated fuel is being used will be avoided.
