AIRCRAFT ACCIDENT REPORT AND EXECUTIVE SUMMARY

| | | | | Reference: | CA18/2/3/9001 | |
| Aircraft Registration | ZS-MAV | Date of Accident | 08 January 2012 | | Time of Accident | 0848Z |
| Type of Aircraft | Cessna 150 | | Type of Operation | Training | | |

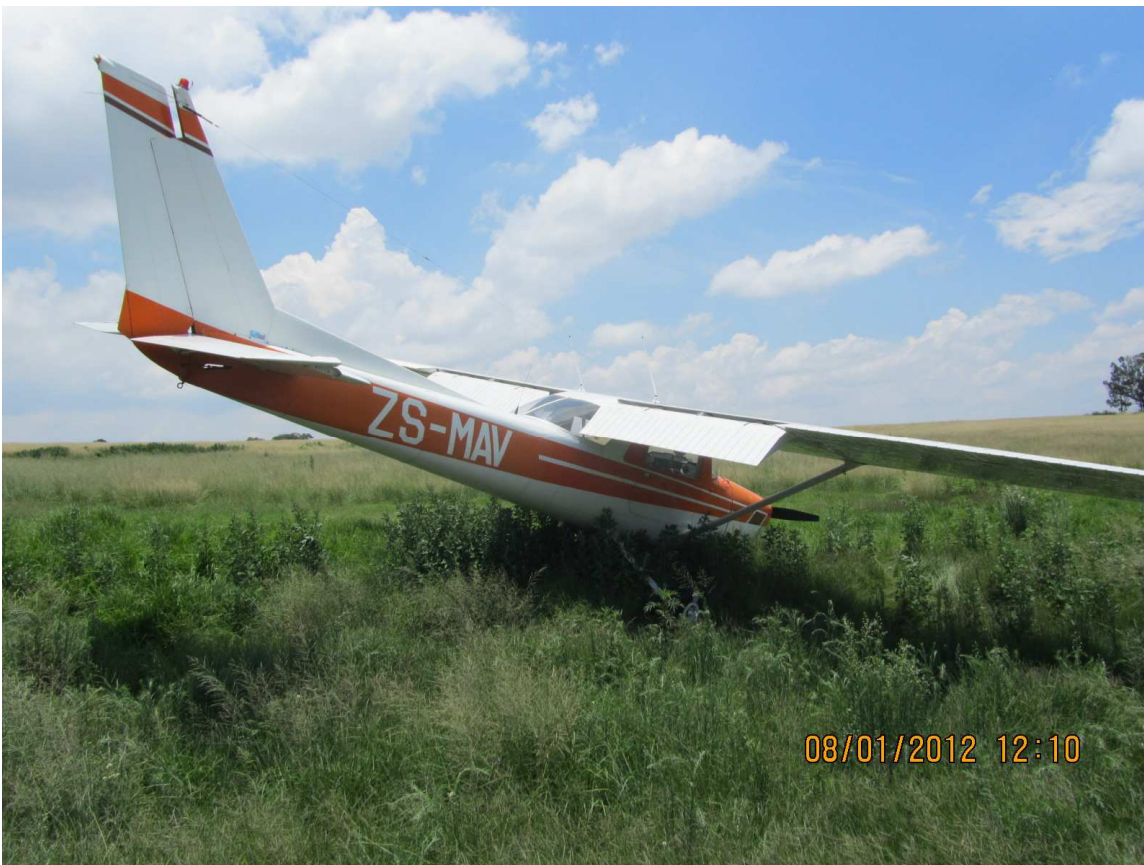
Figure 1: showing the aircraft after the forced landing.

1.12.1 During the forced landing, the aircraft touched down on a grass field. At the end of the landing roll the aircraft collided with an earth embankment causing damage to the right wing and the nose wheel.

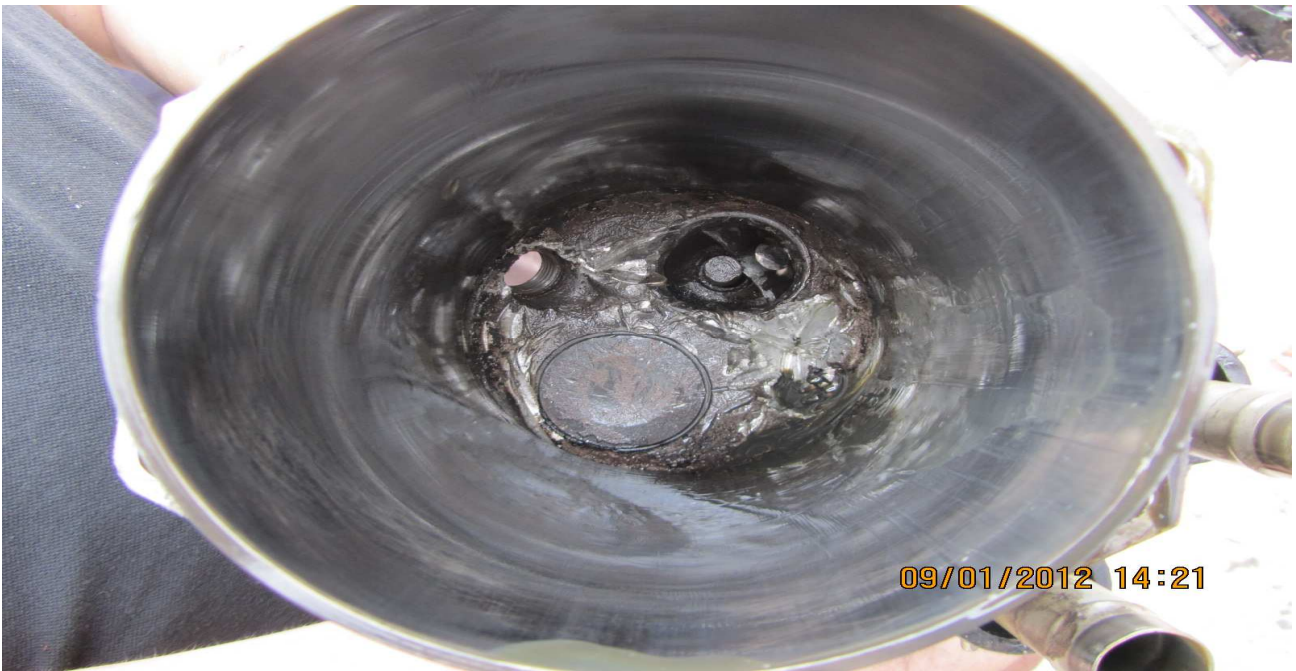
1.16.2 On inspection it was revealed that the number 2 cylinder was damaged. The cylinder was removed and it was found that the exhaust valve had seized in the open position, and the piston had made contact with the valve, bending the valve at the stem. (See figure 2 below)

Figure 2: showing damage caused in the no. 2 cylinder chamber.

- 2.1.3 From the examination made by the AMO, it is clear that the engine suffered a catastrophic failure due to the number two cylinder exhaust valve becoming stuck in the open position. The piston then struck the valve, bending the valve at the stem. This led to the damage of the piston followed by an engine failure.

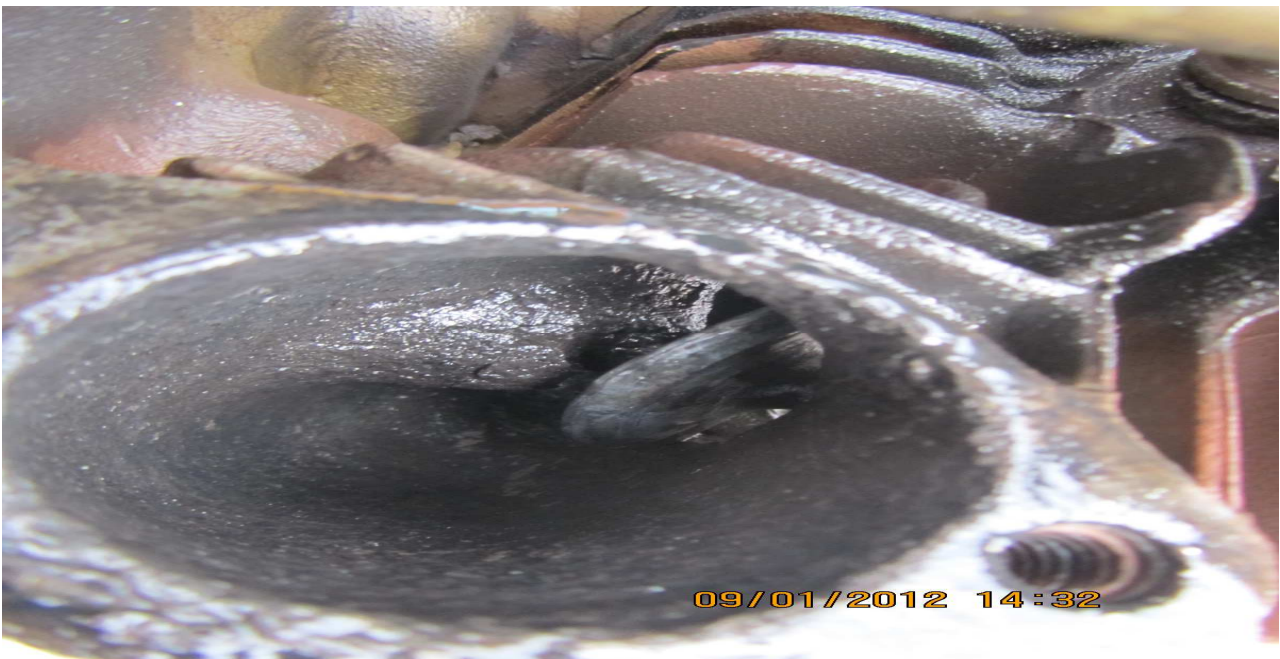
Figure 3: showing the exhaust valve head through the manifold port.

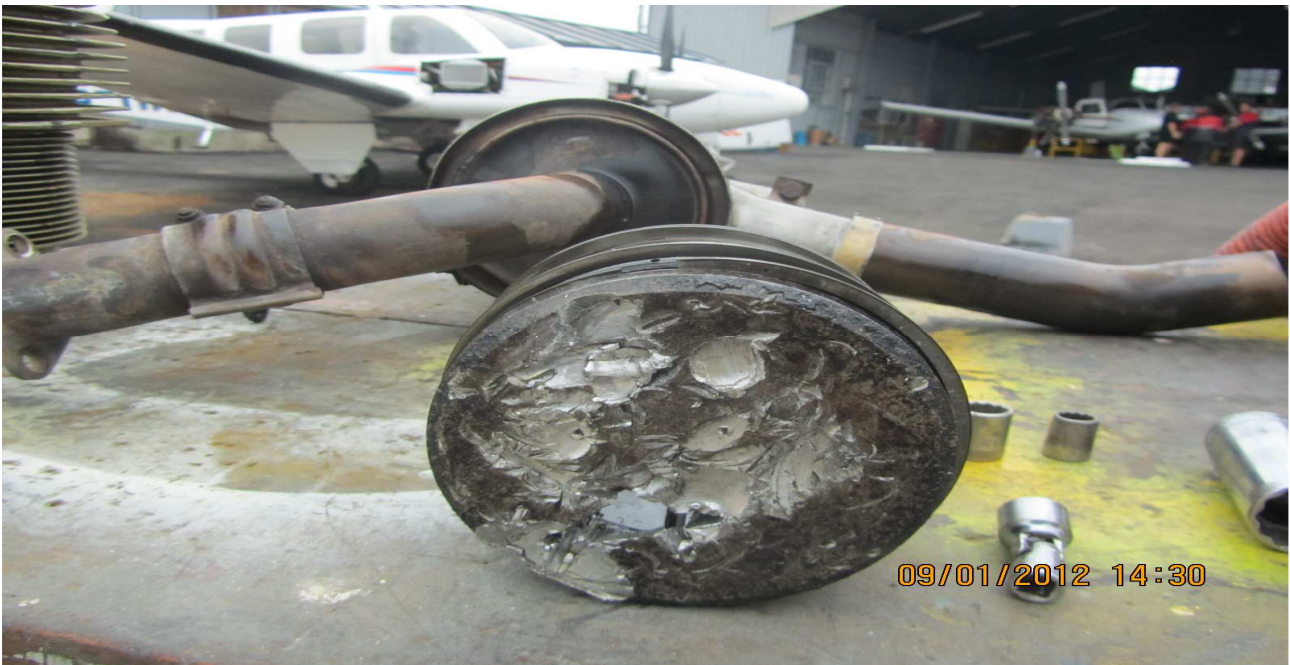
Figure 4: showing damage caused to the no.2 cylinder piston

1.6.2 Further inspection of the cylinder showed a large amount of carbon build up on the piston crown (on the base of the valve guides).
