AIRCRAFT ACCIDENT REPORT AND EXECUTIVE SUMMARY

Reference:	CA18/2/3/9002	
Aircraft Registration	ZU-LOL	Date of Accident	16 January 2012		Time of Accident	1145Z
Type of Aircraft	Van's RV7		Type of Operation	Private Flight		
Pilot-in-command Licence Type	ATP		Age	53	Licence Valid	Yes
Pilot-in-command Flying Experience	Total Flying Hours		15070		Hours on Type	79.7
Last point of departure	South Africa – FAGM (Rand Airport) Gauteng					
Next point of intended landing	South Africa – FALA (Lanseria Airport) Gauteng					
Location of the accident site with reference to easily defined geographical points (GPS readings if possible)						
Rand Airport between Runways 35 and 11 (GPS co-ordinates 26°14'37.83"S 28°08'55.18"E)						
Meteorological Information	Wind: 270°10kts Visibility: CAVOK Temperature: 25 °C					
Number of people on board	1+1	No. of people injured	0	No. of people killed	0	
Synopsis	<p>On 16 January 2012 at approximately 1130Z, the pilot accompanied by a passenger off from Runway 17 at Rand aerodrome on a private flight to Lanseria Airport.</p> <p>The pilot stated that shortly after take-off from runway 17 at Rand Airport, the engine back-fired twice, lost power and subsequently

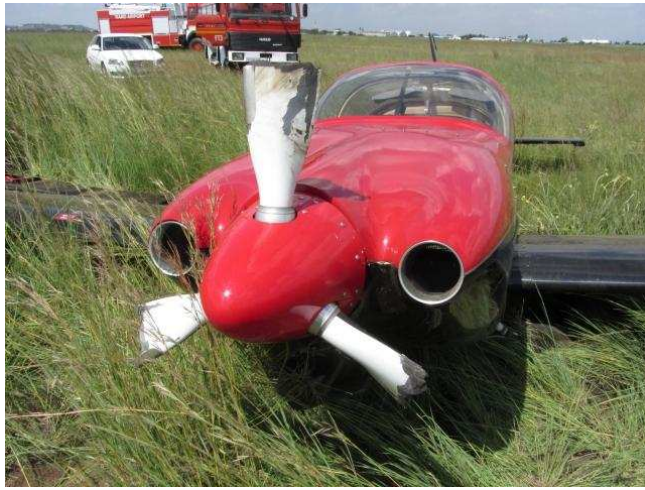
- 1.3.1 The aircraft sustained substantial damage to airframe, under-carriage and propeller.

Fig.1 – Damage to the propeller

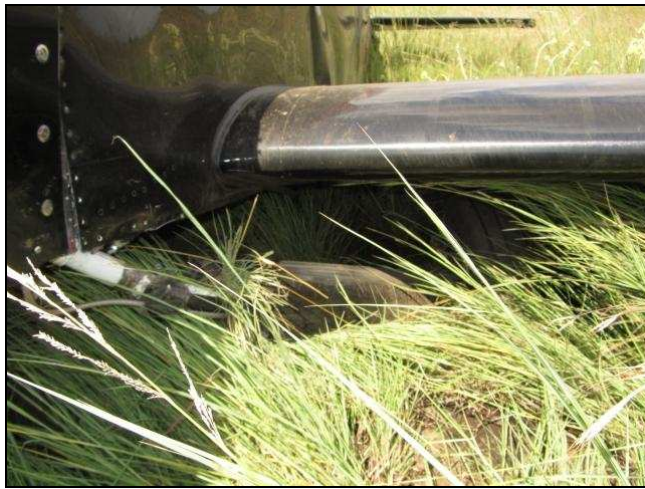
Fig. 2 – Collapsed undercarriage

1.12.4 Upon landing, the right wing impacted the ground first. The right landing gear then collapsed, followed by the left landing gear also to collapse.

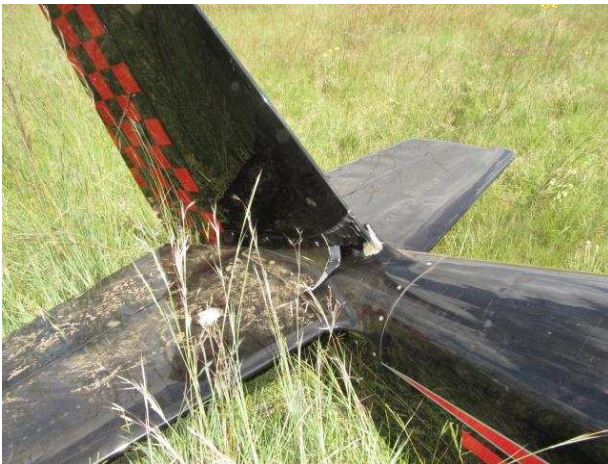
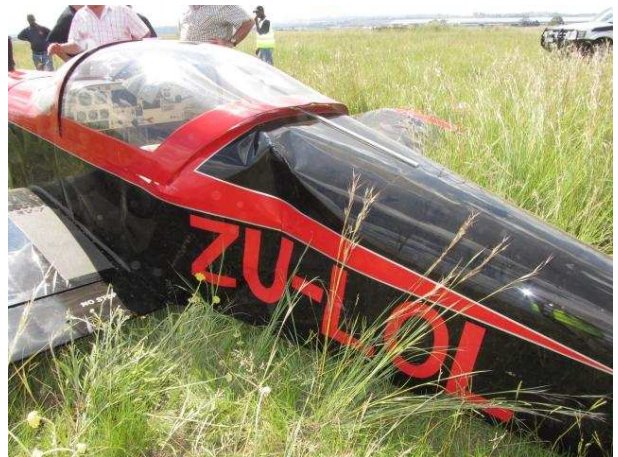
Fig. 3 – Damage to fuselage

1.12.5 During the forced landing the aircraft sustained substantial damage to the airframe, landing gear and propeller
