AIRCRAFT ACCIDENT REPORT AND EXECUTIVE SUMMARY

Reference:	CA18/2/3/9003	
Aircraft Registration	ZU-BGD	Date of Accident	18 January 2012		Time of Accident	1700Z
Type of Aircraft	Windlass Aquilla		Type of Operation	Private		
Pilot-in-command Licence Type		Microlight Private	Age	54	Licence Valid	yes
Pilot-in-command Flying Experience		Total Flying Hours	127.3		Hours on Type	45.3
Last point of departure		Uitenhage aerodrome, Eastern Cape				
Next point of intended landing		Uitenhage aerodrome, Eastern Cape				
Location of the accident site with reference to easily defined geographical points (GPS readings if possible)						
Near Uitenhage at a GPS position determined as S 33°44' 45,75" E025°7' 48.23" at an elevation of 285m ASL						
Meteorological Information		Witnesses reported that fine weather conditions prevailed with variable wind at less than 5 kts, CAVOK A conditions, no cloud and temperature at 20°C				
Number of people on board	1+0	No. of people injured	1	No. of people killed	0

AIRCRAFT ACCIDENT REPORT

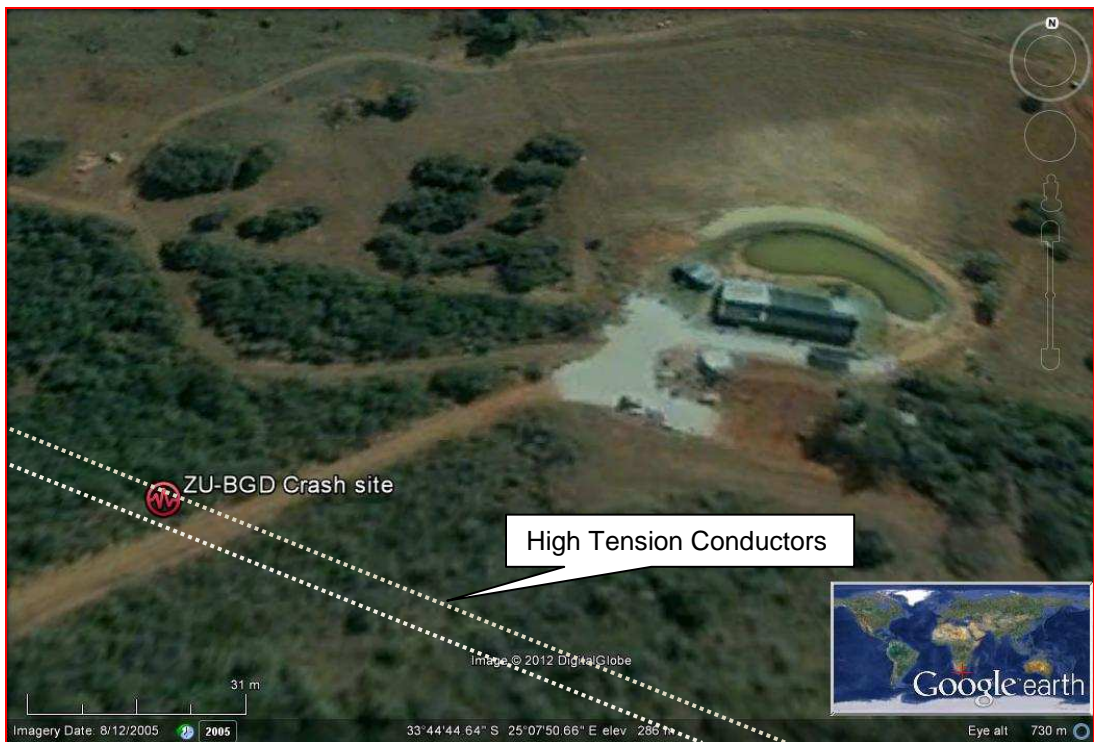
- 1.1.4 The accident occurred during daytime conditions at a GPS position determined as S 33°44' 45,75" E025°7' 48.23" at an elevation of 285m ASL.

Fig 2: Accident site

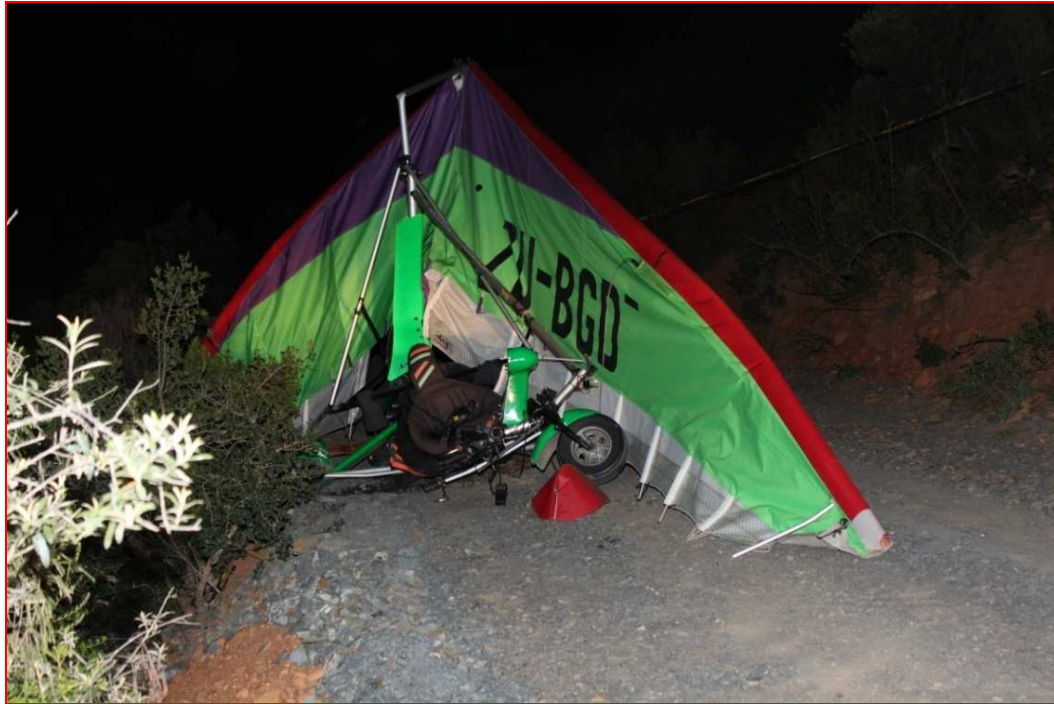
1.3.1 The aircraft sustained substantial damage.

Fig 3: Aircraft wreckage on site

- 1.12.1 The aircraft collided with high tension conductors spanning a valley and then crashed next to a dirt road.
- 1.12.2 The impact with the terrain was almost vertical below the collision point with the high tension conductors with very little to no forward motion.
- 1.12.3 The aircraft sustained substantial damage during the accident sequence.

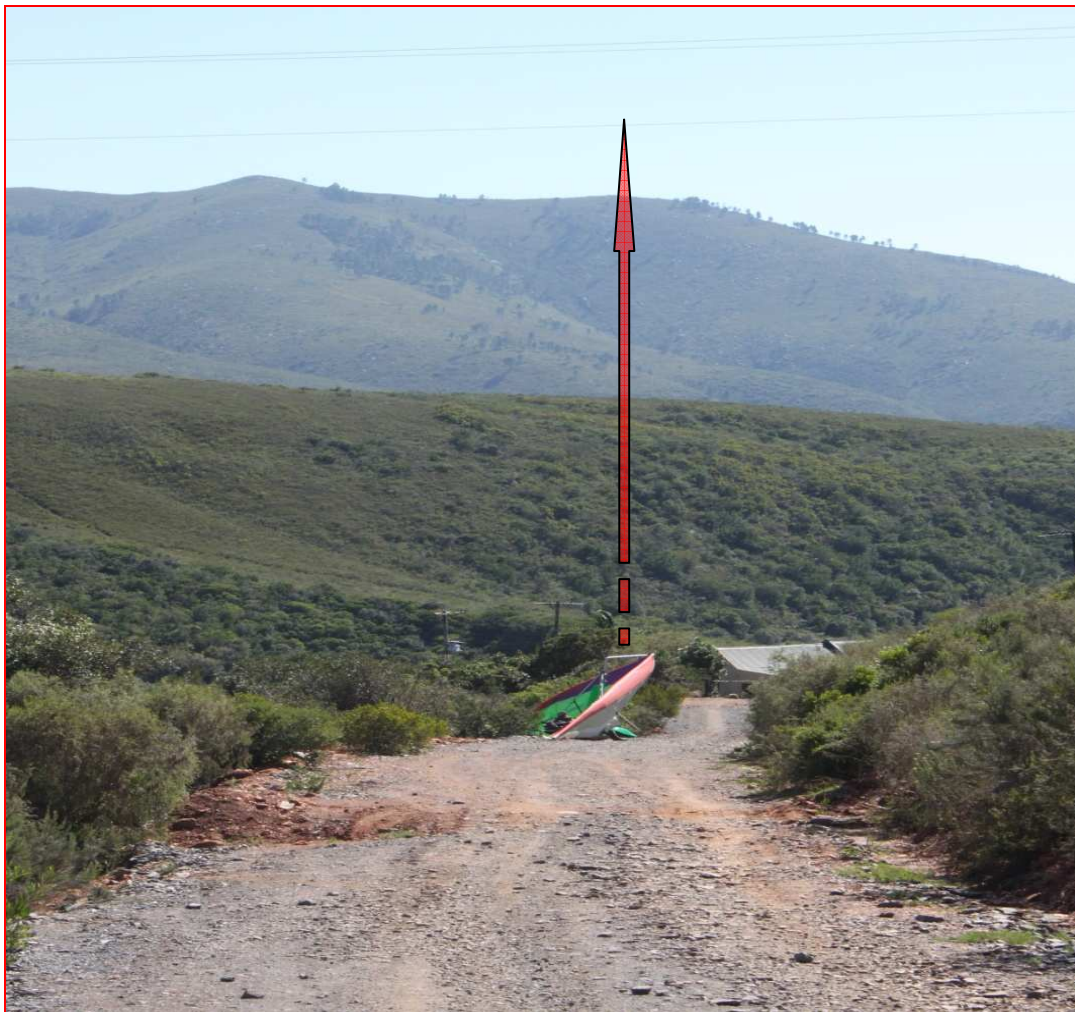
Fig 4: View of the High Tension Conductors directly above the wreckage

3.2.1 Collision with high tension conductors
