AIRCRAFT ACCIDENT REPORT AND EXECUTIVE SUMMARY

Reference:	CA18/2/3/9007	
Aircraft Registration	ZS-LHG	Date of Accident	2 February 2012		Time of Accident	0730Z
Type of Aircraft	Piper PA-20 (Aeroplane)		Type of Operation		Private Flight	
Pilot-in-command Licence Type		Commercial Pilot	Age	24	Licence Valid	Yes
Pilot-in-command Flying Experience		Total Flying Hours	293,2		Hours on Type	6.3
Last point of departure		Angels' Way aerodrome, (KwaZulu-Natal province)				
Next point of intended landing		Angels' Way aerodrome, (KwaZulu-Natal province)				
Location of the accident site with reference to easily defined geographical points (GPS readings if possible)						
Angels' Way aerodrome near Eston (geographical co-ordinates: South 29°51'32.83" East 030°31'05.19")						
Meteorological Information		Surface wind; 045%4-5kt; Temperature: 23°C; Visi bility: +10 km				
Number of people on board	2 + 0	No. of people injured	2	No. of people killed	0	
Synopsis

AIRCRAFT ACCIDENT REPORT

Name of Owner : Angel's Way Trust
Name of Operator : Private Flight
Manufacturer : Piper Aircraft Corporation
Model : PA-20
Nationality : South African
Registration Marks : ZS-LHG
Place : Angel's Way aerodrome near

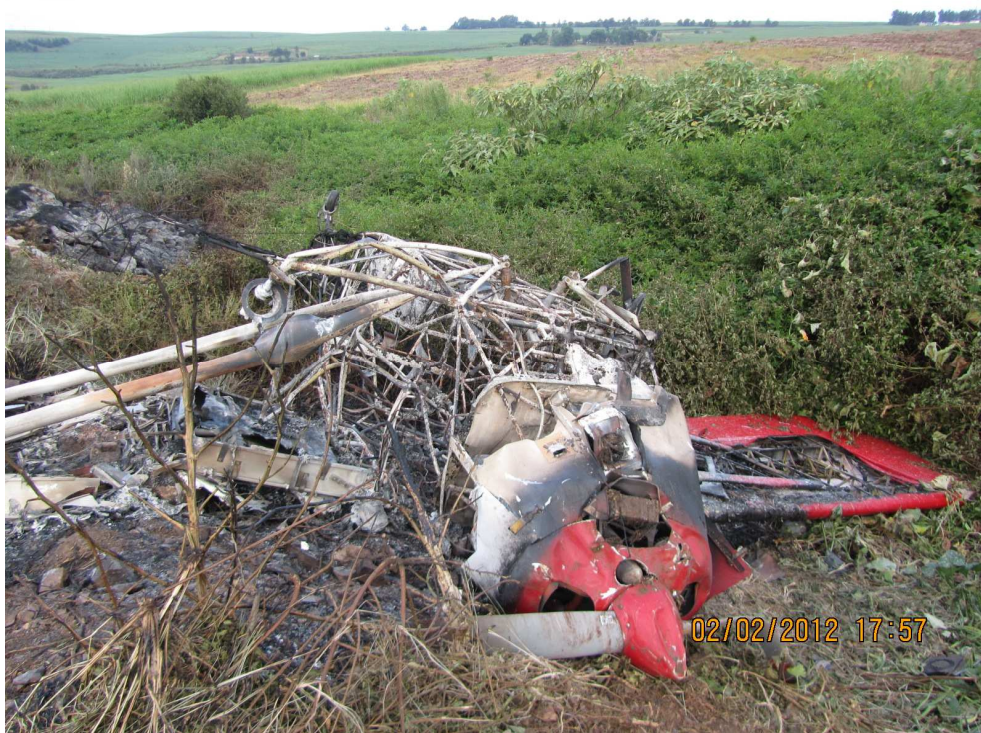
1.3.1 The aircraft was destroyed by the post-impact fire. All that remained were the spinner, propeller and tail wheel.

Figure 1: The burnt-out wreckage.

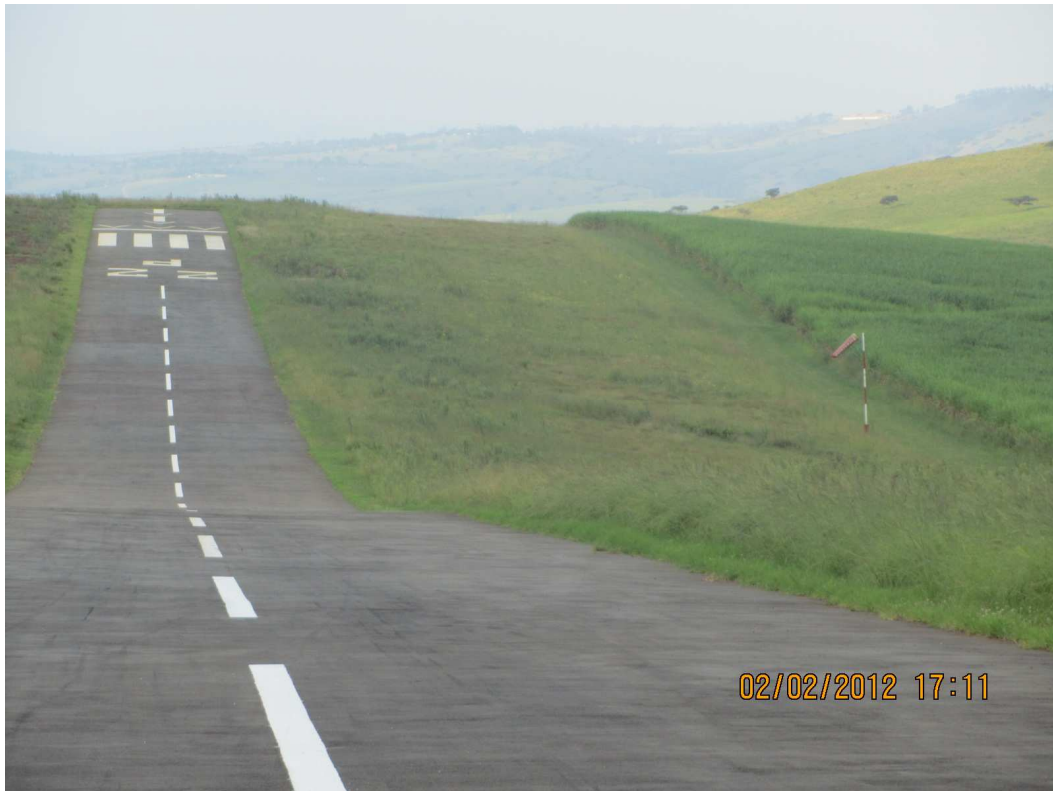
1.7.3 Figure 2 below was taken by the IIC shortly after his arrival at the aerodrome. The view is from runway 04 facing the direction of takeoff, i.e., towards the threshold of runway 22. The windsock is visible on the right, indicating a crosswind.

Figure 2: View from runway 04 with the windsock visible on the right.

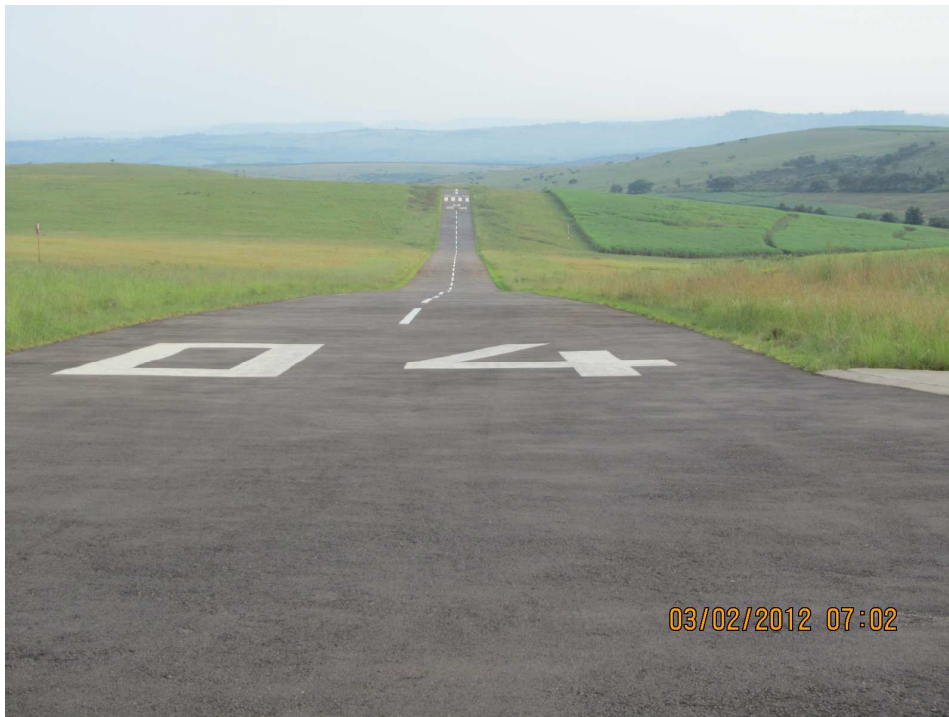
The aerodrome is constructed on sloping terrain. The runway slopes downwards from both thresholds at approximately 5°, as can be seen in Figure 4.

Figure 4: The runway seen from the threshold of runway 04.

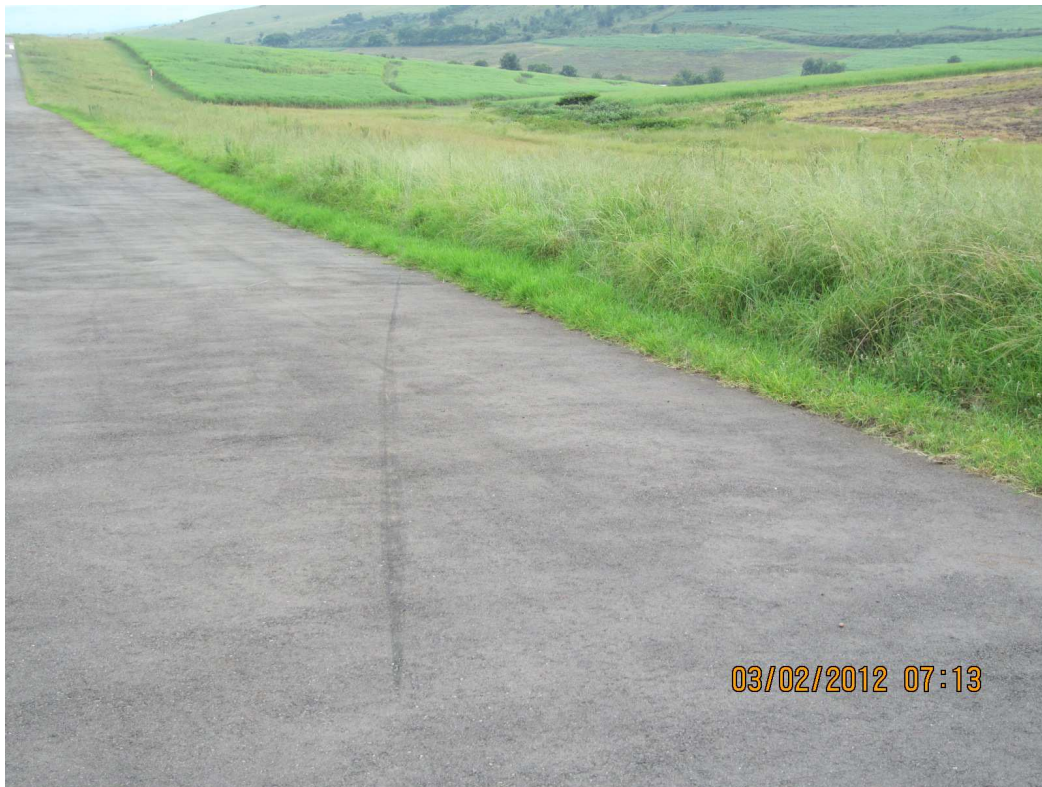
1.12.1 The aircraft veered off the right of runway 04 approximately 250 m from the threshold. The print from the left main tyre can be clearly seen on the surface (see Figure 5). The aeroplane then rolled downhill through a grassy area for 112 m before striking a heap of building rubble hidden in the vegetation. It nosed over on impact, coming to rest inverted in a ditch. A fire erupted near the auxiliary fuel tank and destroyed the aircraft.

Figure 5. The left main tyre print on the runway surface.
