<b>AIRCRAFT ACCIDENT REPORT AND EXECUTIVE SUMMARY</b>
---

Reference:	CA18/2/3/ 9009	
<b>Aircraft Registration</b>	ZU-EGH	<b>Date of Accident</b>	4 February 2012		<b>Time of Accident</b>	0615Z
<b>Type of Aircraft</b>	Microlight – Windlass Aquila 582		<b>Type Operation</b>		Private	
<b>Pilot-in-command Licence Type</b>		Microlight	<b>Age</b>	42	<b>Licence Valid</b>	Yes
<b>Pilot-in-command Flying Experience</b>		Total Flying Hours	± 285.0		Hours on Type	± 285.0
<b>Last point of departure</b>		Crosswinds Airfield – Krugersdorp, Gauteng				
<b>Next point of intended landing</b>		Crosswinds Airfield – Krugersdorp, Gauteng				
<b>Location of the accident site with reference to easily defined geographical points (GPS readings if possible)</b>						
An open grass field at GPS co-ordinates: S 26°02.352' E027°42.199' in the Krugersdorp area.						
<b>Meteorological Information</b>		Wind direction:080°, Wind speed: 04 kt, Temperature: 21°C , Visibility: CAVOK.

## AIRCRAFT ACCIDENT REPORT

**Name of Owner/Operator** : Paradise Petals SA (Pty) Ltd  
**Manufacturer** : Solo Wings CC  
**Model** : Windlass Aquilla  
**Nationality** : South African  
**Registration Marks** : ZU-EGH  
**Place** :

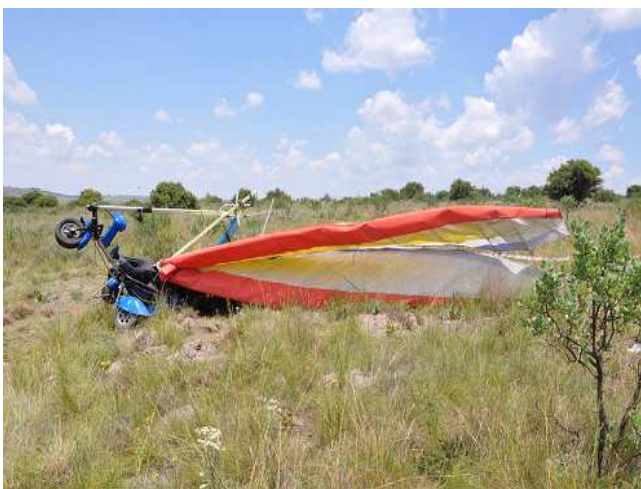
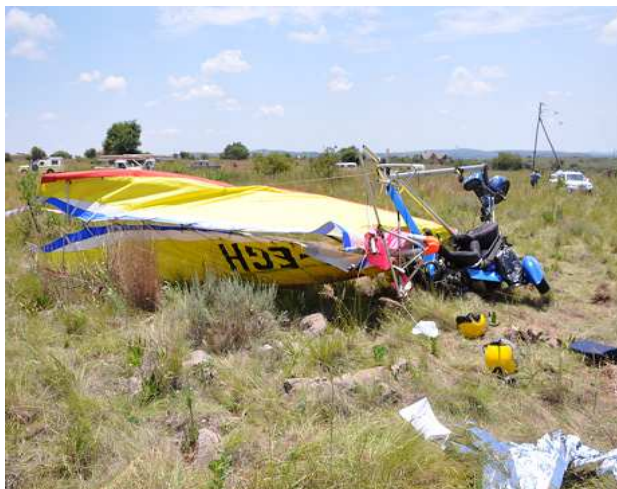
1.3.1 The microlight aircraft sustained substantial impact damage during the collision with the high tension wires and on impact with the terrain that followed.

Figure 2 and figure 3, shows the aircraft's main wreckage at the grass covered rocky terrain.

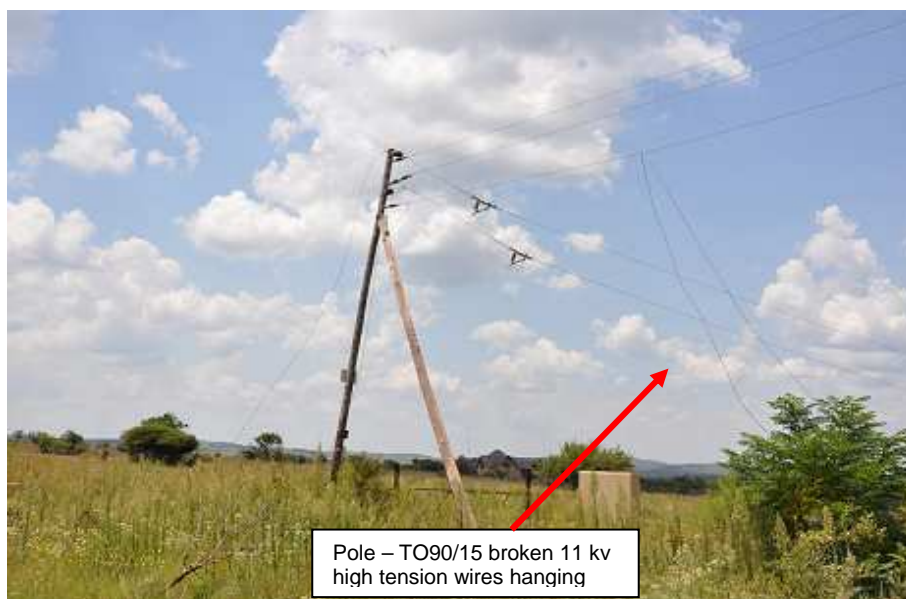
1.4.1 The high tension wires were severed when the microlight collided with it.

Figure 4, shows the damage to the high tension power lines.

- 3.1.5 The high tension wires were subsequently severed when the aircraft impacted the wires during a low level flight.
- 3.1.6 The aircraft wings, airframe structure and propeller were substantially damaged during the impact sequence with the high tension wires and the rocky terrain.

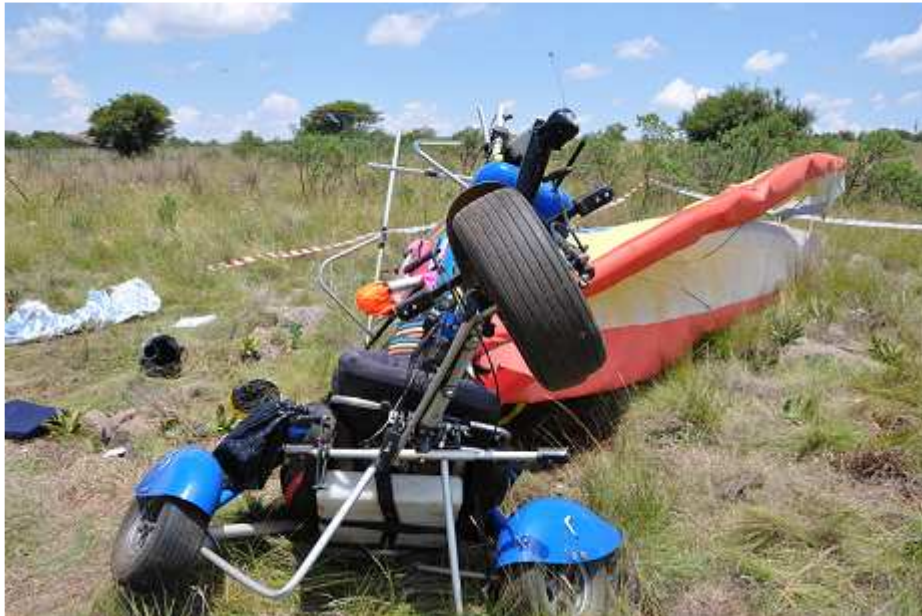
1.12.3 The aircraft wreckage came to rest approximately 50 metres beyond the high tension wires. The wreckage remained fairly intact after it collided with the high tension wires and during the ground impact sequence. The aircraft airframe structure, wings, undercarriage, engine and propeller were substantially damaged during the accident sequence.

Figure 5, shows the damage caused to the airframe structure.

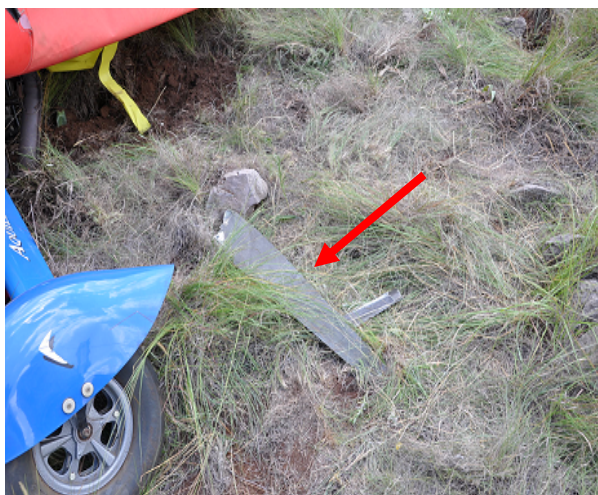
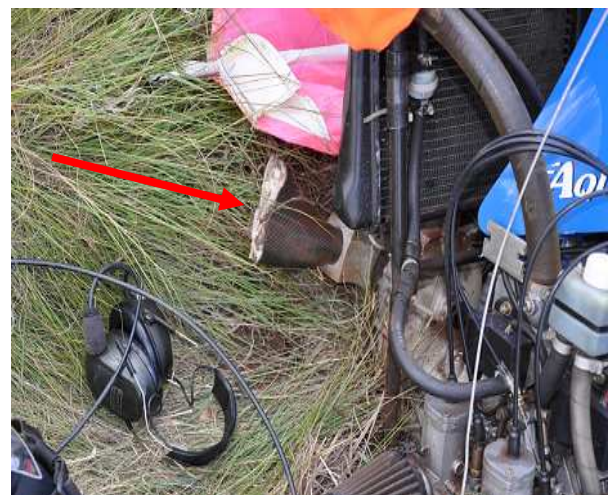
Figure 5 and 6, shows the damage caused to the propeller during the impact sequence.

- 2.5 The aircraft was substantially damaged on impact with the high tension wires and rough rocky ground terrain.
- 2.6 During the on-site investigation, the aircraft was thoroughly examined but there was no evidence of a defect or malfunction that may have contributed to the cause of the accident. The three-bladed propeller showed that the engine was producing sufficient power prior to the impact sequence. The pilot also confirmed that he did not experience any defects malfunctioning during the flight.
