## AO-2012-036: CS-TQM, Hard Landing

<b>Date and time:</b>	28 February 2012, 2327 CST	
<b>Location:</b>	Darwin Airport, Northern Territory	
<b>Occurrence category:</b>	Incident	
<b>Occurrence type:</b>	Hard landing	
<b>Aircraft registration:</b>	CS-TQM	
<b>Aircraft manufacturer and model:</b>	Airbus A340-313X	
<b>Type of operation:</b>	Charter	
<b>Persons on board:</b>	Crew – 8	Passengers – 116
<b>Injuries:</b>	Crew – Nil	Passengers – Nil
<b>Damage to aircraft:</b>	Serious incident

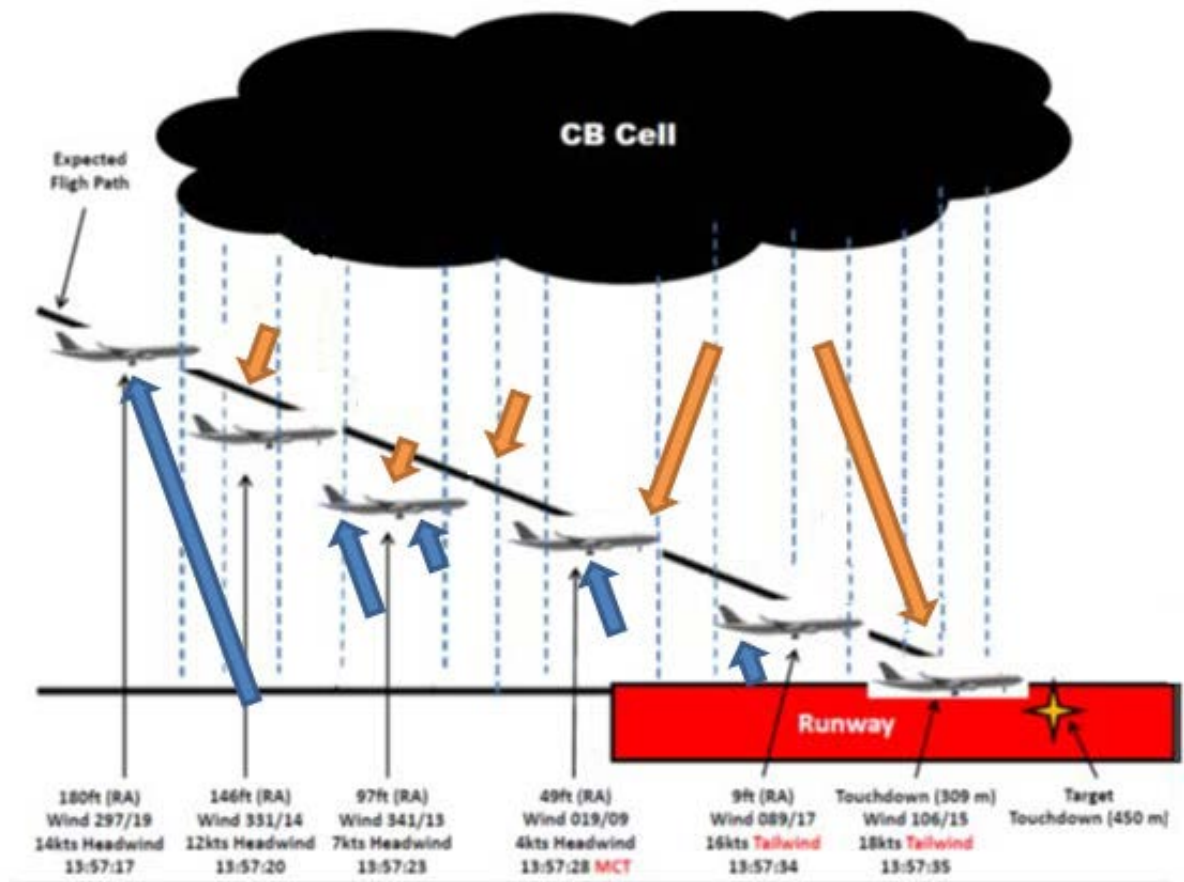
Figure 1: Flight path diagram with wind component

The Flight Data Recorder (FDR) data was provided to the ATSB by the operator for analysis. Airbus also completed an analysis of the flight data which showed that just prior to touchdown, the wind changed from a 9 kt headwind to a 6 kt tailwind, with a downdraft component of 7 kts in a 2.5 second period (Figure 1).

The Bureau of Meteorology (BOM) issued a report detailing weather conditions at Darwin Airport at the time of the incident. The report noted that there were no obvious dry slots in the atmosphere that would be typically present in a microburst. The report could not rule out the presence of a microburst forming under rain showers (Figure 1).
