## AIRCRAFT ACCIDENT REPORT AND EXECUTIVE SUMMARY

| | | | | Reference: | CA18/2/3/9022 | |
| Aircraft Registration | ZS-NUP | Date of Accident | 26 March 2012 | | Time of Accident | 0945Z |
| Type of Aircraft | MOONEY - M20R | | Type of Operation | Private | | |

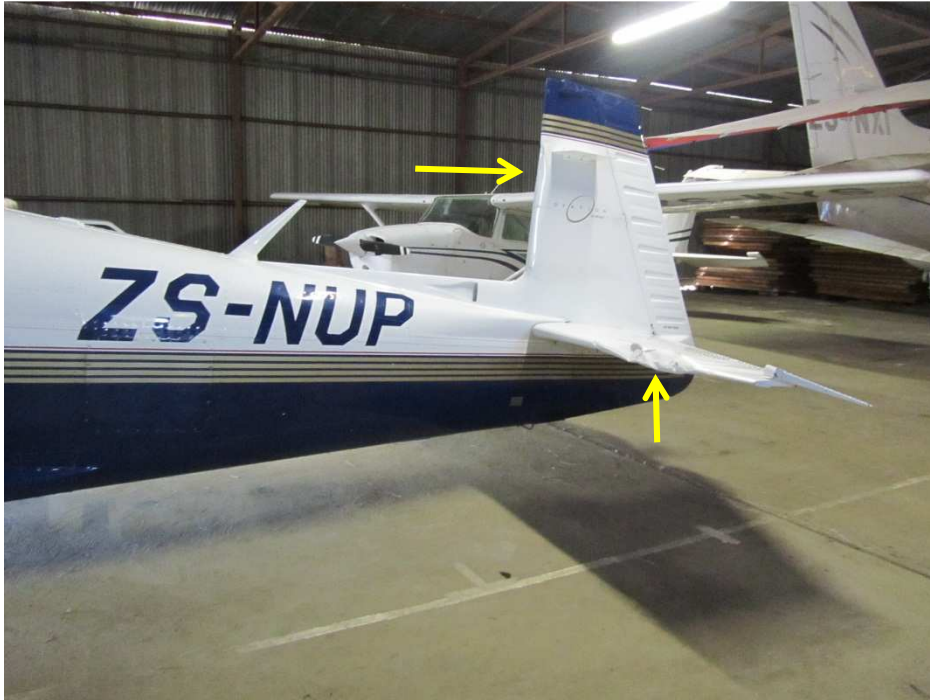
Figure 1, showing damage to the horizontal and vertical stabiliser.

1.12.3 The tail plane of the aircraft was damaged on the horizontal stabiliser on the port side and on the vertical stabiliser.

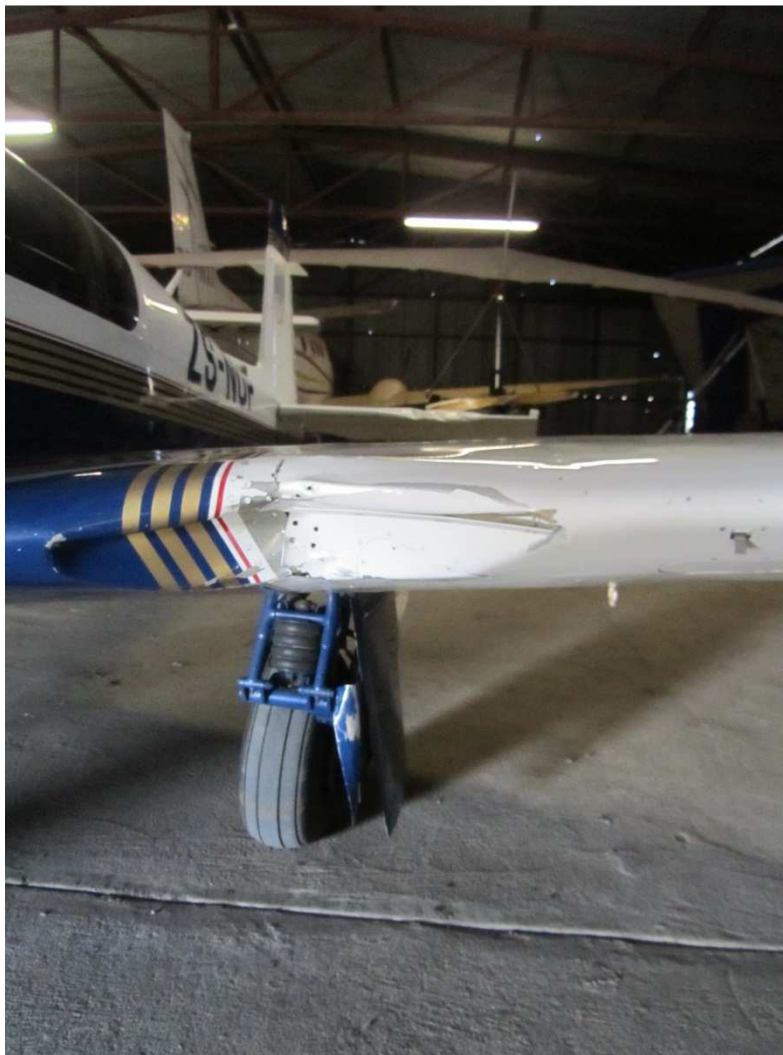
Figure 2, showing damage to the port-side wing.

1.12.2 The leading edge of the port wing was damaged 1 metre from the fuselage. There was a 50cm wide dent on the port wing of the aircraft.

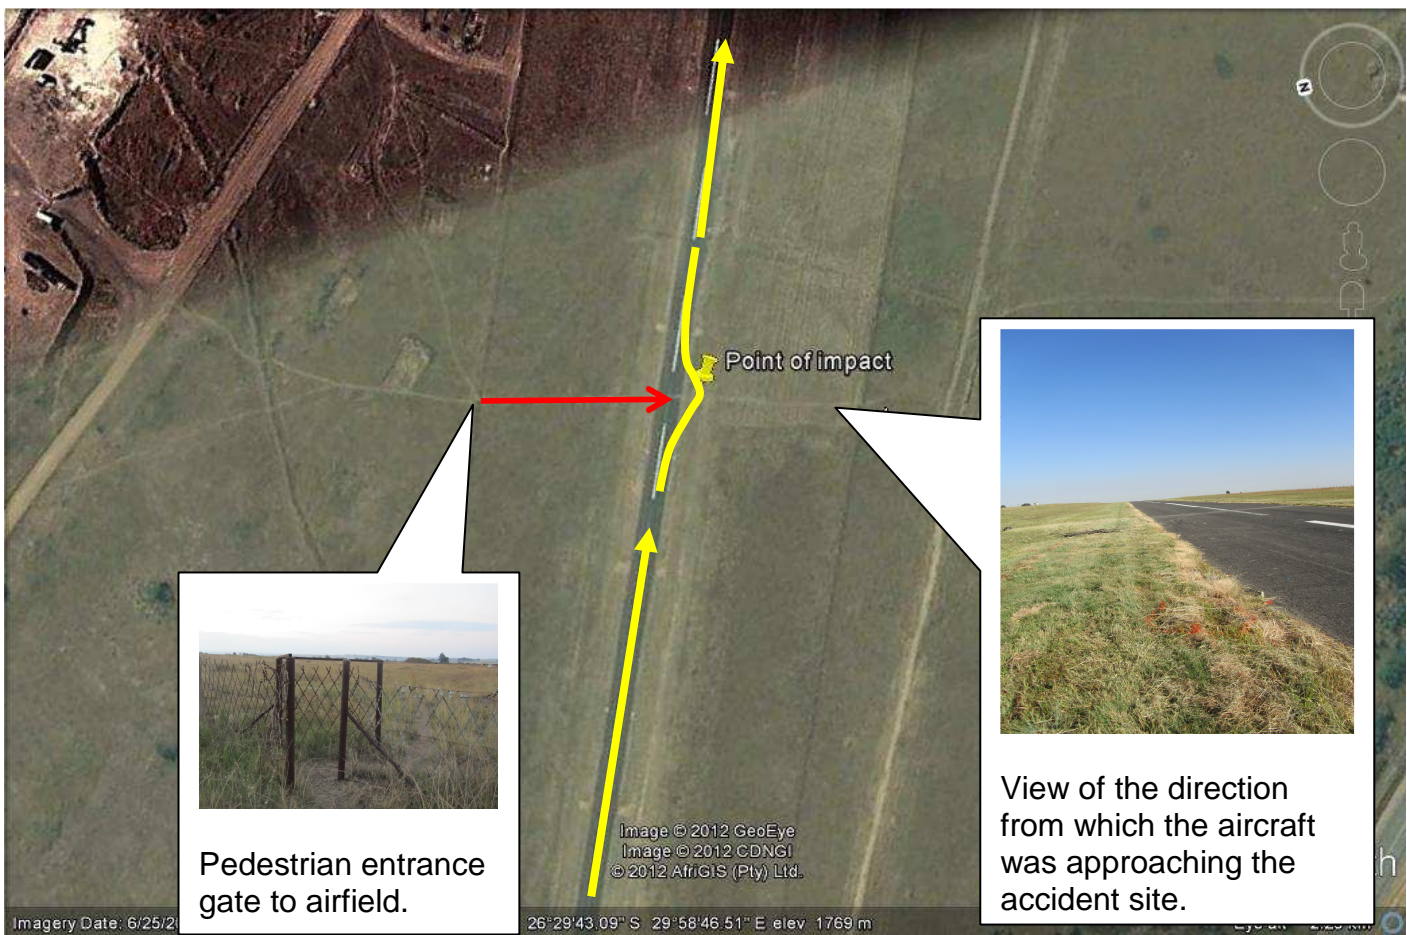
1.18.2 The airfield has a pedestrian entrance to the airfield as shown in figure 3.

1.18.5 Pedestrians enter the airfield from the town in order to collect firewood and cross the runway again once they have collected the firewood. The path that they take is close to the beginning of runway 13 in the area of the down slope.

1.18.6 The red arrow shows the direction in which the pedestrian was moving when she was struck by the aircraft.

1.18.7 The yellow line shows the direction in which the aircraft landed and the path it took when it impacted the pedestrian.

Figure 3, showing point of impact.
