## AIRCRAFT ACCIDENT REPORT AND EXECUTIVE SUMMARY

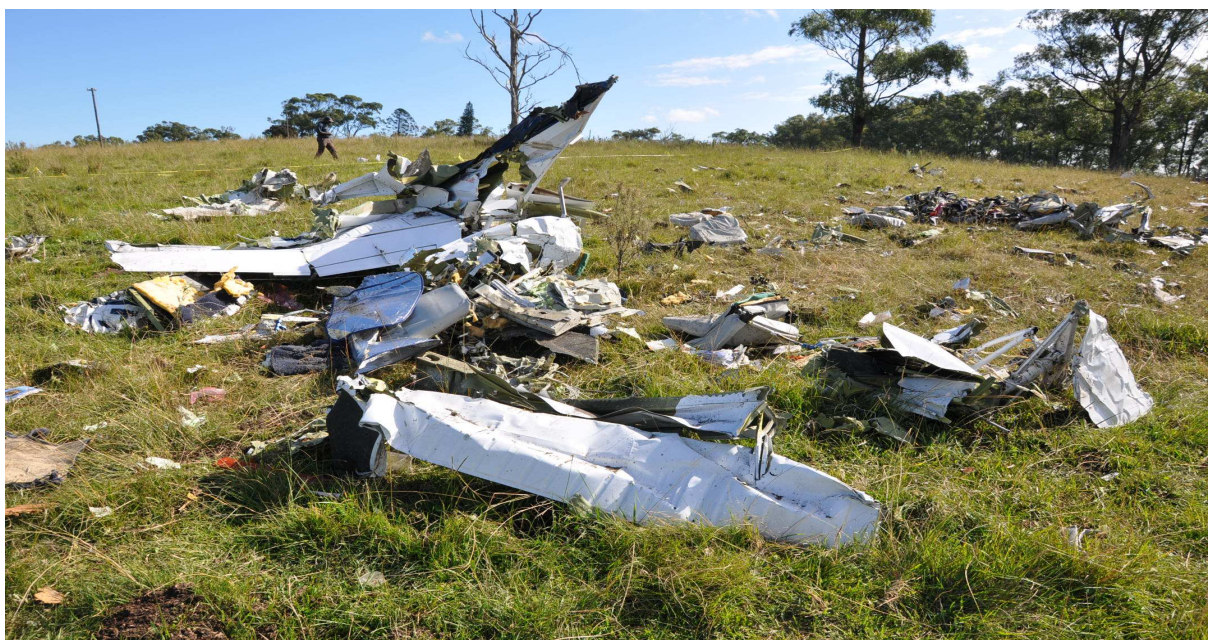
Figure 1: View of the aircraft as found at the accident site.

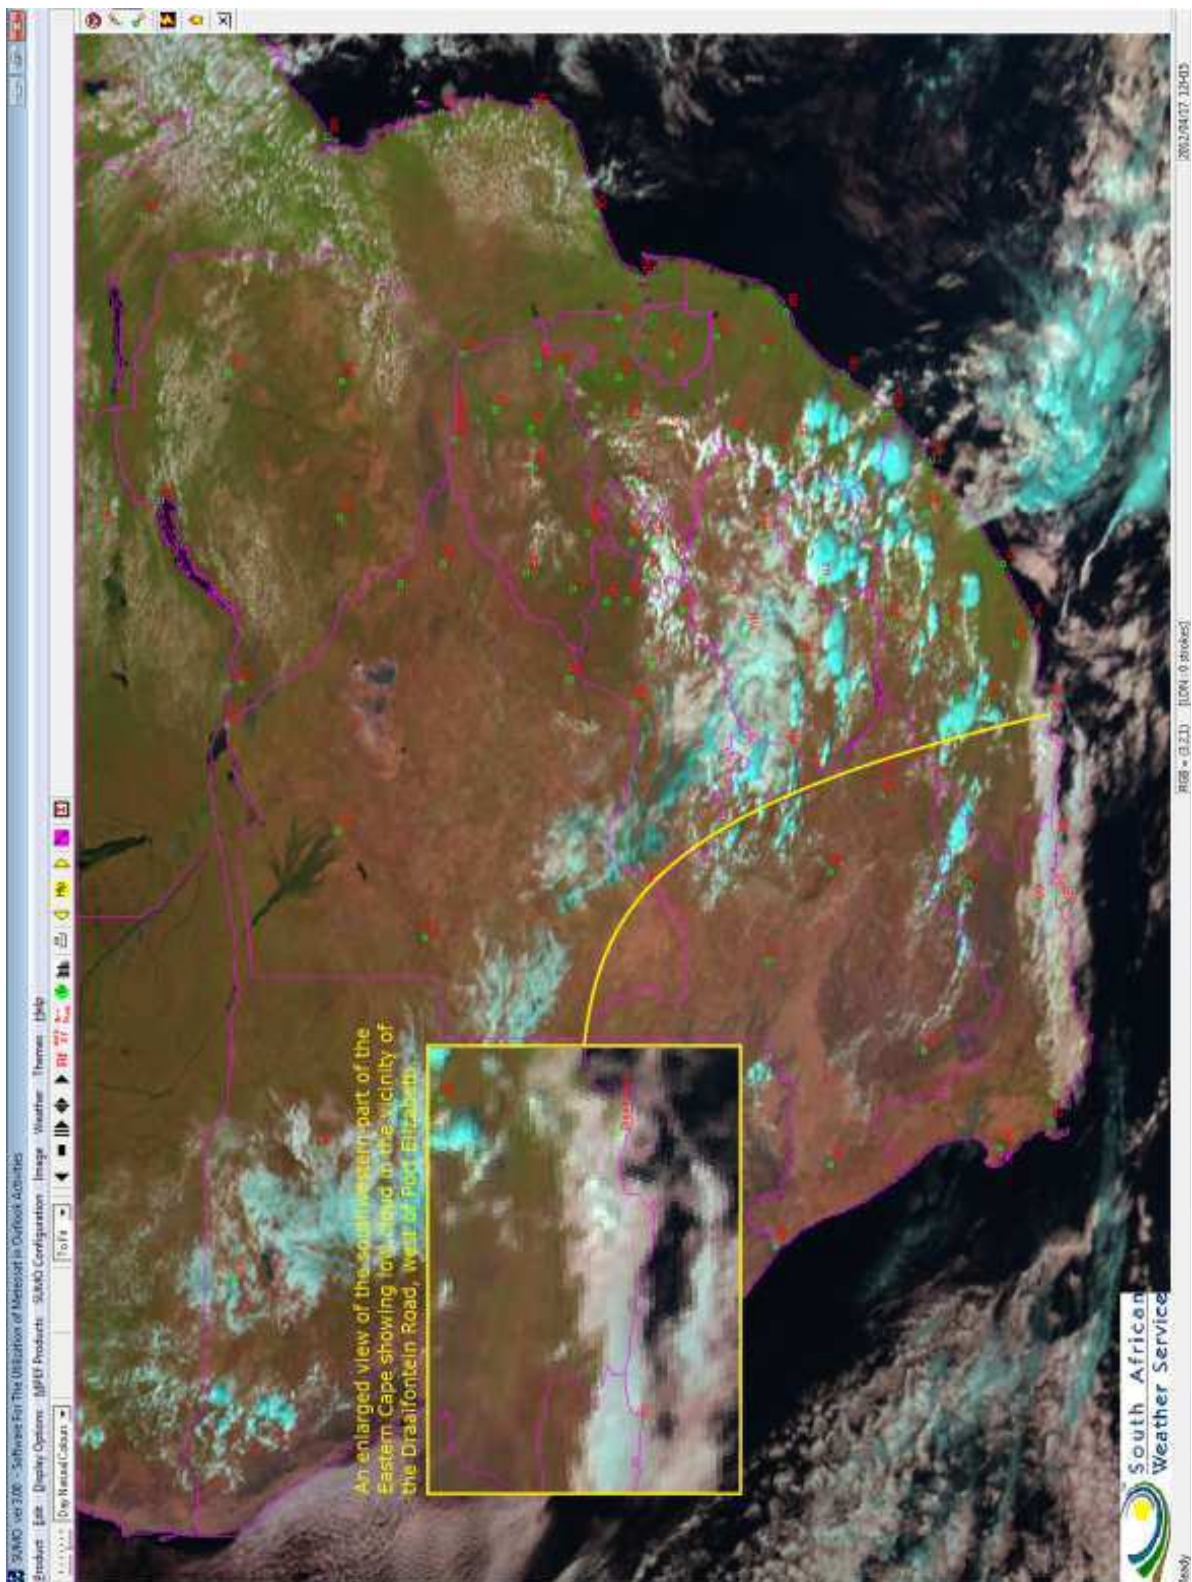
Figure 3: View of the weather chart.

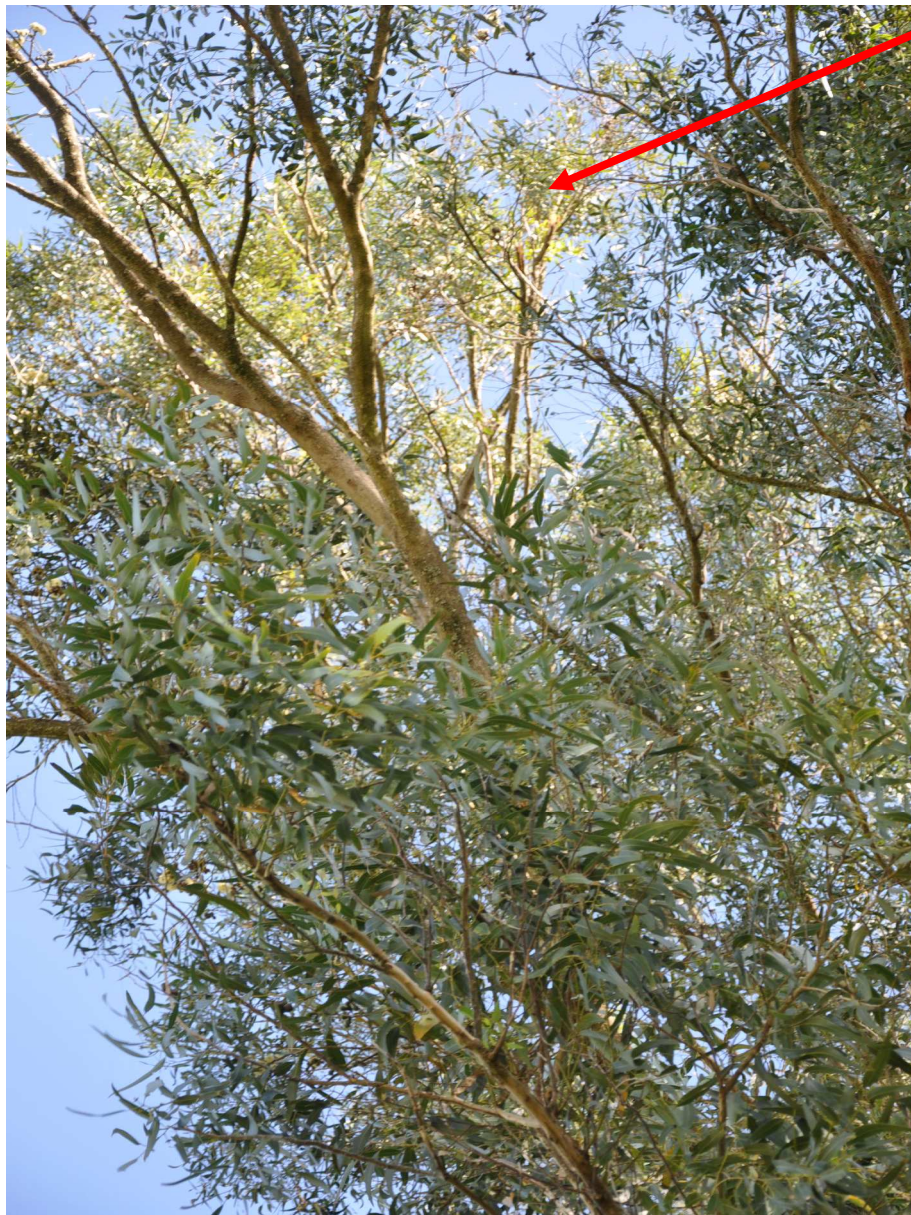
Tree cut on the branches.

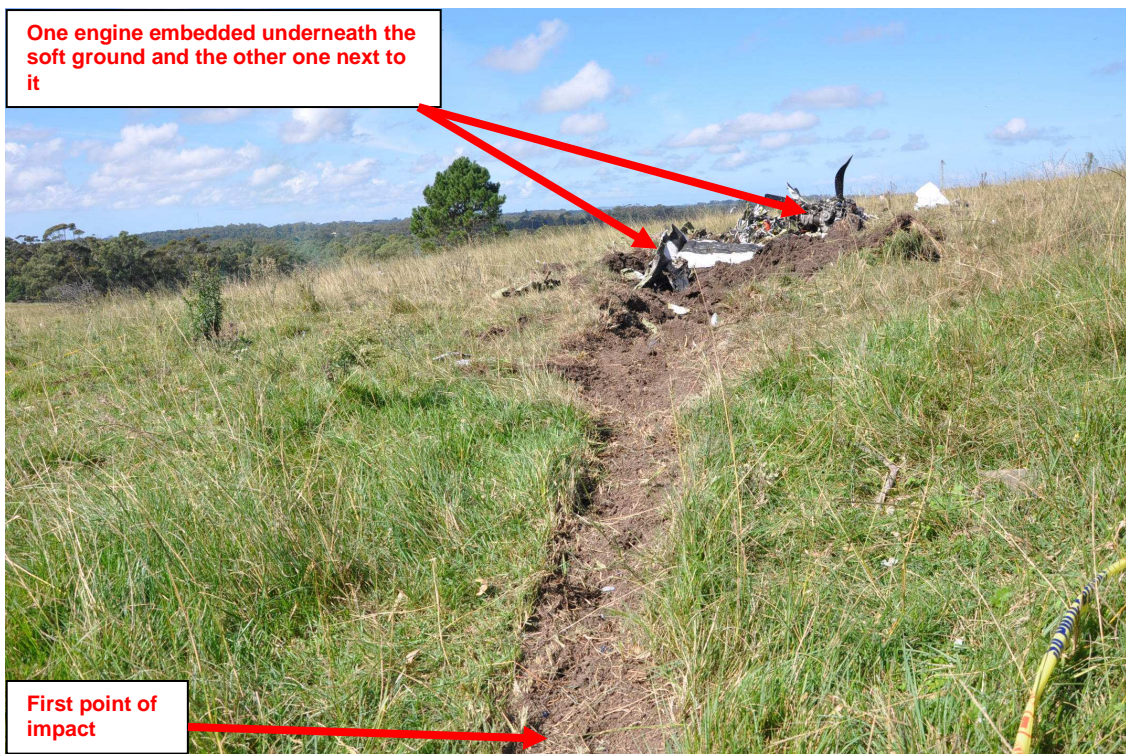
Figure 5: View off the engines as found at the accident site and first point of impact:

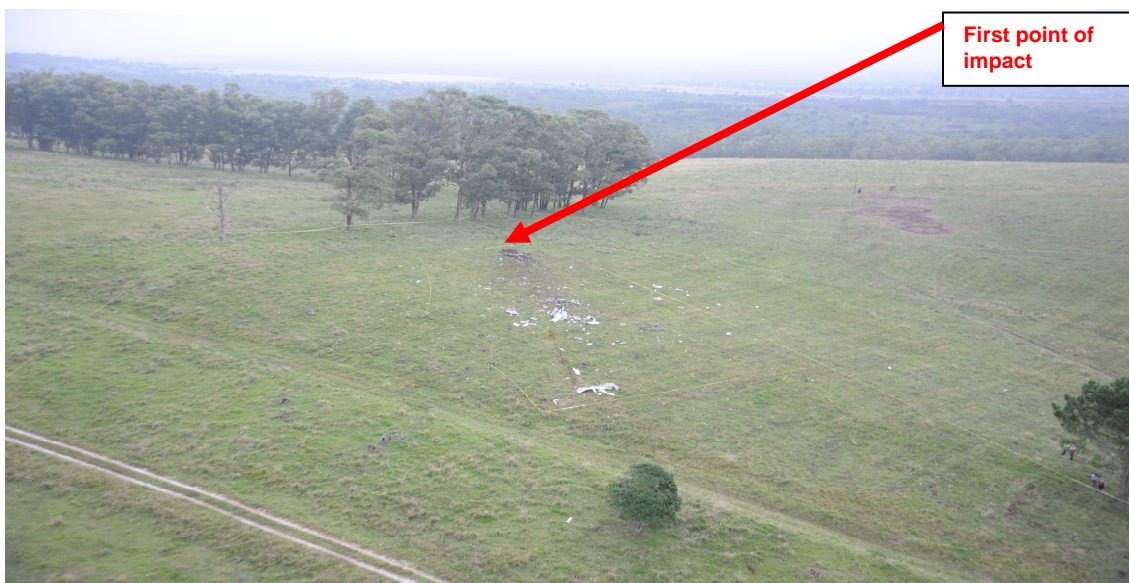
Figure 6: Showing the aerial view of the accident site with aircraft debris all over the area.
