AIRCRAFT ACCIDENT REPORT AND EXECUTIVE SUMMARY

Reference:	CA18/3/2/0909	
Aircraft Registration	ZU-BTT	Date of Incident	19 April 2012		Time of Incident	1242Z
Type of Aircraft	Falco F8L		Type of Operation		Private	
Pilot-in-command Licence Type		Private Pilot	Age	67	Licence Valid	Yes
Pilot-in-command Flying Experience		Total Flying Hours	367.5		Hours on Type	79.35
Last point of departure	Kimberley Aerodrome (FAKM) – Northern Cape					
Next point of intended landing	Beaufort West - Western Cape					
Location of the incident site with reference to easily defined geographical points (GPS readings if possible)						
Approximately 50 km south of Victoria West in the Northern Cape.						
Meteorological Information	Wind : Westerly 5 – 10 kt, Temperature: 12°C, Cloud base: CAVOK..					
Number of people on board	1 + 1	No. of people injured	0		No. of people killed	0
Synopsis	<p>On 19 April 2012 at approximately 1055Z, the pilot accompanied by a passenger departed from Kimberley aerodrome (FAKM) on a private flight to Beaufort West in the Western Cape.</p> <p>The flight en-route to Beaufort West was uneventful, but after a flight time of approximately 1.85 hours, the propeller suddenly separat

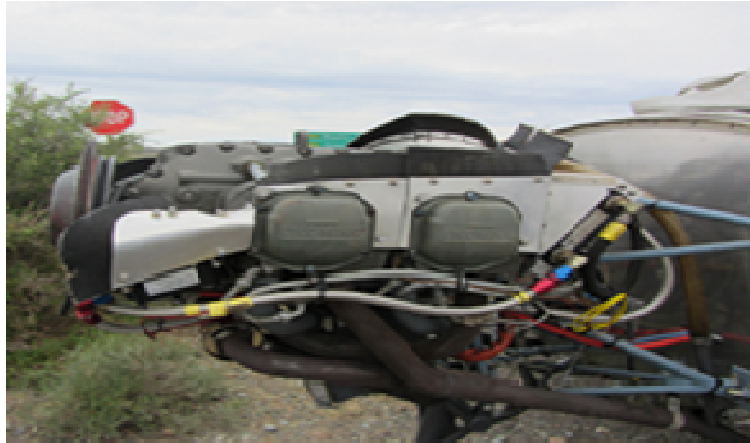
Figure 1, shows engine on aircraft without propeller.

1.12.1 During cruise on a private flight, the propeller suddenly separated from the engine in mid-air. After the propeller separated from the engine at the engine attachment flange, it impacted the engine cowling on the left and the left wing, causing substantial damage to the cowling and left wing.

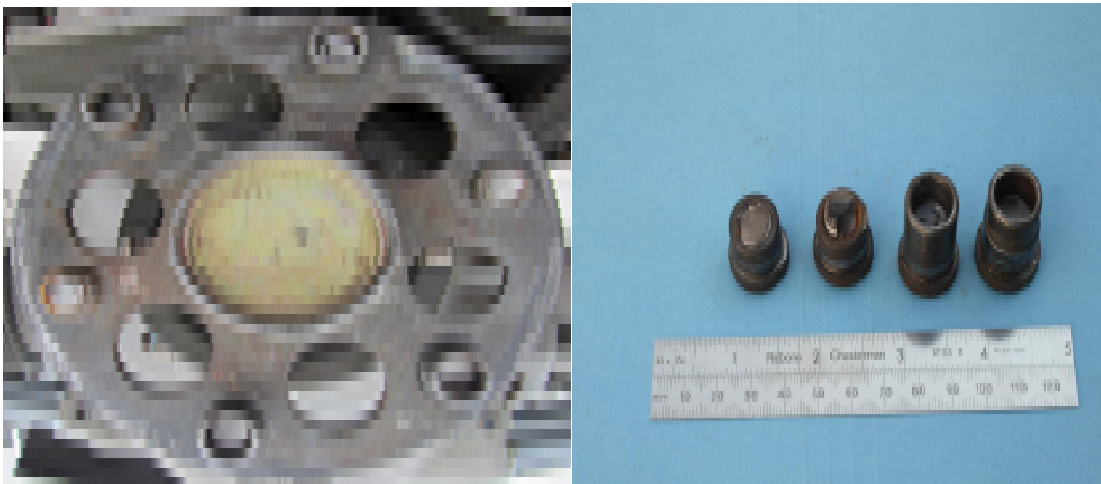
- (i) All six (6) propeller bolts that secure the propeller onto the attachment flange on the engine ring gear fractured and subsequently caused the propeller to separate from the engine.

Figure 2, shows propeller attachment flange with fractured bolts.

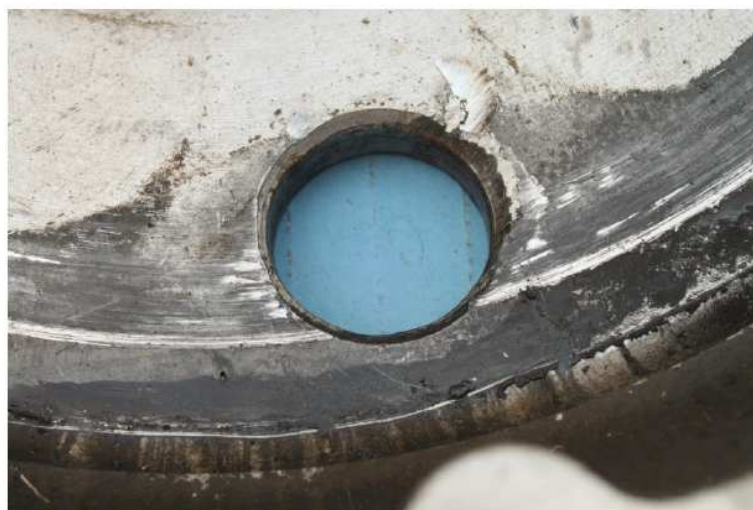
The burring and scoring found on the disc itself indicate that failure had been in progress for some time before final fracture. It is considered probable that the two holes so affected were the location of the two missing fasteners, which probably failed and were lost shortly before final failure.

Figure 4. Burring of bolt holes on disk.

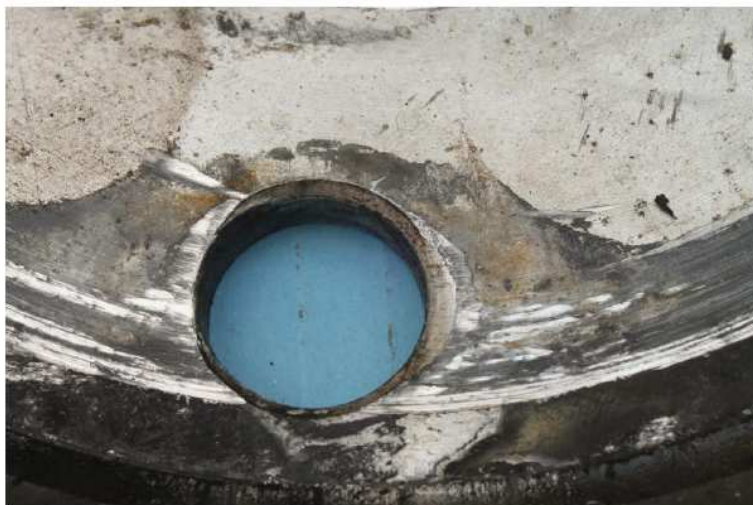
Figure 5. Burring of bolt holes on disk.

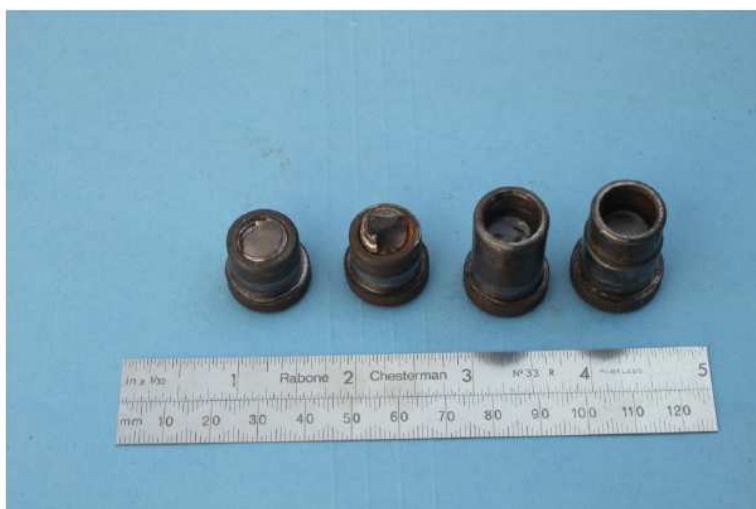
The bolts were submitted within recess nuts, figure 6, and were extracted with difficulty since attempts appear to have been made to drill them out, partially destroying the hexagonal recess in the bolt end. Once removed, rust was observed to be present on the threads, figure 7, indicating that they had been in place for some time and had been assembled without any protective coating. No evidence of thread locking compound was observed.

Figure 6. The fasteners as submitted, within recess nuts.

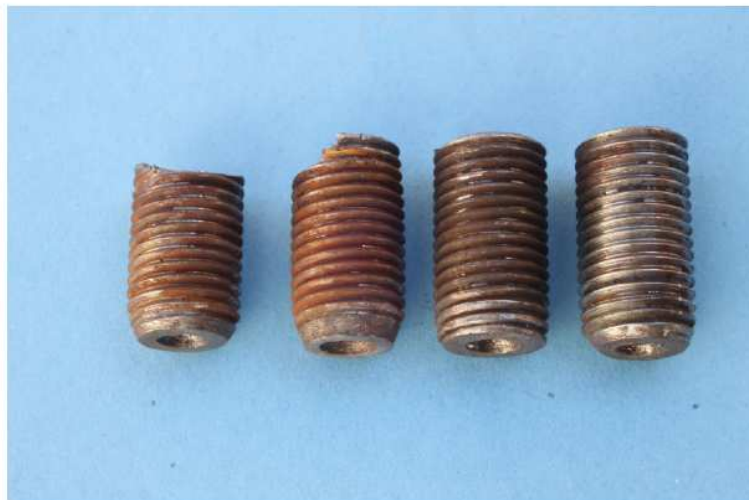
Figure 7. Corrosion observed on the threads after removal from the nuts.

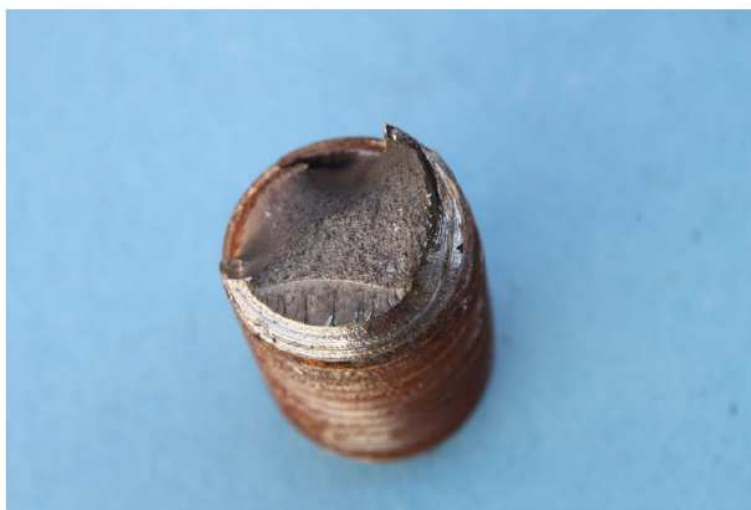
The fracture surface of one bolt showed unmistakable features indicating failure in fatigue, figure 8. Two other fracture surfaces showed features which may indicate the early stages of fatigue, i.e. apparent ratchet marks at the apparent origin, figures 9 & 10.

Figure 8. Characteristic features of fatigue observed on one fracture surface.

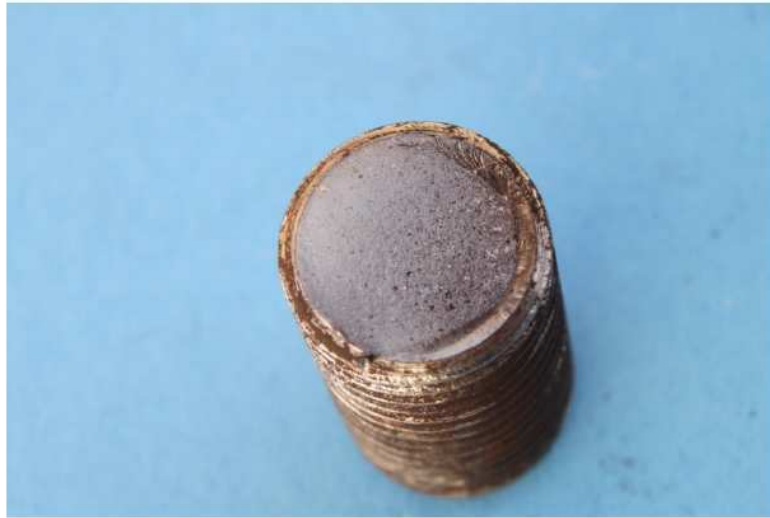
Figure 9. Apparent ratchet marks observed on another fastener indicating early stages of fatigue.

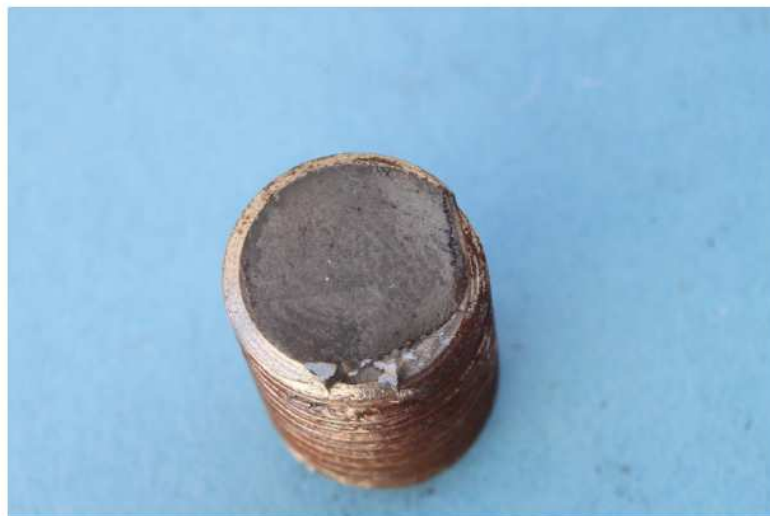
Figure 10. Apparent ratchet marks observed on another fastener indicating early stages of fatigue.

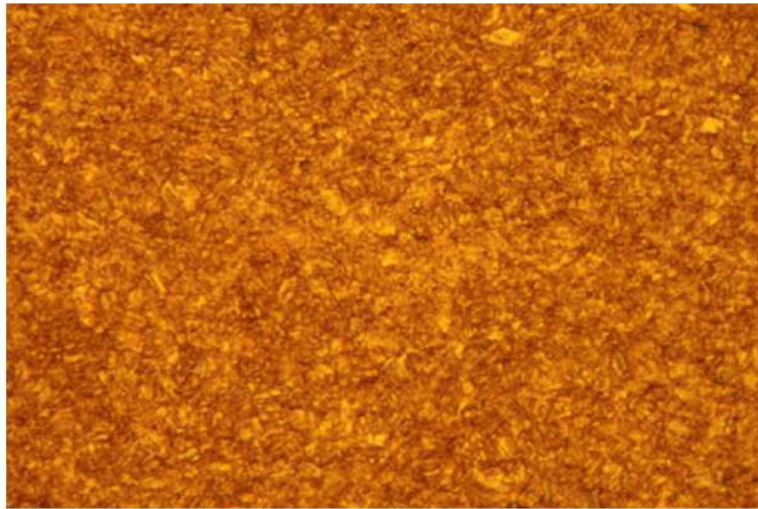
After etching in Nital-2 (2% nitric acid in ethanol) to reveal the structure, a microstructure of lightly tempered martensite was observed, figure 11. When the structure in the thread roots was examined, compression of the structure and small surface laps and folds indicated that the threads had been formed by rolling rather than cutting, figure 12.

Figure 11. Microstructure of lightly tempered martensite. Approx x 400, etched Nital-2.

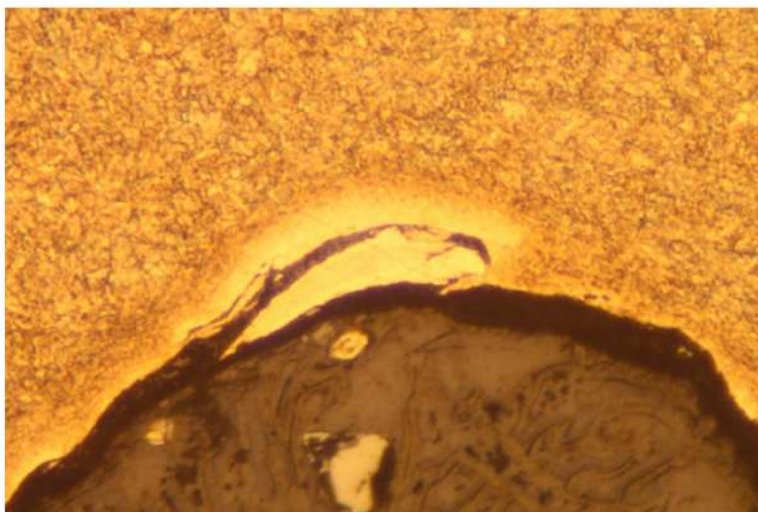
In this instance, however, surface defects which were crack-like in nature were observed in the roots of the threads. Such defects are very harmful, causing both an increase in stress and acting as initiators for the fatigue mechanism.

Formed during the thread-rolling process, crack-like laps in the thread roots are most commonly caused by over-filling of the rolls. Since they are a commonly found defect, aircraft grade fasteners, which are generally manufactured in small batches, are subject to destructive testing of representative samples to ensure that fasteners so affected are not released for use. This in turn suggests that these fasteners were not manufactured and tested to the appropriate standards and may not have been intended for aircraft use.

The presence of crack-like lap defects in the thread roots, formed during the thread rolling operation, is considered to be the primary cause.

Figure 12. Crack-like lap defect observed in thread root. Approx x 400, etched Nital-2.
