AIRCRAFT ACCIDENT REPORT AND EXECUTIVE SUMMARY

Reference:	CA18/2/3/9052	
Aircraft Registration	ZU-FHO	Date of Accident	30 April 2012		Time of Accident	1000Z
Type of Aircraft	Jabiru UL		Type of Operation	Private		
Pilot-in-command Licence Type		Microlight Aeroplane Pilot	Age	56	Licence Valid	Yes
Pilot-in-command Flying Experience		Total Flying Hours	308.5		Hours on Type	149.2
Last point of departure		Margate Aerodrome (FAMG), KwaZulu-Natal				
Next point of intended landing		Springs Aerodrome (FASI), Gauteng				
Location of the accident site with reference to easily defined geographical points (GPS readings if possible)						
About a kilometre south-east of Nagle dam in Pietermaritzburg, KwaZulu-Natal (GPS co-ordinates: S29°35,469' E030°39,097')						
Meteorological Information		Temperature: 21°C, wind: light and variable, dew point: 1°C, cloud cover: broken; cloud base: unknown; visibility: good				
Number of people on board	1 + 0	No. of people injured	1	No. of people killed	0

AIRCRAFT ACCIDENT REPORT

Name of Owner/Operator : Lewis DP
Manufacturer : Shadow Lite CC
Model : Jabiru UL
Nationality : South African
Registration Marks : ZU-FHO
Place : Pietermaritzburg
Date : 30 April 2

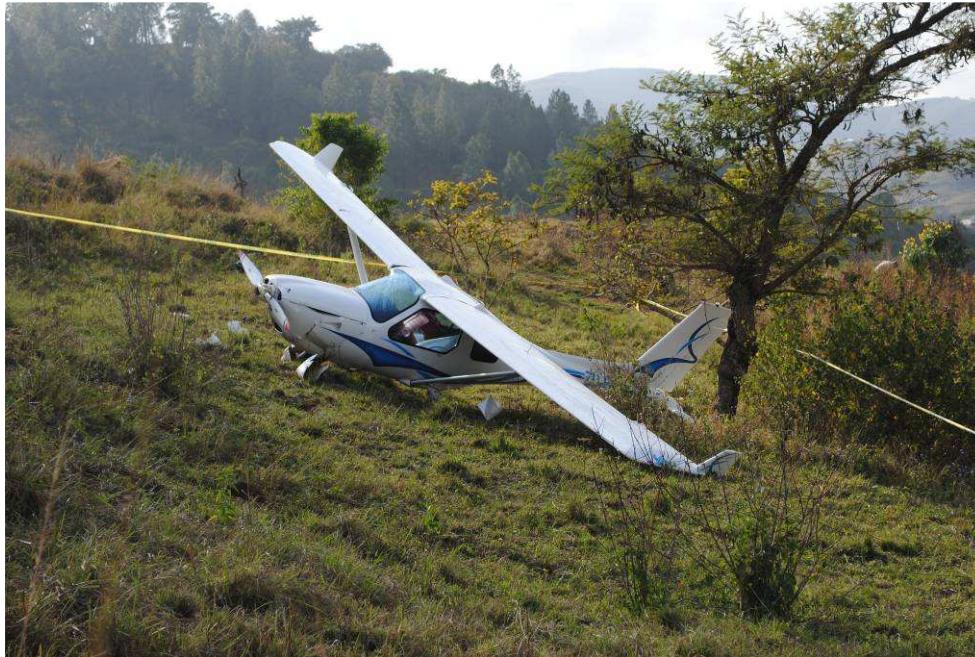
Figure 3: The aircraft wreckage

1.3.1 The aircraft sustained substantial damage during the accident sequence.

1.12.2 Although the wreckage was intact, the aircraft sustained damage to the right wing, right wing flaps, left wing, propeller, flight control system, landing gear and horizontal stabiliser.

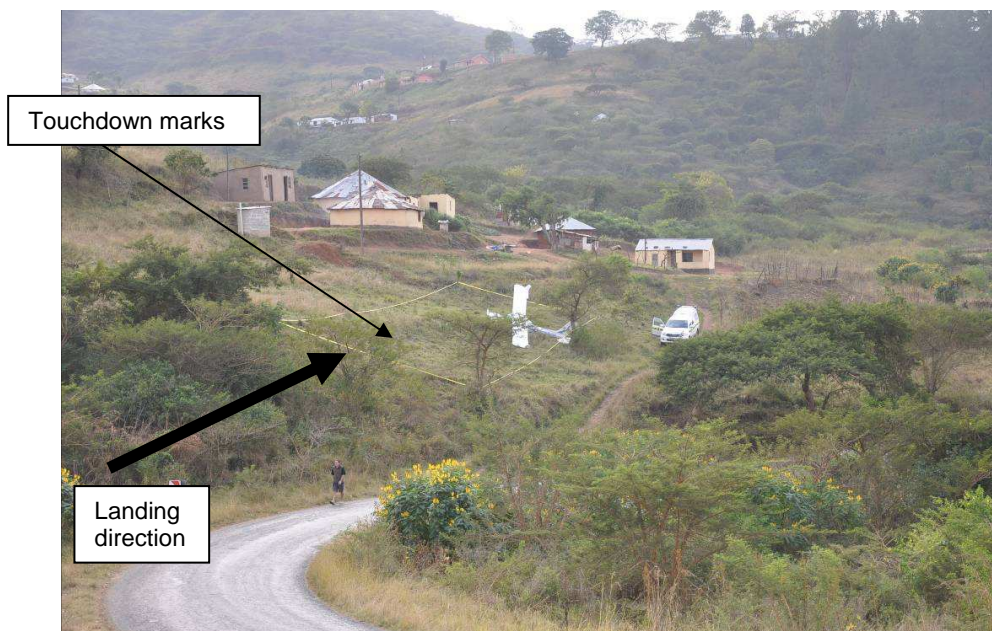
Figure 4: View of accident site

1.12.1 During the forced landing sequence, the aircraft landed uphill with a slope down to the right. Due to the low landing speed and gradient of the terrain, the aircraft had hardly any forward motion after landing. The aircraft came to rest next to a tree 3 m from the touchdown mark.

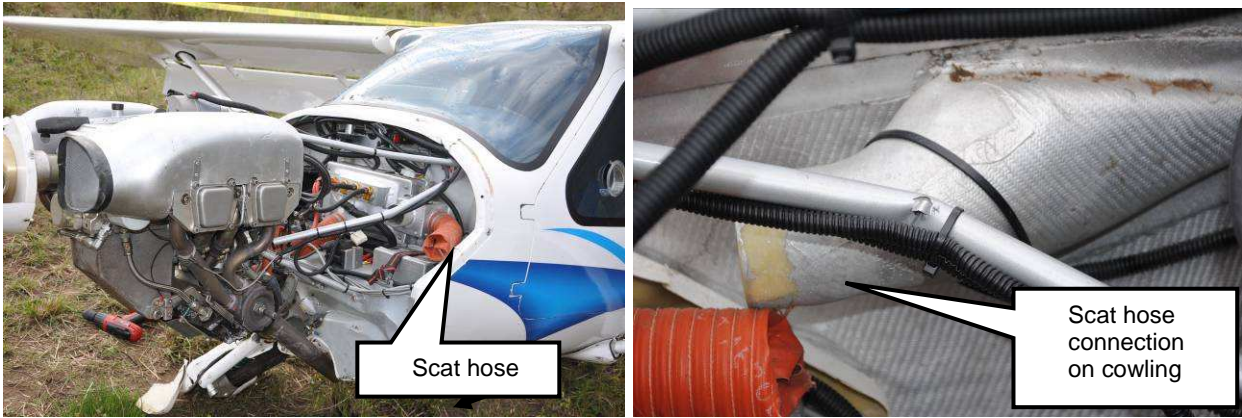
Figures 5 and 6: Scat hose

1.16.1 During the on-site investigation, the scat hose was found not connected to the cowling air intake, although a clamp was in place to secure the hose.

1.16.4 The scat hose connection on the inside of the cowling was found to be tapered. The scat hose is reinforced with a steel wire that makes it more rigid. On the accident aircraft, the steel wire reinforcing at the end of the scat hose was removed to make the scat hose more flexible in order for it to fit on the cowling duct. The investigator is of the opinion that the scat hose was connected with a clamp to the cowling but due to vibration during operation and the tapered shape of the connection, the scat hose became dislodged from its attachment on the cowling.

- 2.4 The investigator is of the opinion that the scat hose was connected with a clamp to the cowling but due to vibration during operation and the tapered shape of the connection, the scat hose became dislodged from its attachment on the cowling. This then caused the scat hose to collapse and close, resulting in air starvation to the engine and subsequent engine power loss. However, there is a possibility that the scat hose was never secured after connection due to time and pressure on the technicians.

- i. The SACAA Airworthiness Department should ensure that all owners of Jabiru aircraft be made aware of the above findings, thus ensuring the sufficient securing of the scat hose.*
- ii. The SACAA Airworthiness Department should assist the manufacturer in finding a solution with regards to the potential problematic tapered connector.*
- iii. The SACAA Airworthiness Department together with the manufacturer should look at the possibility of including a failsafe alternative in the air supply system should the above finding re-occur or the air intake be blocked by foreign objects.*

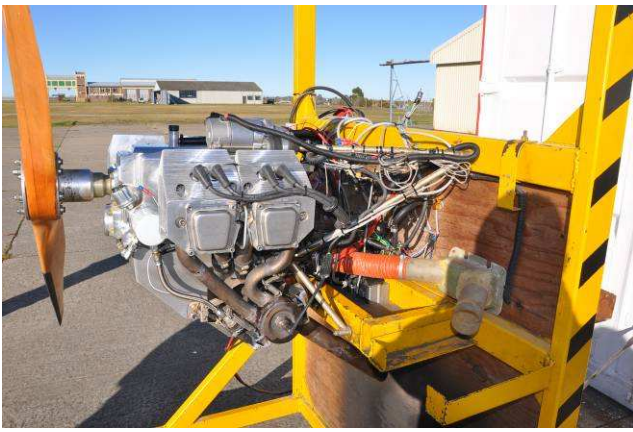
Figure 9: The engine being operated

- The engine was found to be operating normally.
- The two fuel pumps were also found to be operating normally.
- No obstruction was found in the header tank or fuel filters.
- The scat hose was closed (collapsed) during the engine operation and the engine immediately stopped.

The engine investigation concluded that as the scat hose was found not connected to the cowling, the scat hose restricted airflow (collapsed) to the engine and the engine failed in operation shortly thereafter.

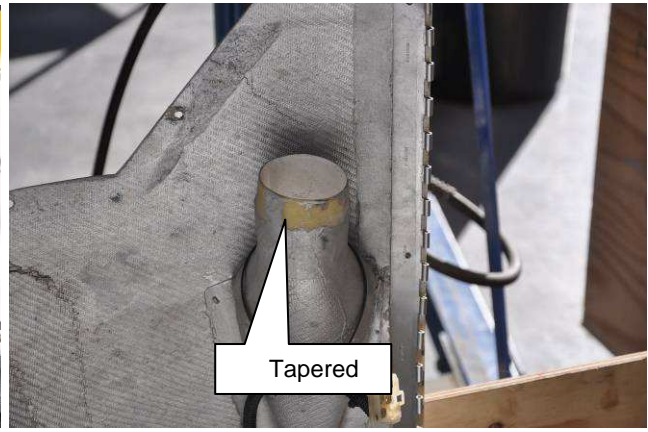
Figure 10: The scat hose connection on the engine cowl

1.16.3 The scat hose is connected to the intake air duct on the engine cowl and provides the fuel control system with air for engine operation.

- 2.3 The scat hose connection on the inside of the cowling was found to be tapered. The scat hose is reinforced with a steel wire that makes it more rigid. On the accident aircraft, the steel wire reinforcing at the end of the scat hose was removed to make the scat hose more flexible in order for it to fit on the cowling duct.
