**AIRCRAFT ACCIDENT REPORT AND EXECUTIVE SUMMARY**

Reference:	CA18/2/3/9039	
<b>Aircraft Registration</b>	ZS-OCH	<b>Date of Accident</b>	04 May 2012		<b>Time of Accident</b>	1620Z
<b>Type of Aircraft</b>	Cessna U206G Stationair		<b>Type of Operation</b>	Private		
<b>Pilot-in-command Licence Type</b>	Private		<b>Age</b>	47	<b>Licence Valid</b>	Yes
<b>Pilot-in-command Flying Experience</b>	Total Flying Hours		Unknown		<b>Hours on Type</b>	Unknown
<b>Last point of departure</b>	Piet Retief aerodrome (FAPF): Mpumalanga province.					
<b>Next point of intended landing</b>	Greytown aerodrome (FAGY):Kwa-Zulu Natal province.					
<b>Location of the accident site with reference to easily defined geographical points (GPS readings if possible)</b>						
In the vicinity of Stanger (Kwa-Dukuza) area into the plantations at GPS position determined to be; South 29° 03.297' East 030°37.856' at an elevation of 1144 feet above mean sea level (AMSL).						
<b>Meteorological Information</b>	Low clouds (stratus and possibly fog) were observed in the vicinity of Greytown area. <b>Stratus</b> clouds are uniform, greyish clouds that often cover the entire sky.

<b>AIRCRAFT ACCIDENT REPORT</b>
-----------

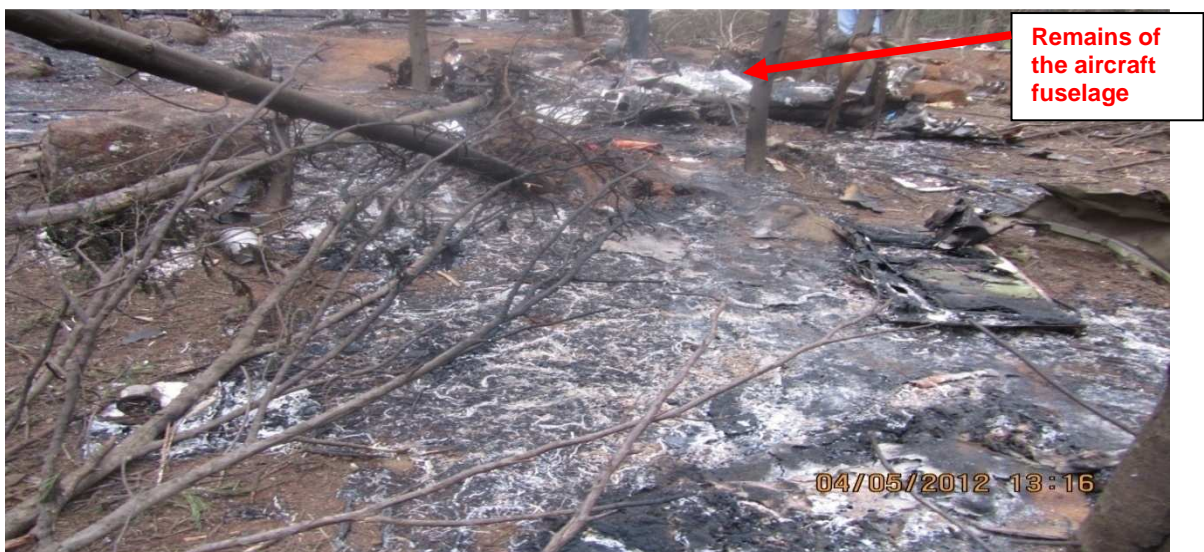
1.3.1 The aircraft was destroyed by impact and post impact fire that erupted.

Figure 2: Aircraft wreckage, showing the extensive fire damage.

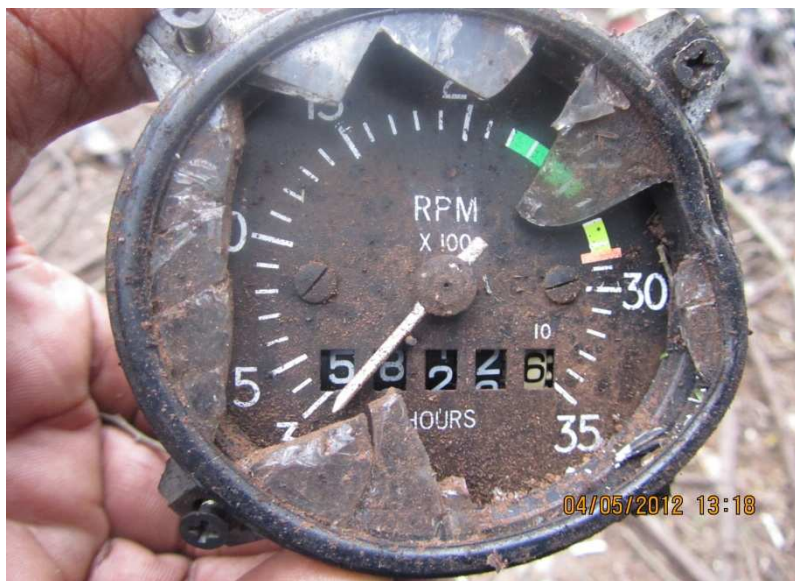
\*NOTE: The last Mandatory Periodic Inspection (MPI) carried out on the 12<sup>th</sup> of August 2011 revealed that the aircraft tachometer was recording 5776.1 hours and the tachometer as found at the accident site was recording 5822.6 hours, which showed that the aircraft has flown a total of 46.5 hours since the last MPI.

**Figure 4: View of the aircraft tachometer as found at the accident site.**

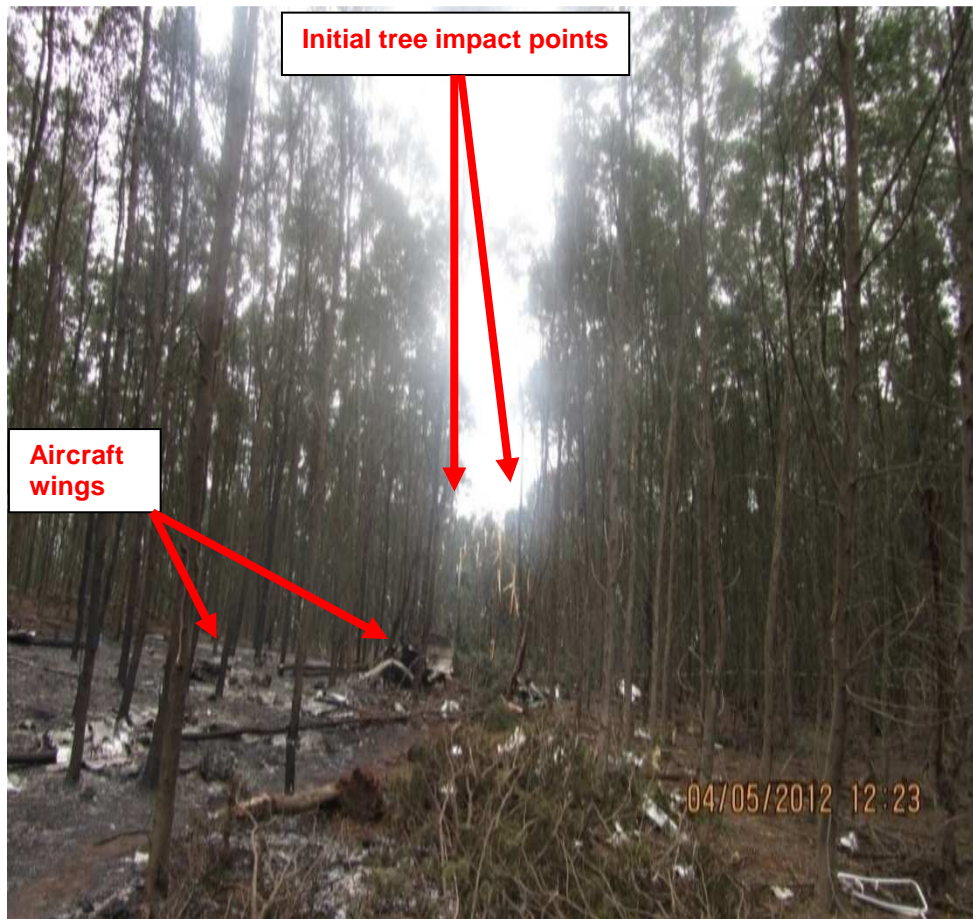
1.12.1 The aircraft was routing in a South Westerly direction when it collided with the plantations at an altitude of 1144 feet above mean sea level (AMSL) and came to rest approximately 94.3 metres from the initial point of contact with the

1.12.2 The wreckage was contained within 120 feet from the first point of impact. The wreckage and the high degree of damage indicated that the aircraft had impacted the ground at a nose-low, wing level attitude at high speed. Due to the considerable amount of energy on impact with the plantations, both wings failed at their attachment points to the fuselage.

**Figure 5: Flight path before impact and witness marks on the plantations.**

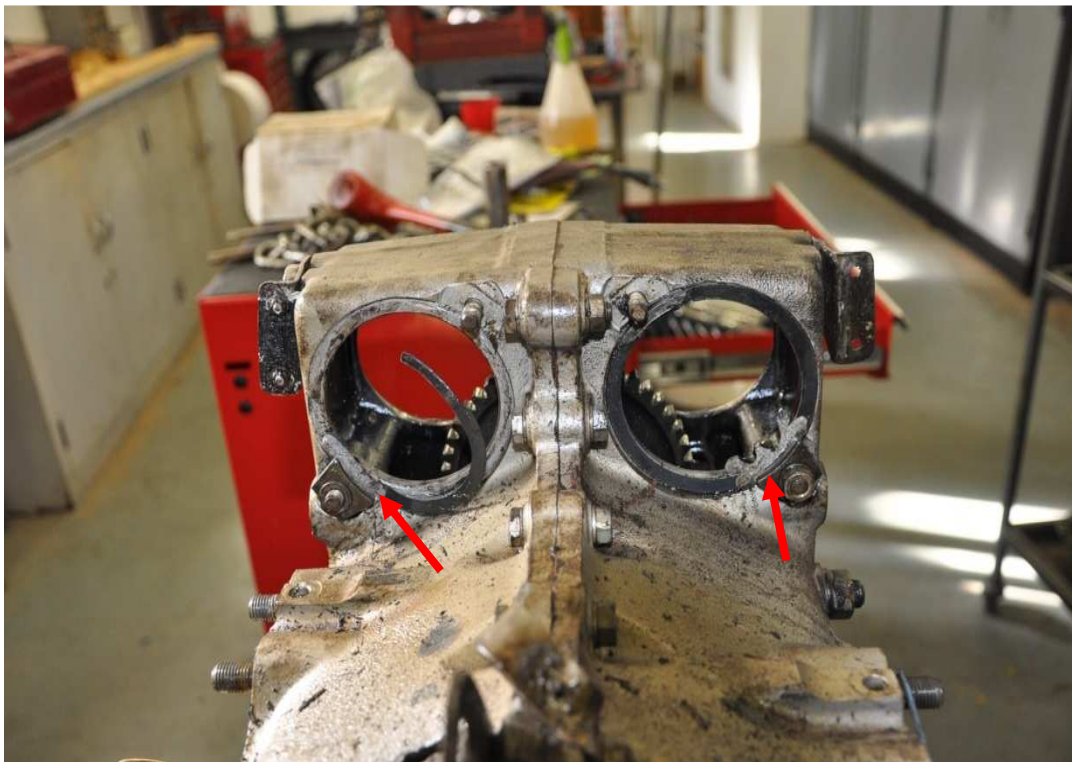
1.12.4 The engine separated from the mountings and the propeller detached from the hub. Magnetos detached from the engine during the accident sequence and were found to have been damaged. See figure 6 below:

**Figure 6: Evidence of Left and Right magnetos remains left on the engine casing.**

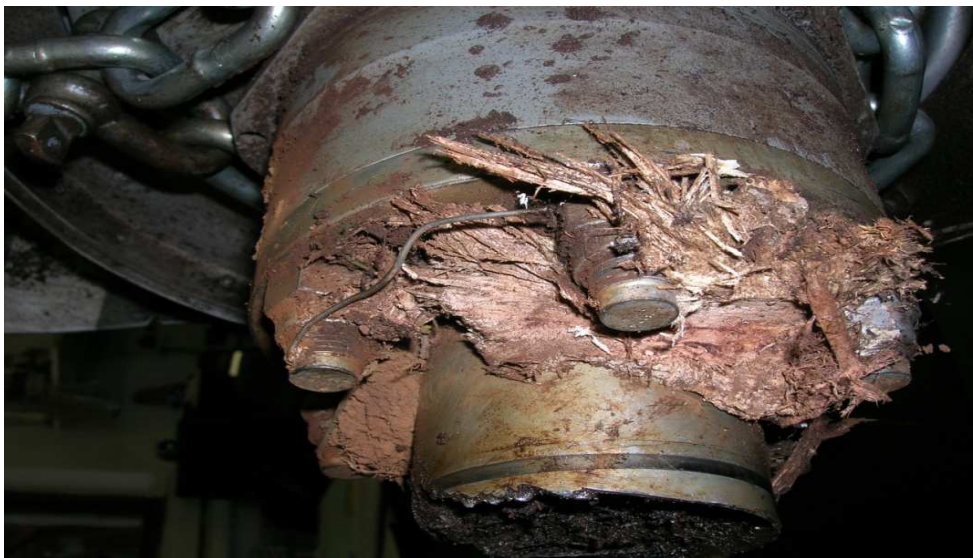
- (b) During the engine strip down, it was evident that the crank could still rotate and no anomalies were detected. Suspected side on impact (right forward) side damaged propeller and crank flange with tree bark and fibre forced in between propeller attachment bolts. The evidence from this impact also suggests that the propeller was still turning on impact however the amount of power it was producing couldn't be determined by visual inspection. The position of the tree bark and fibres were found to be parallel to the sideways bending moment fracture line as it can be seen on figure 7 below.

**Figure 7: View of the propeller attachment point (hub).**

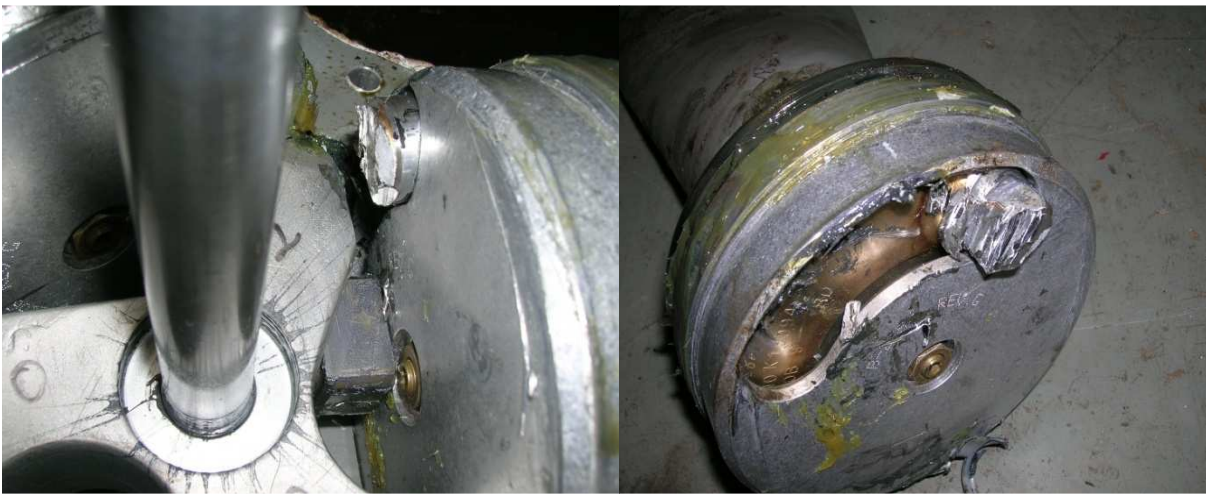
- (a) On removal of the blades from the crank flange side hub half, it was found that the blade pitch pins sheared from the blade bases in different ways. The probable cause for this seems to be due to the different impact points and bending damage on the different blades. Other than the sheared pins and indentation damage caused by the blade hubs on the hub bases, no abnormalities could be detected with this part of the pitch change system. This suggests that the engine oil pressure was in fact available to activate the constant speed mechanism as this is the function of the throttle and the other cockpit settings. See figure 8 and 9 below.

**Figure 8 and 9: Evidence of damage on the blades inside the hub.**

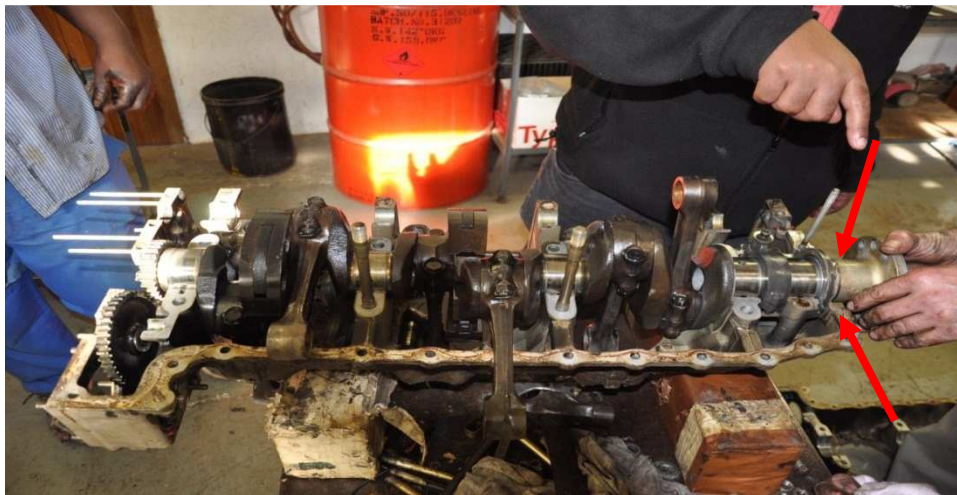
- ❖ The piston pins were all checked for free rotational movement and were then removed with the pistons. No anomalies were found.
- ❖ The connecting rods were checked for normal movement on the big end bearings of the crankshaft and were found to be normal.
- ❖ Crankshaft rotation was then checked and was found to be able to rotate normally.
- ❖ The crank case was then split and the crank with connecting rods was removed to expose the main crank bearings. Other than normal wear, no abnormalities could be found with the main bearings.
- ❖ The cam shaft was removed and inspected. No abnormalities could be found with the camshaft and camshaft bearings.
- ❖ Cam shaft gear drive train was removed and inspected. No abnormalities were found as it can be seen on figure 10 below.

**Figure 10: View of the crank shaft and severed flange.**

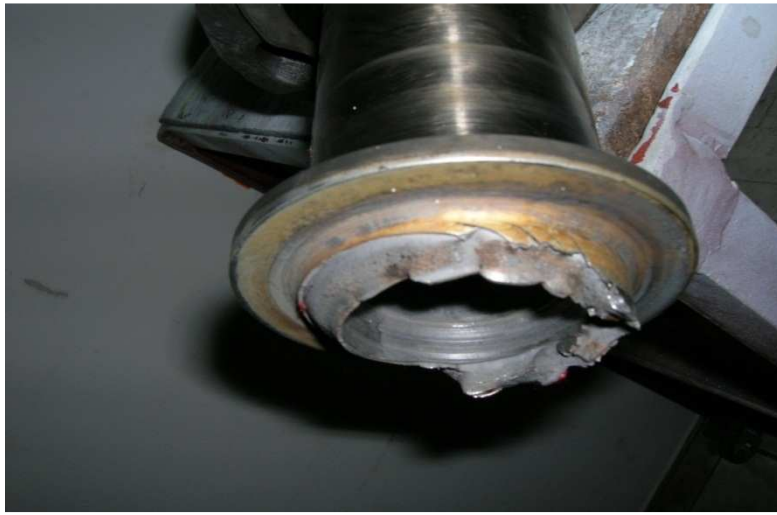
- (a) The crank shaft and the fractured propeller flange were magnetized with direct current and coil magnetization technique. No other crack indications could be found in the rest of the crank shaft main and big end journals. On inspecting the crankshaft multiple cracks were evident. These cracks emanate at a tangent angle from the main fracture line, suggesting that the crankshaft journal was partly fractured under the initial torque impact load as it can be seen on figure 11 below.

**Figure 11: Evidence of damage on the crank shaft.**

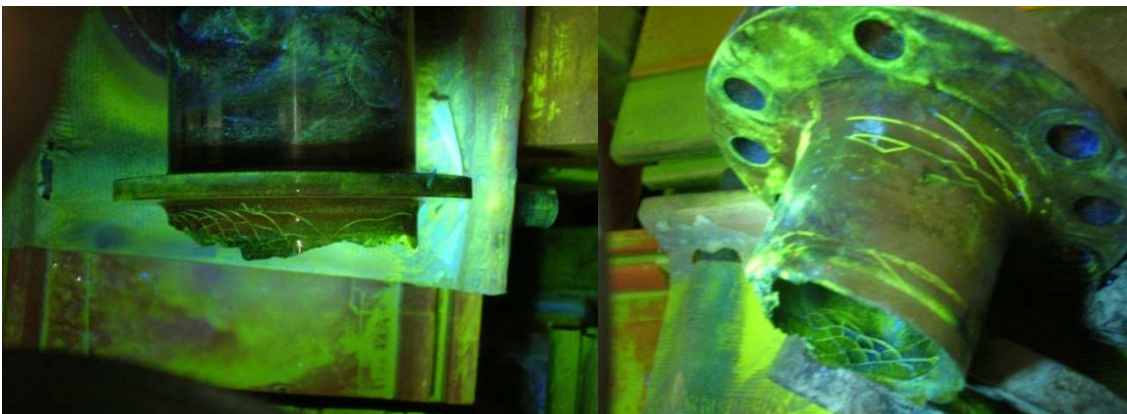
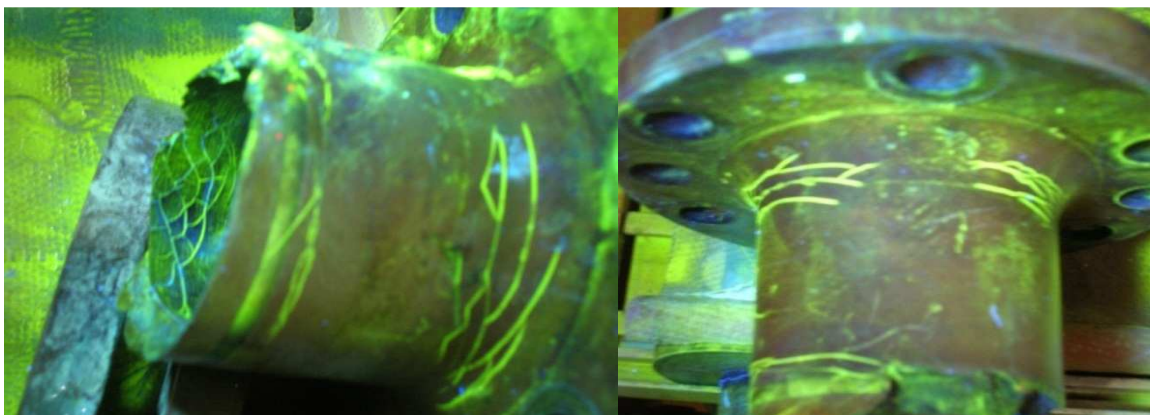
- (a) During the inner flange side inspection on the crank shaft impact cracks were evident on the outer surface, in the rear radius of the propeller flange. These impact cracks occur opposite of each other at 180 degrees and parallel to the fracture cracks on the inside of the hollow shaft, suggesting high sideways impact on the propeller. See the cracks from different angles on the picture 12, 13, 14 and 15 below.
