Final Report No. 2226 of the Swiss Transportation Safety Investigation Board STSB

concerning the serious incident (Airprox)

involving the Dassault Falcon 2000 aircraft,
registration OM-OPF, operated by Opera Jet AS
under flight plan callsign OPJ 700

and the Hawker Hunter T Mk 68 aircraft,
registration HB-RVP,
operated by the 'Verein Fliegermuseum Altenrhein'

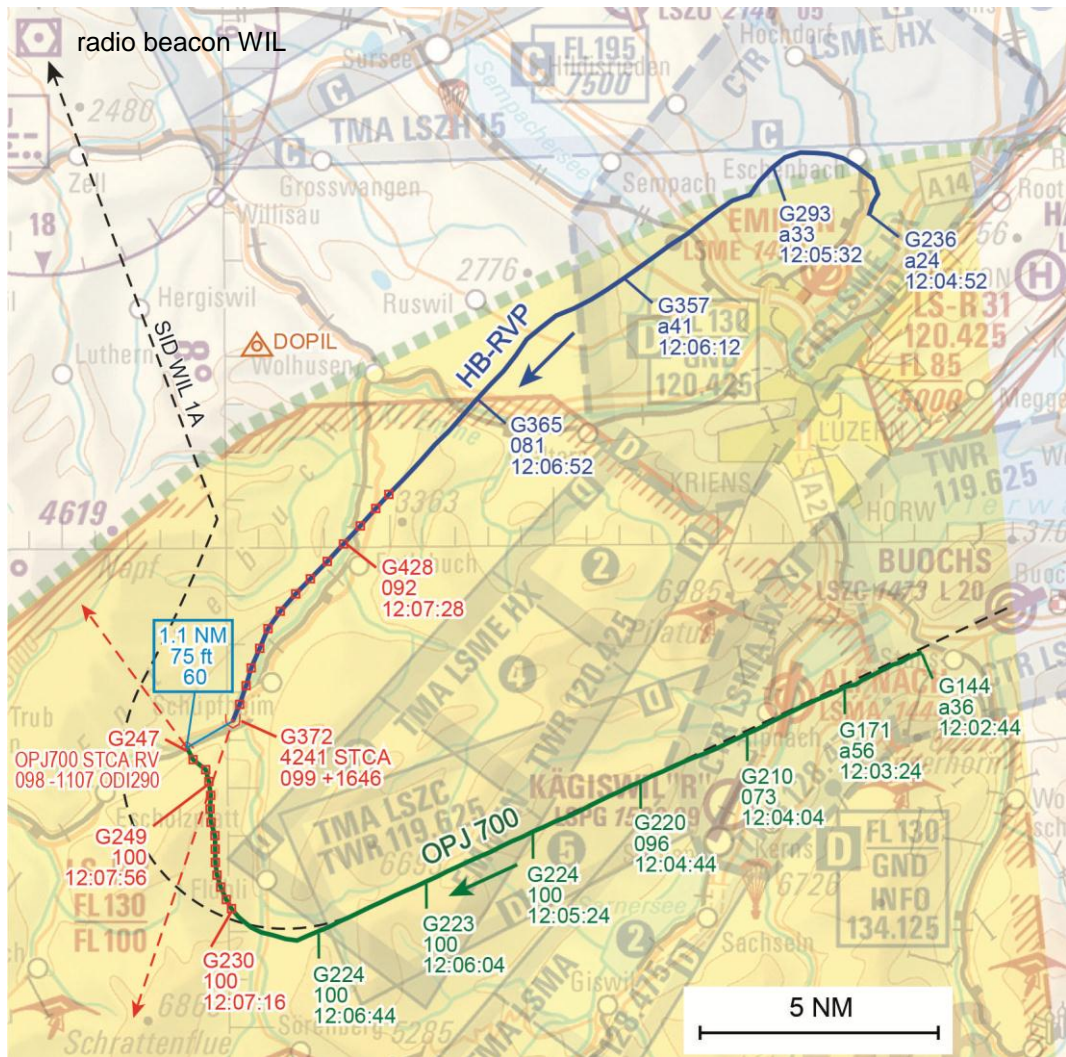
Figure 1: Overview of the flight paths of the two aircraft HB-RVP and OPJ 700. The radar labels consist of three lines that include the following information: first line: ground speed in knots; second line: altitude in hundreds of feet; third line: time in UTC. The radar echoes and the radar labels during the active STCA alarm are displayed in red. The nominal flightpath of the SID WIL 1A is displayed as black dotted line, containing the overfly waypoint ZC601. The radio beacon is situated in the left upper corner of the figure. The military training area "Schrattenfluh" is yellow shaded accented. The layers of the basic chart come from Swisstopo.

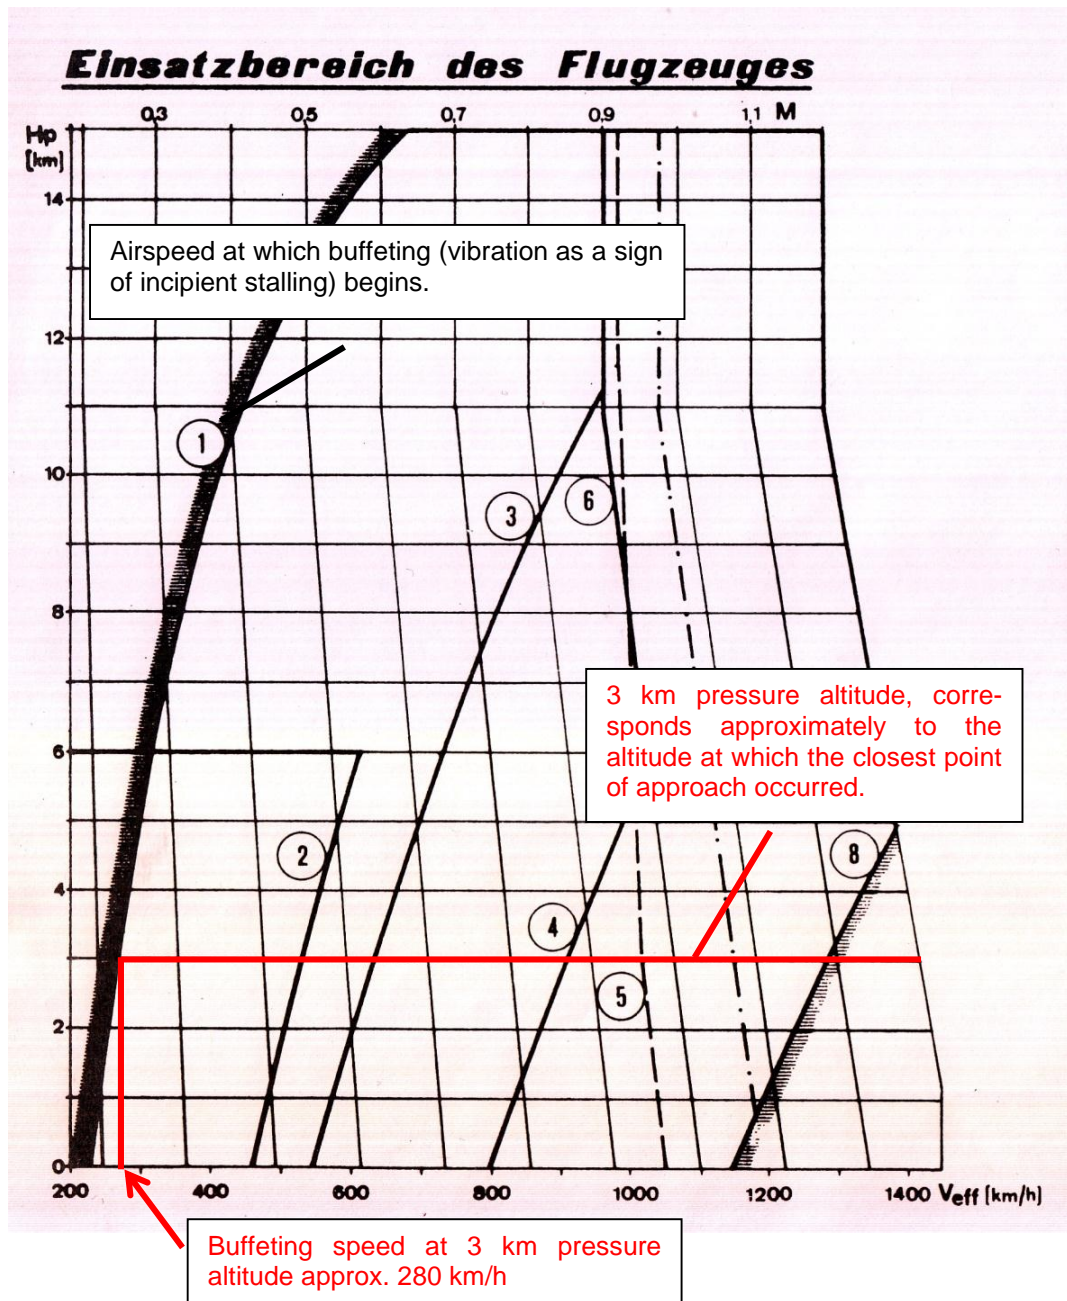
The crew of HB-RVP claimed that this former combat aircraft could be flown only with difficulty under the 250 knots indicated airspeed (KIAS) limit for flights below FL 100 which are applicable to civil aircraft.

Figure 2: Operating range of the Hawker Hunter T Mk 68 aircraft according to the aircraft manual. Only the relevant data was referred to.

According to this information, the speed at which an incipient stall is indicated - in the form of shaking of the aircraft (buffeting) - was approximately 280 km/h (corresponding to 152 kt) true airspeed (TAS) at an altitude of 3 km (approximately 10 000 feet). With a safety margin factor of 1.5 on the buffeting speed, the Hawker Hunter can be flown at TAS of 230 kt, corresponding to approximately 200 KIAS.

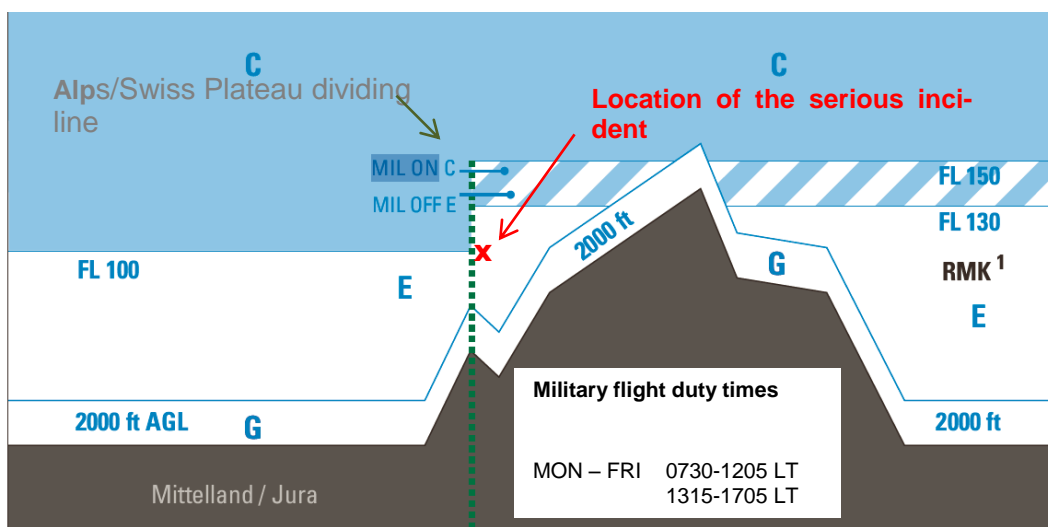
The serious incident took place in class E airspace. At the time of the serious incident, the status 'MIL ON' applied in relation to the upper limit of ECHO airspace, i.e. to the south of the line separating the Alps from the Swiss Plateau, the upper limit of ECHO airspace was flight level (FL) 130.

Figure 3: Vertical structure of airspace ECHO with 'MIL ON' status

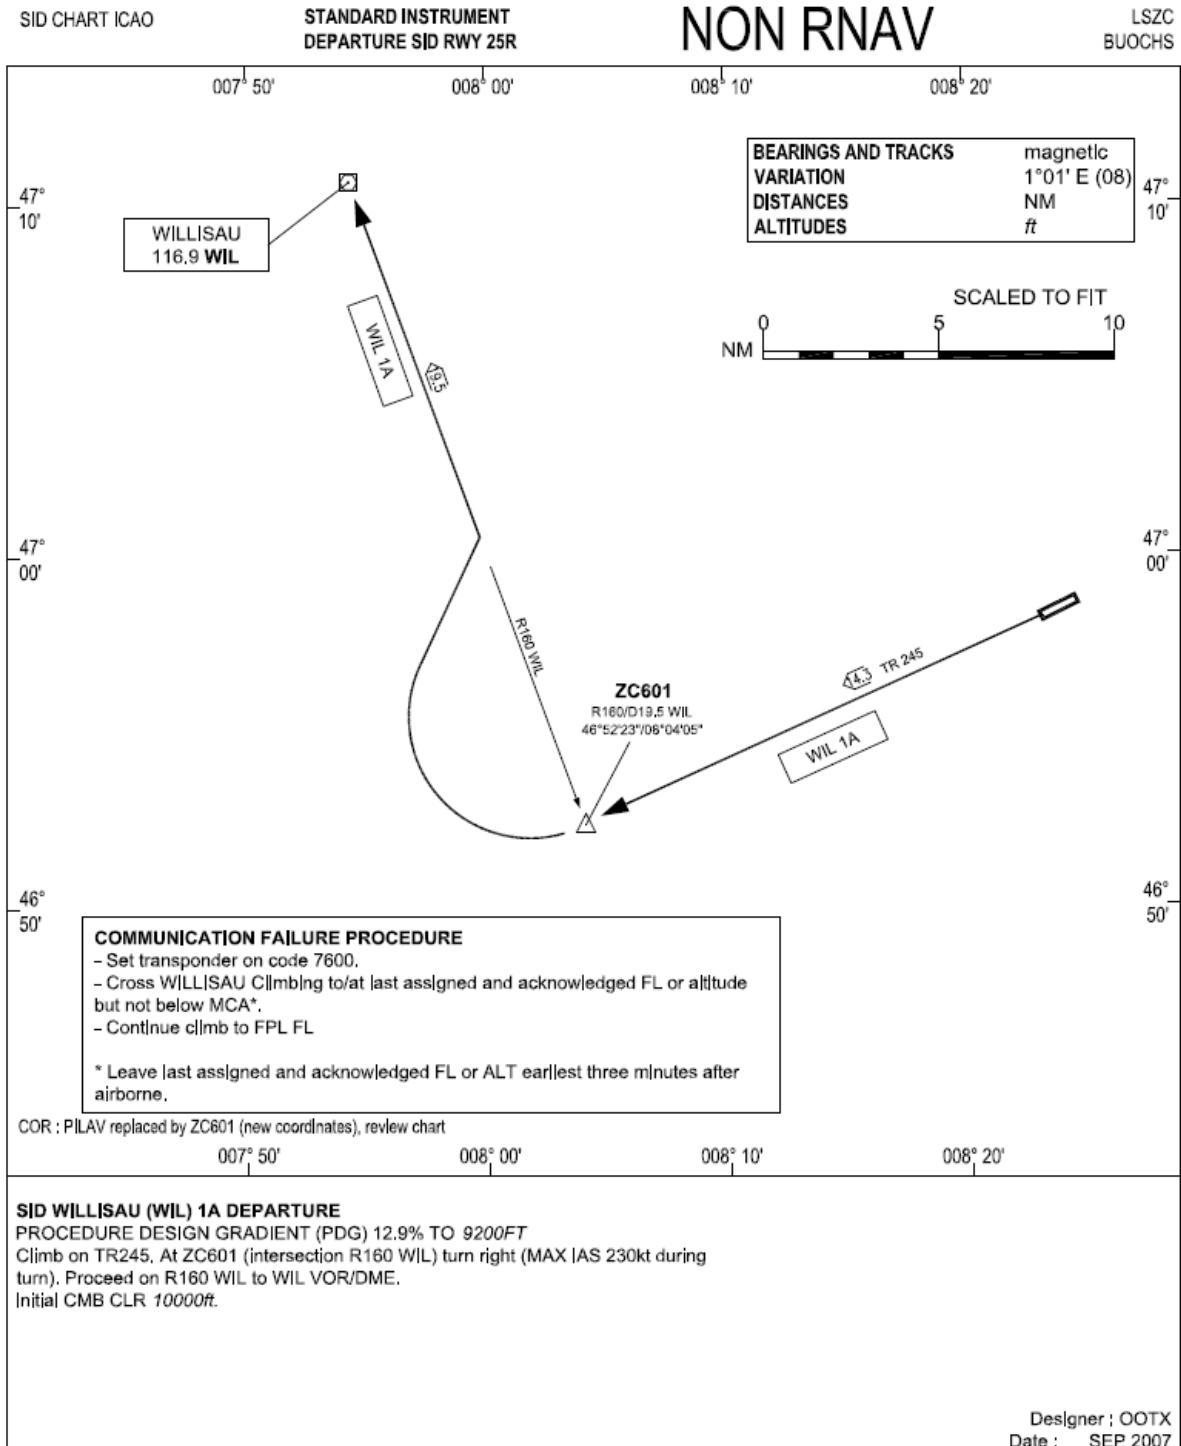
Annex 1: Standard instrument departure (SID) Willisau (WIL) 1A from Buochs aerodrome (LSZC)

The serious incident was facilitated by the fact that the standard instrument departure route (SID) WIL 1A from Buochs aerodrome was never published. This led to the following contributory factors:
