AIRCRAFT ACCIDENT REPORT AND EXECUTIVE SUMMARY

Reference:	CA18/2/3/9054	
Aircraft Registration	ZU-HIT	Date of Accident	30 June 2012		Time of Accident	0802Z
Type of Aircraft	L-39C		Type Operation	Display		
Pilot-in-command Licence Type	ATP - Aeroplane		Age	49	Licence Valid	Yes
Pilot-in-command Flying Experience	Total Flying Hours		2019		Hours on Type	41
Last point of departure	Klerksdorp Aerodrome – North-West Province					
Next point of intended landing	Klerksdorp Aerodrome – North-West Province					
Location of the accident site with reference to easily defined geographical points (GPS readings if possible)						
Outside Klerksdorp Aerodrome boundary at GPS co-ordinates: S26°52.0" E026°43.0"						
Meteorological Information	Fine weather conditions prevailed at the time and place of the accident.					
Number of people on board	1+0	No. of people injured	0	No. of people killed	1	
Synopsis						
<p>On 30 June 2012, two L-39C aerobatic type aircrafts were scheduled to perform some aerobatic manoeuvres at the air show being held at Klerksdorp Aerodrome in the North-West province.</p> <p>Shortly after both aircraft took off from Runway 36 at Klerksdorp Aerodrome at approximately 0802Z,

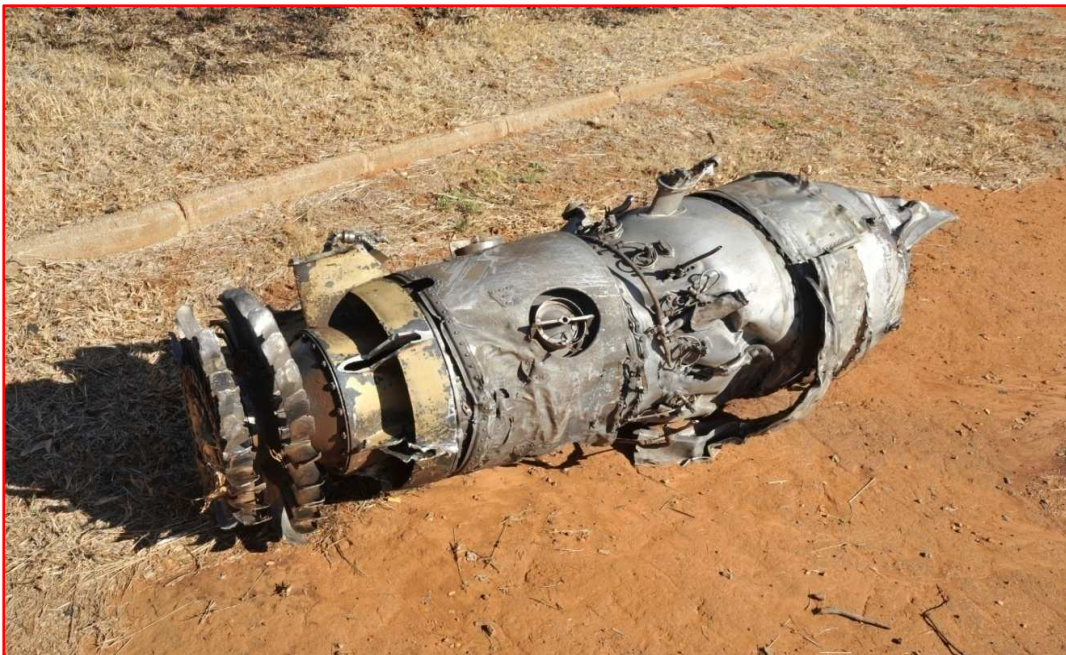
Figure 1: The main core of the turbine engine that separated from the A/C on impact

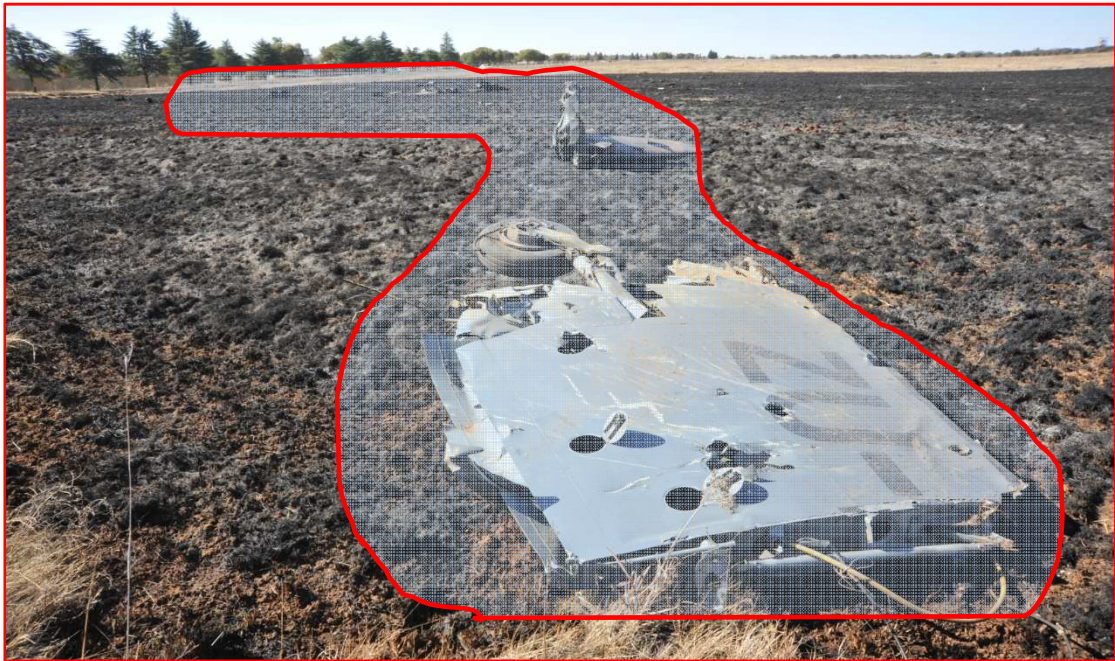
Figure 2: Wreckage pieces were spread over a distance of approximately 300m

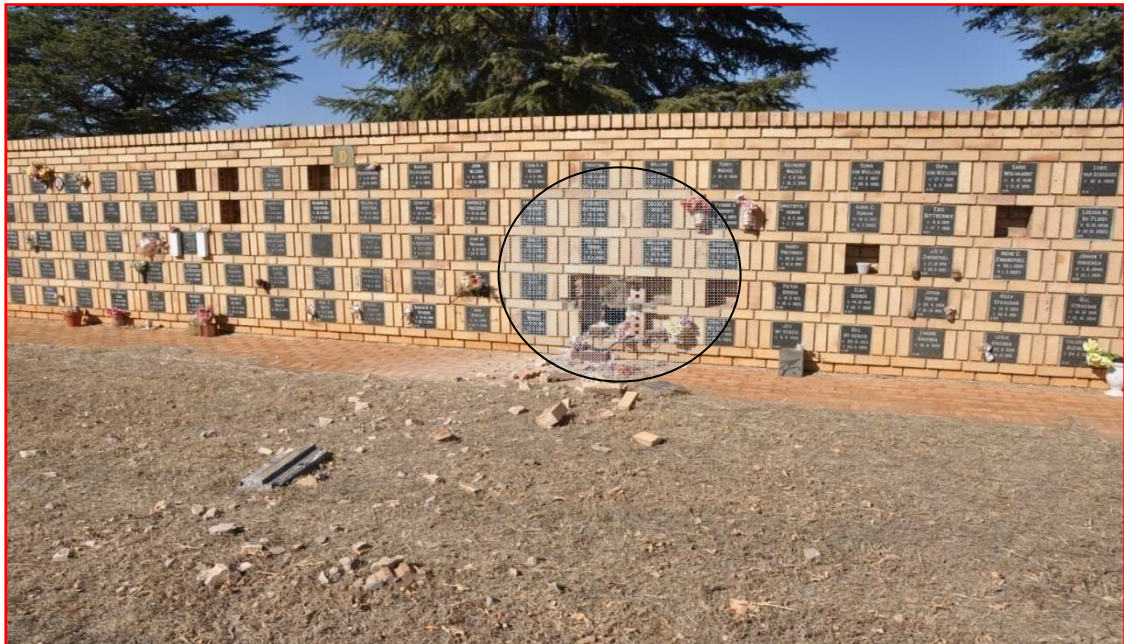
- 1.4.1 After the ground impact, the wreckage skidded a further 250m. Debris from the aircraft wreckage propelled and caused damage to a pedestrian entry gate at the cemetery and to the “wall of remembrance”.

Figure3: Shows damage to the “Wall of Remembrance”

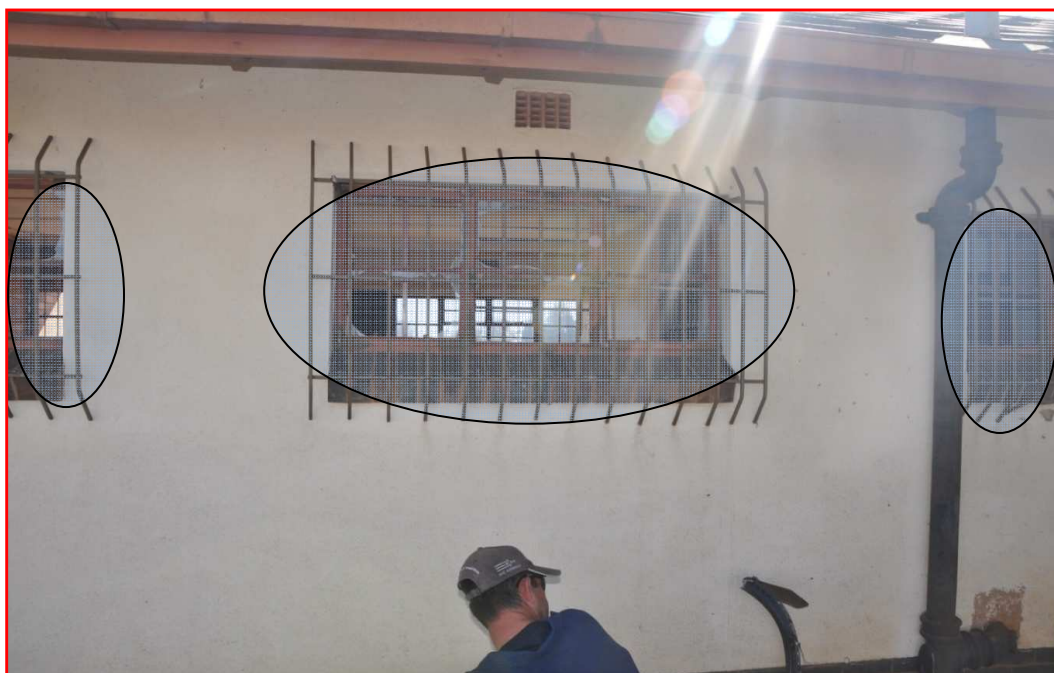
- 1.4.2 One of ejector seat explosive canisters separated from the wreckage and was located next to the unoccupied caretakers’ cottage at the Klerksdorp Cemetery. The South African Police exploded the canister, as they believed that it was a safety hazard. The exploding canister shattered all the windows of the caretakers’ cottage.

Figure 4: Damage to the Caretakers Office

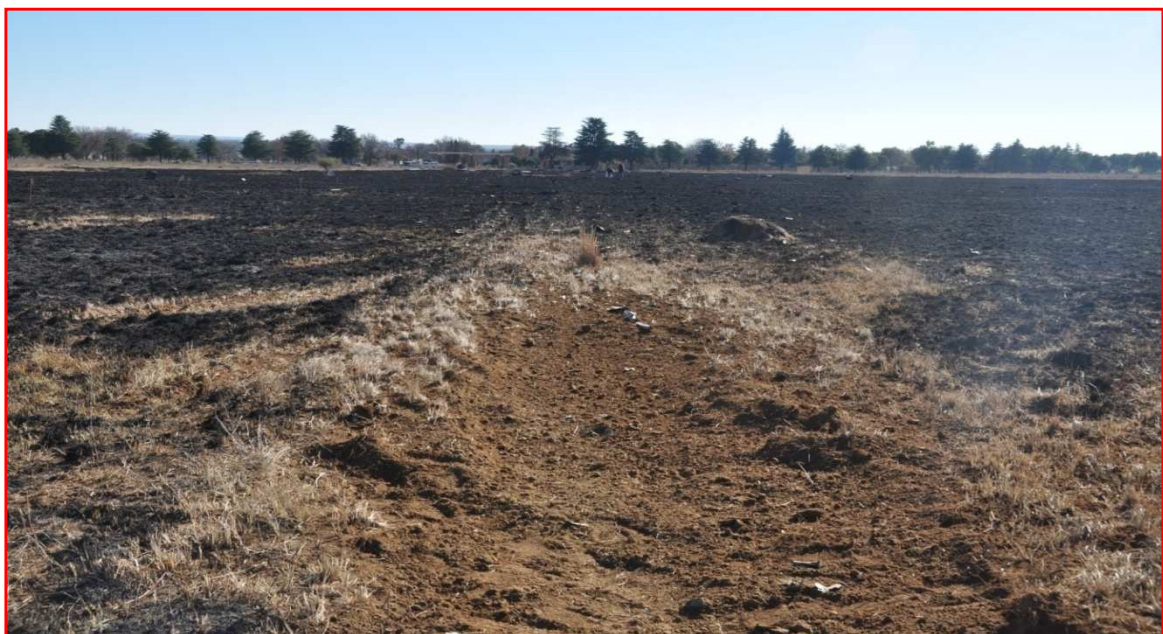
1.12.1 The ground impact was almost in a wings level attitude. After the initial impact the aircraft partly disintegrated and the wreckage was spread over a distance of approximately 250m.

Figure5: Shows the deep scar mark during the initial impact sequence

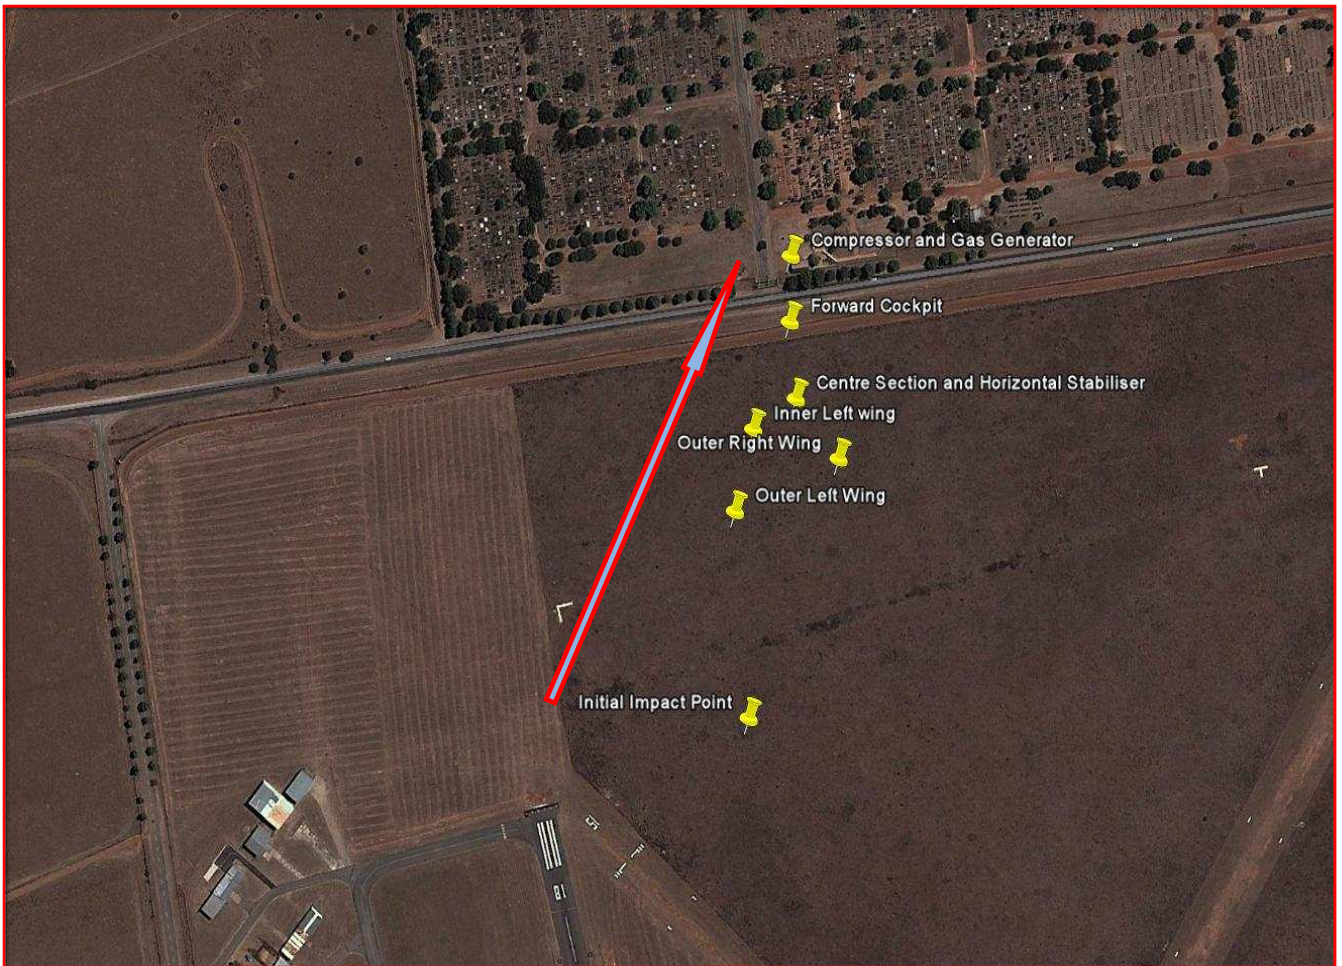
Figure 6: Shows the wreckage trail after the initial impact with the ground

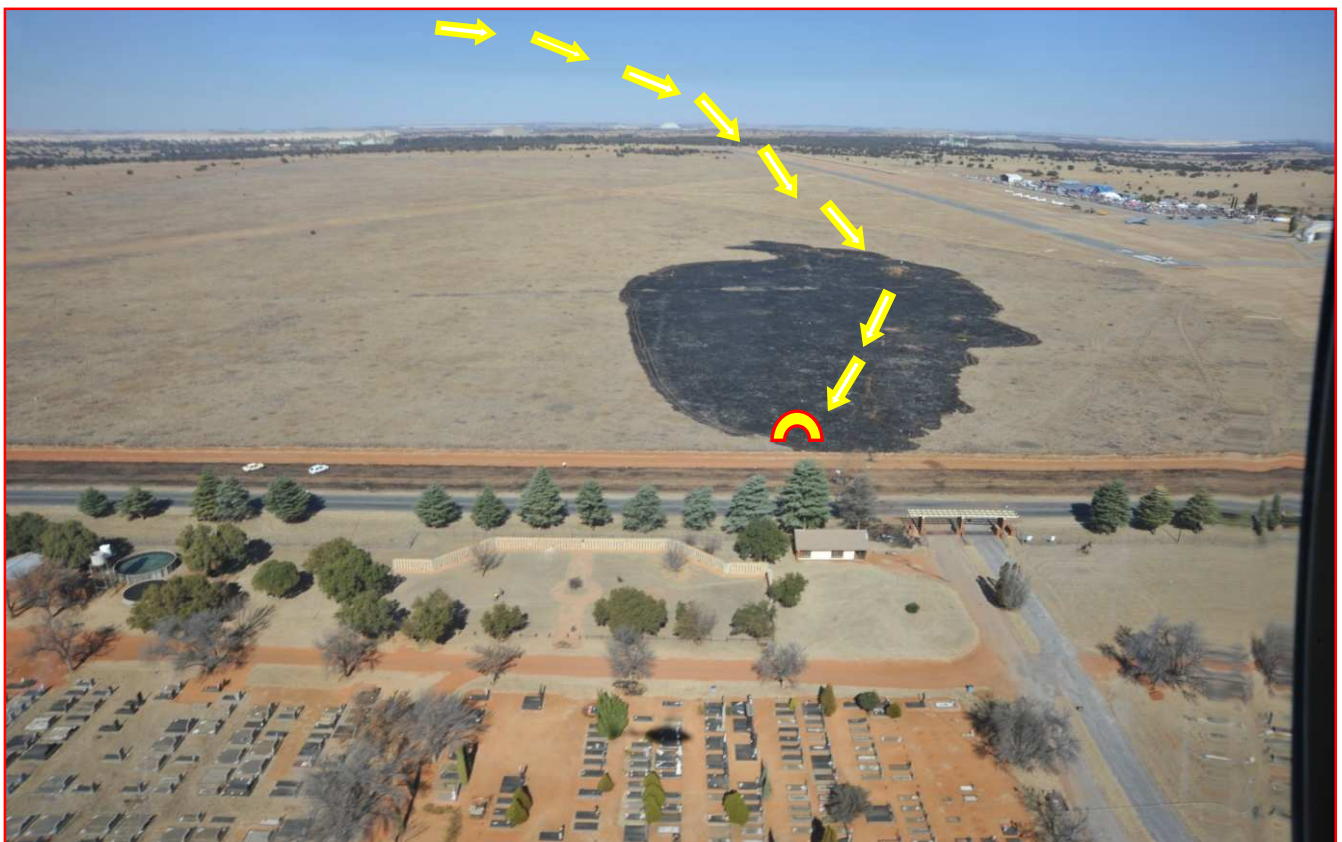
Figure 7: Shows a view of the approximate flight path followed by the aircraft with the position of the forward cockpit as indicated.

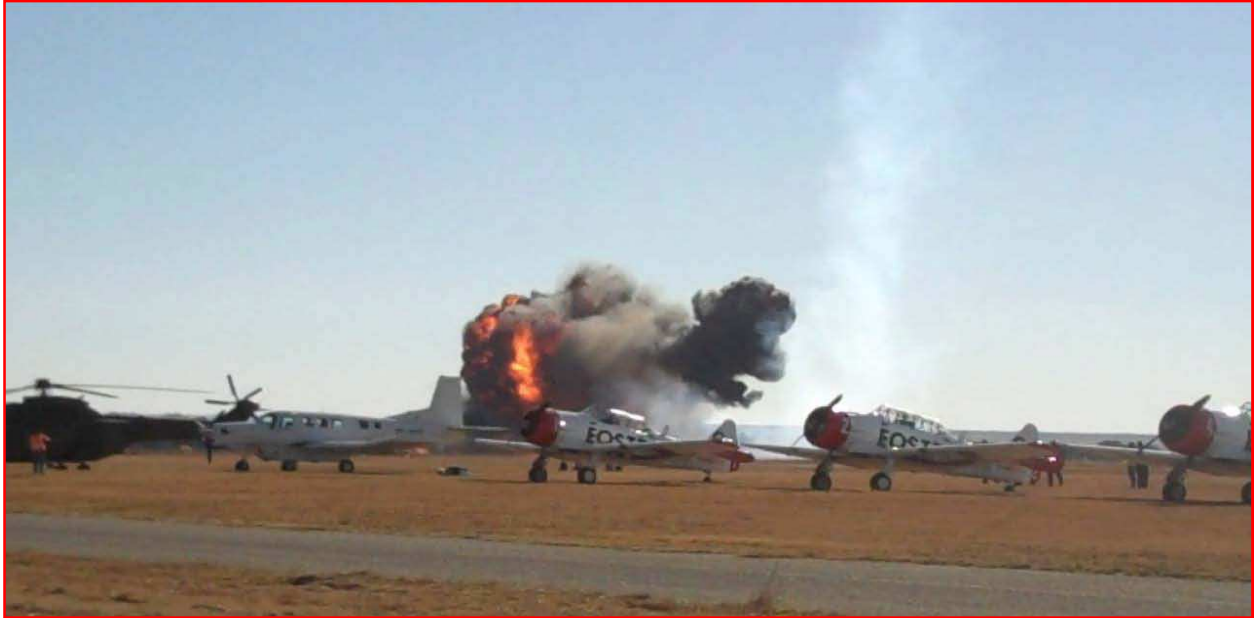
1.14.1 The aircraft erupted in fire during the ground impact.

Figure 8: The aircraft exploded and a post impact fire erupted during the ground impact

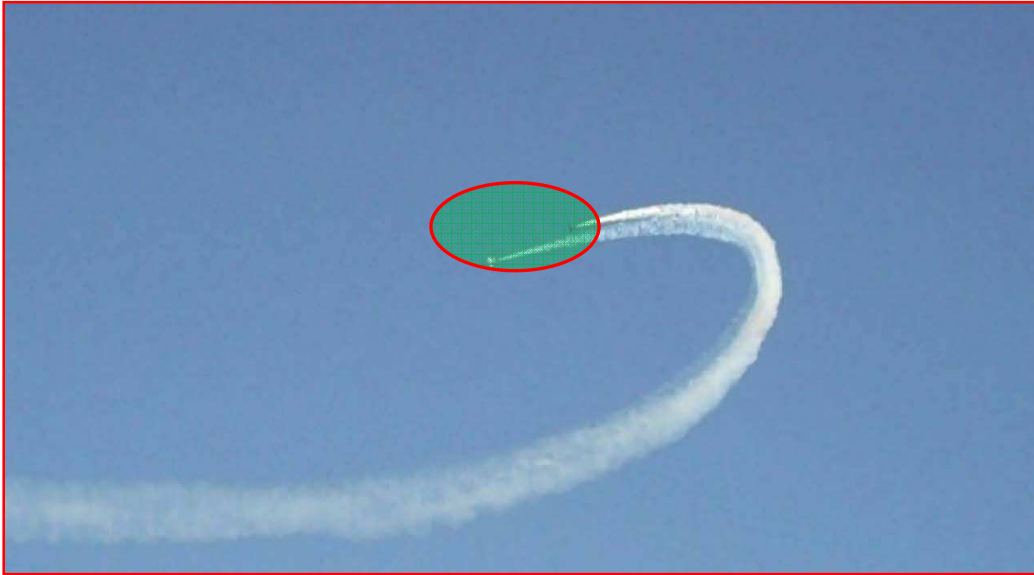
Figure 10: Commencing with the 2nd “loop”, the leading pilot made a steep turn and the pilot of the accident aircraft moved into a “line astern” position as planned.

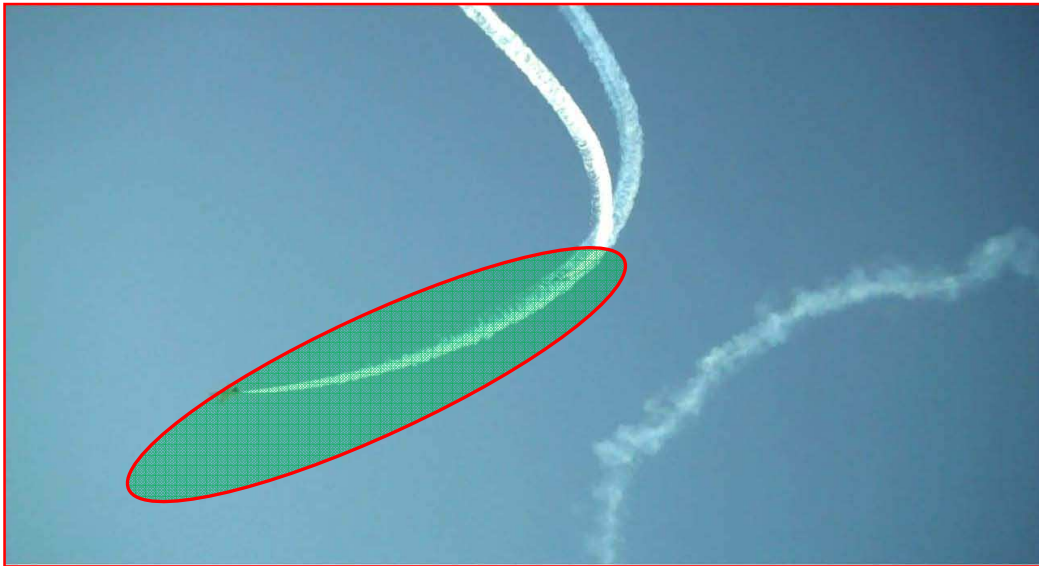
Figure 11: The accident aircraft flies into the wake of the leading aircraft.

- 1.19.5 The pilot unintentionally without realising it, flew into the wake turbulence of the leading aircraft resulting in a high speed stall followed by an uncontrolled inverted dive.
- 1.19.6 The pilot of the leading aircraft stated that the levelling height after recovery was at 5500' AMSL which is approximately 1000ft AGL and insufficient height to recover when the aircraft went into an inverted attitude. The pilot managed to level the wings of the aircraft but the aircraft impacted the ground due to the high rate of descent.

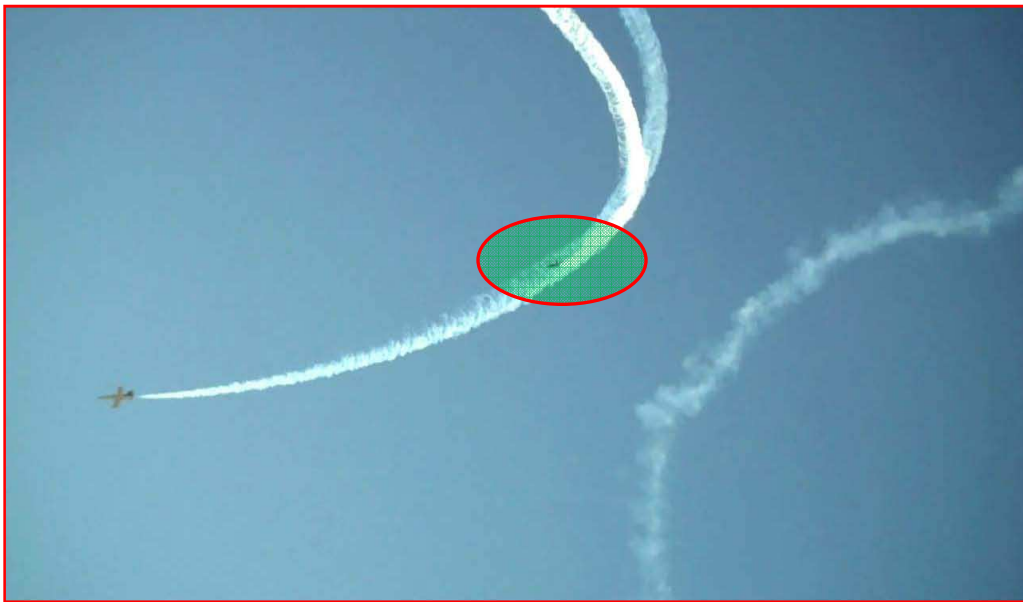
Figure 12: The nose of the accident aircraft pitches upwards

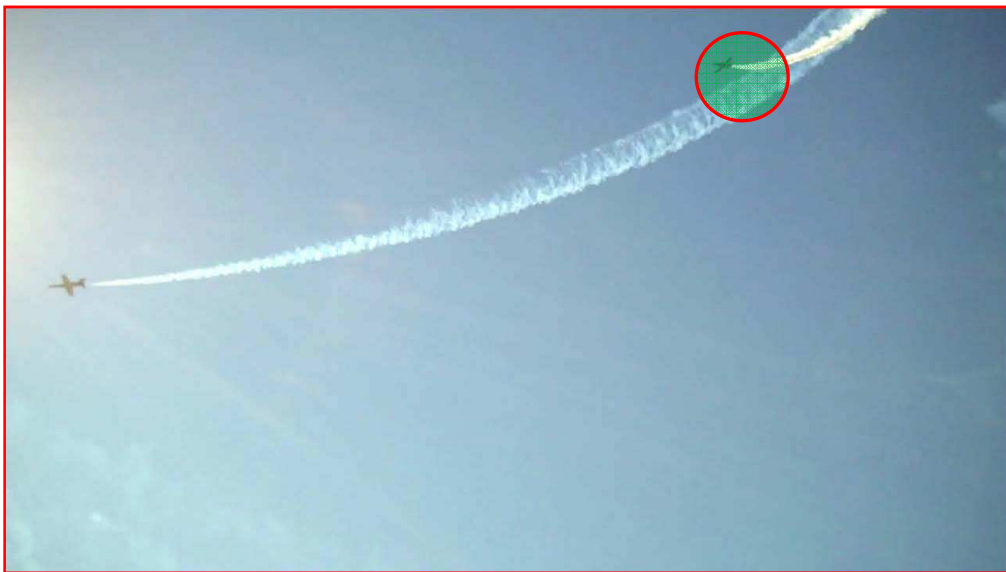
Figure 13: The accident aircraft starts rolling to the right

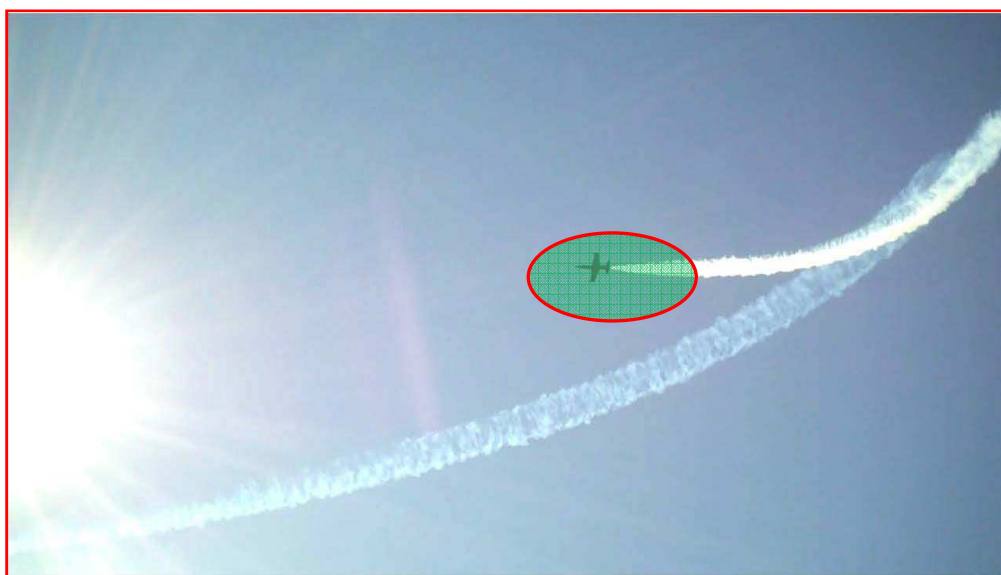
Figure 14: The accident aircraft continues rolling to the right

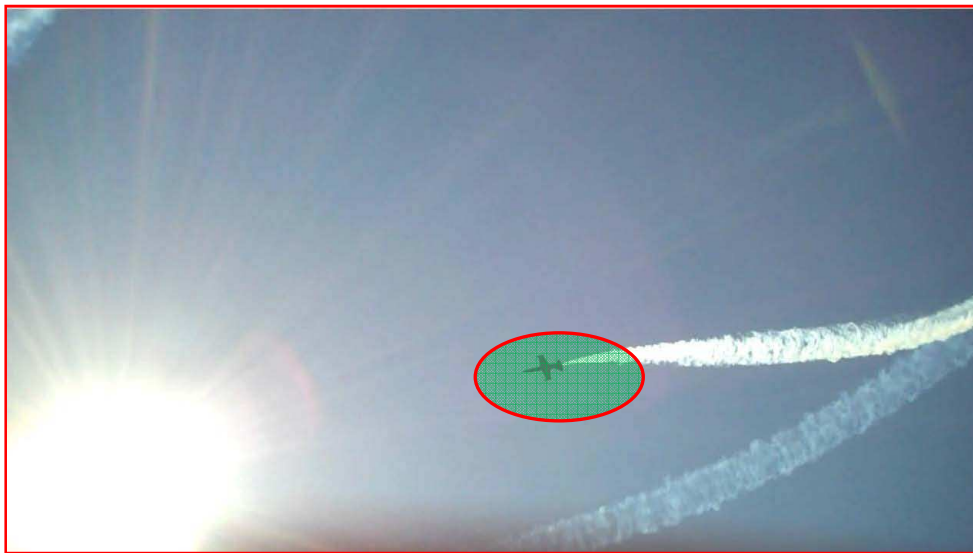
Figure 15: The accident aircraft is now inverted.
Note the vertical fin facing downward

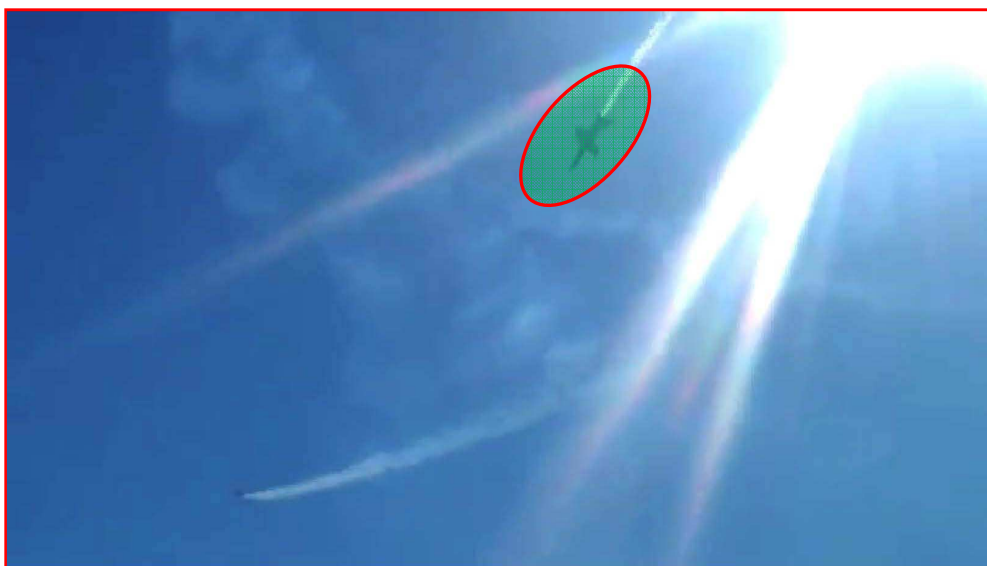
Figure 16: The accident aircraft diving inverted downwards

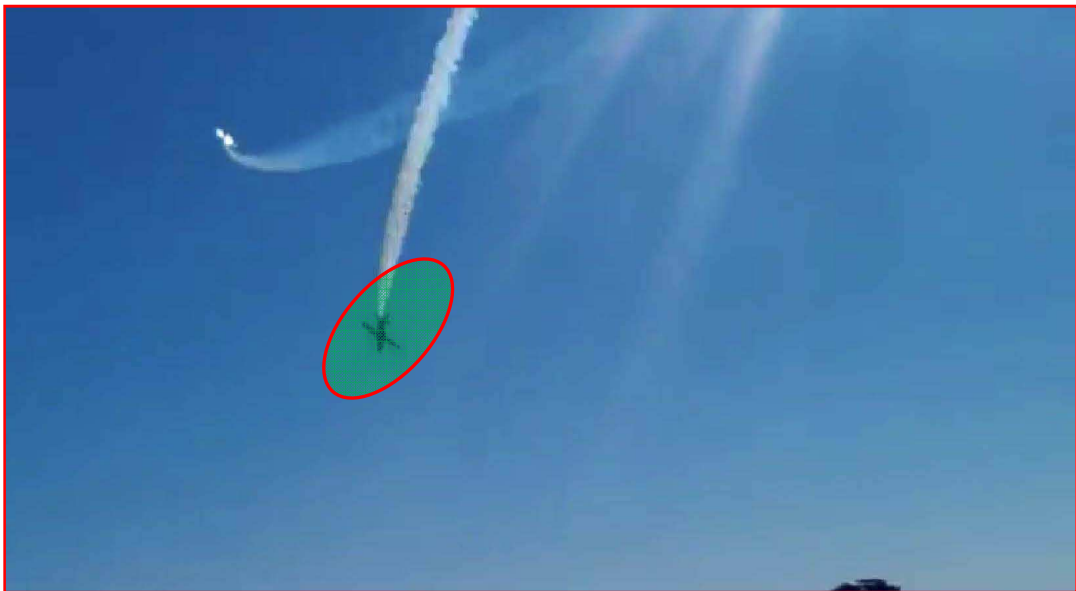
Figure 17: The pilot of the accident aircraft starts rolling to the wings level

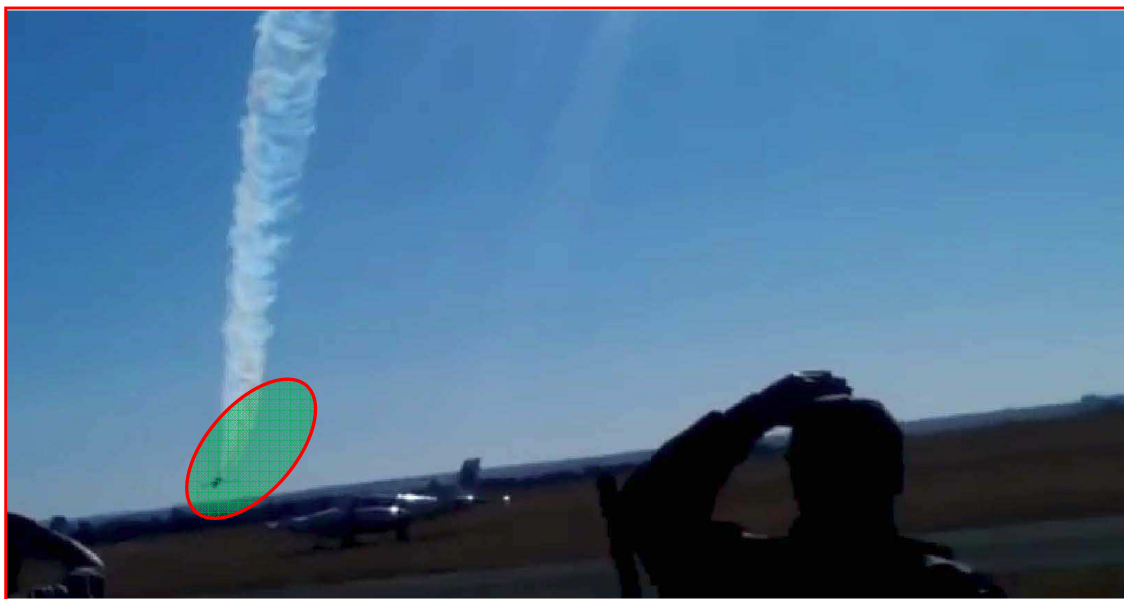
Figure 18: The accident aircraft starts pulling out of the dive close to the ground

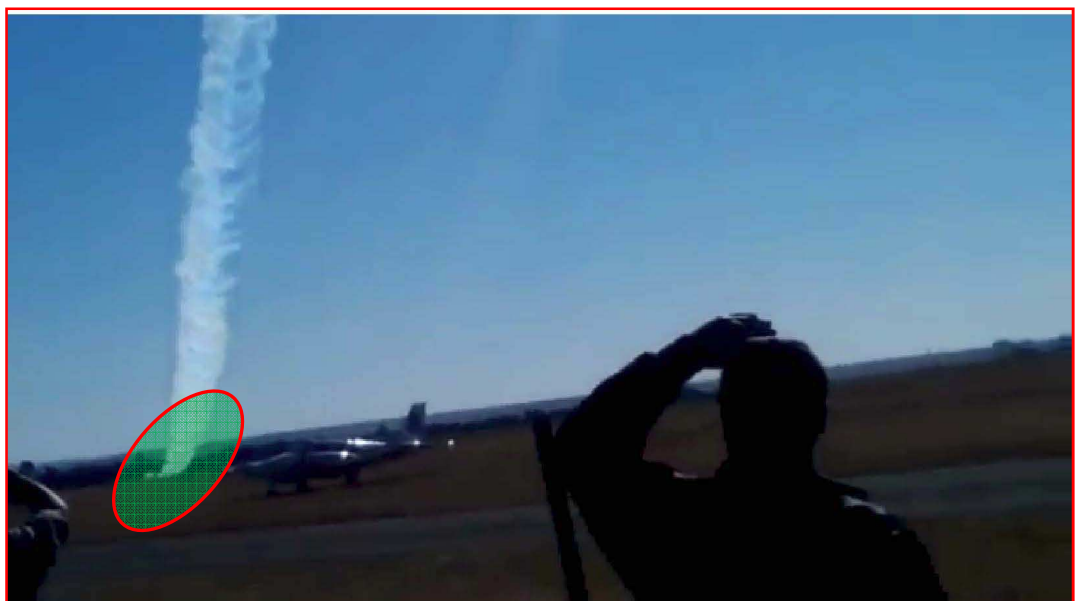
Figure 19: Shows as the accident aircraft “mushed” into the ground
