<b>AIRCRAFT ACCIDENT REPORT AND EXECUTIVE SUMMARY</b>
---

Reference:	CA18/2/3/9058	
<b>Aircraft Registration</b>	<b>ZS-ISD</b>	<b>Date of Accident</b>	10 July 2012		<b>Time of Accident</b>	0745Z
<b>Type of Aircraft</b>	Piper PA34-200		<b>Type of Operation</b>	Training		
<b>Pilot-in-command Licence Type</b>	Commercial	<b>Age</b>	23	<b>Licence Valid</b>	Yes	
<b>Pilot-in-command Flying Experience</b>	Total Flying Hours	2100.0		Hours on Type	58.0	
<b>Last point of departure</b>	Port Alfred Aerodrome (FAPA) Eastern Cape					
<b>Next point of intended landing</b>	Port Alfred Aerodrome (FAPA) Eastern Cape					
<b>Location of the accident site with reference to easily defined geographical points (GPS readings if possible)</b>						
On Runway 28L at Port Alfred Aerodrome (FAPA) Eastern Cape						
<b>Meteorological Information</b>	Wind: 300°/10 km, Visibility: 9999, Temperature: 20°C, Cloud Cover and Cloud Base: CAVOK,					
<b>Number of people on board</b>	1 + 1	<b>No. of people injured</b>	0	<b>No. of people killed</b>	0

## AIRCRAFT ACCIDENT REPORT

**Name of Owner/Operator** : 43 Air School (Pty) Ltd  
**Manufacturer** : Piper Aircraft Corporation  
**Model** : PA34-200  
**Nationality**

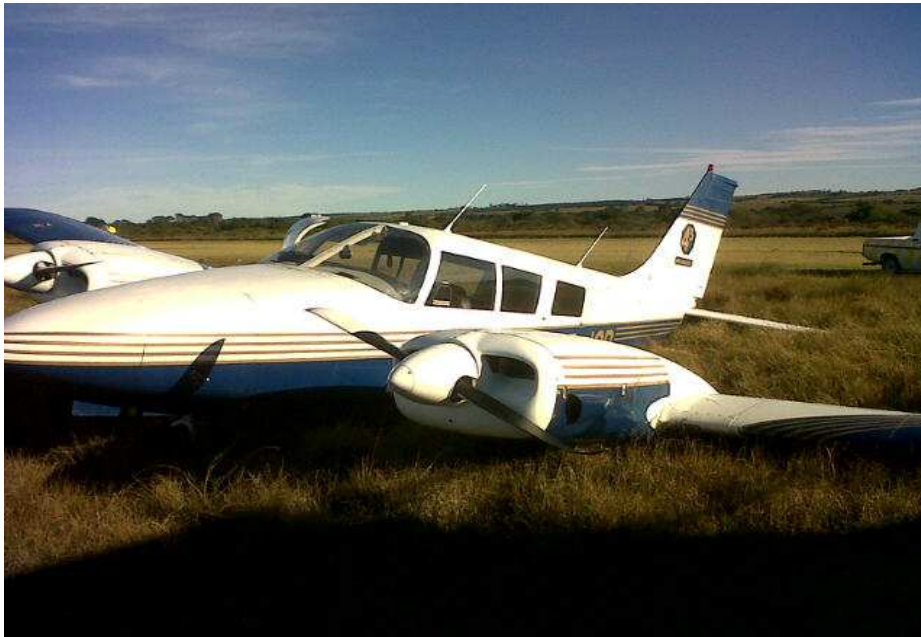
1.3.1 The aircraft sustained minor damage to the left hand wing under surface and left engine propeller blades.

Figure 1, shows aircraft with left main landing gear collapsed.

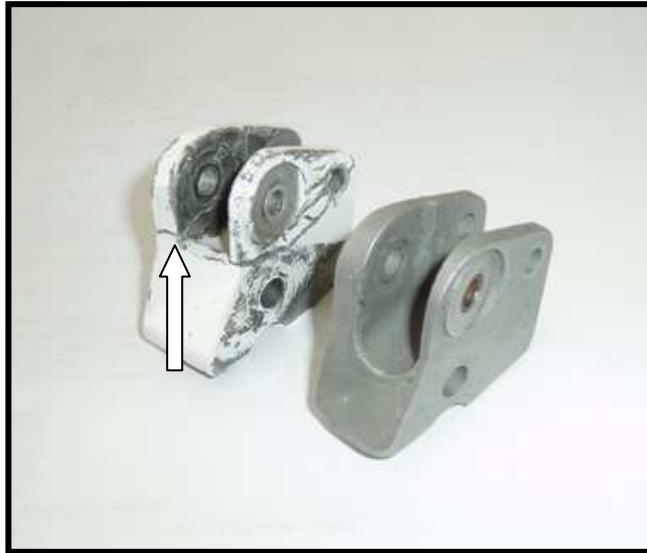
- The AMO established that the spring attachment bracket on the left hand main landing gear down-lock mechanism fractured , due to a crack that developed. As a result, there was no spring tension and the left hand main landing gear could not lock down positively in the down-lock position causing the main landing gear collapsed during landing.
- The AMO also established that the bracket that fractured due to a crack that developed during operation was the original part since manufacturing. The bracket hours on the aircraft was calculated as 6371.0 hours since installation on the aircraft. See bracket with crack below:

Figure 2, shows the landing gear bracket that failed.

- The inspection further identified that the mechanical malfunction was caused by the bracket that failed. The fracture lines on the bracket were clearly visible that it originated on its corners.
- Note: The AMO's that conducted maintenance work on the Piper Arrow fleet at Port Alfred stated that sometimes during hard landings, the brackets were found to be fractured or damaged and had to be replaced.

3.1.8 The aircraft was recovered to an AMO for further examination to determine the cause of the left hand main landing gear failure. It was established that the mechanical down lock bracket fractured due a crack that developed over time, rendering the tension spring attached to bracket ineffective to insure the gear in the down lock position.

3.1.9 The aircraft was submitted to a wheels up "belly" landing incident two years ago. The possibility is that the bracket may have sustained some damage during that incident which caused it to eventually fail.

1.16.2 There are currently new types of bracket available which is approved for installation. The difference between the new and old type bracket are as followed:

- (i) The old bracket has a 90° corner at which the fracture originates from.
- (ii) The new bracket is milled round and far more deeply than the old bracket. This allows far more free movement of the hydraulic arm which lowers and raises the undercarriage.

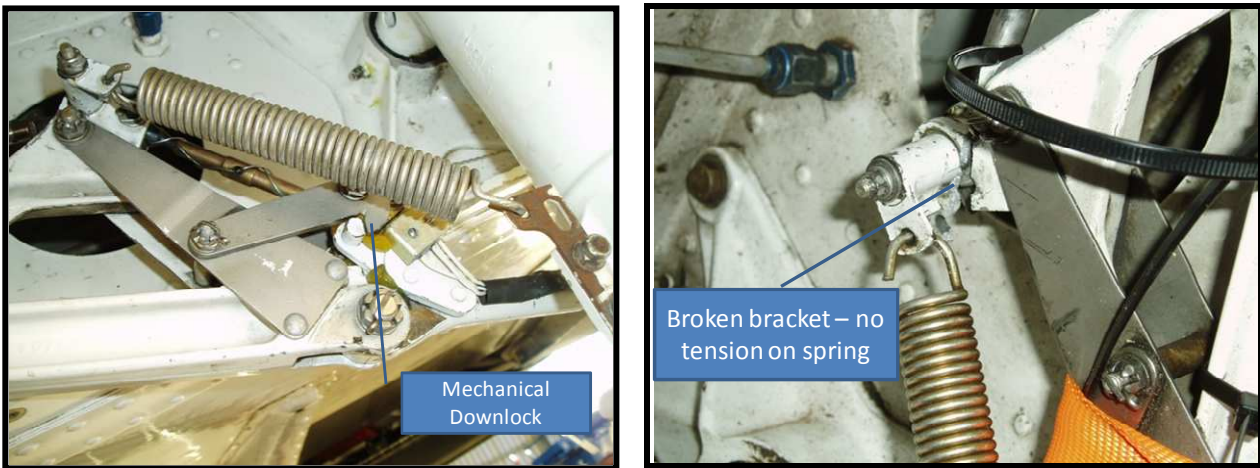
Figure 3, shows the affected left hand main landing gear down lock spring and bracket.

- 2.3 The aircraft was recovered from the accident site to the facility of the AMO for an inspection. The AMO discovered that a bracket attached to the left hand side main landing gear down lock mechanism had failed. Due to the failure of the bracket, the spring tension of the mechanical down lock was affected and was free to move out of the down lock position.
