<b>AIRCRAFT ACCIDENT REPORT AND EXECUTIVE SUMMARY</b>
---

Reference:	CA18/2/3/9064	
<b>Aircraft Registration</b>	ZS-HCR	<b>Date of Accident</b>	27 July 2012		<b>Time of Accident</b>	±0605Z
<b>Type of Aircraft</b>	Garlick UH-1H (Helicopter)		<b>Type of Operation</b>		Private (Industrial Aid)	
<b>Pilot-in-command Licence Type</b>		Commercial Pilot	<b>Age</b>	32	<b>Licence Valid</b>	Yes
<b>Pilot-in-command Flying Experience</b>		Total Flying Hours	775,3		Hours on Type	314,3
<b>Last point of departure</b>		Amatole mountains near Hogsback, (Eastern Cape province)				
<b>Next point of intended landing</b>		Amatole mountains near Hogsback, (Eastern Cape province)				
<b>Location of the accident site with reference to easily defined geographical points (GPS readings if possible)</b>						
Amatole mountains (GPS position; South 32°34.256' E ast 027°05.277' elevation 5 294 feet AMSL)						
<b>Meteorological Information</b>		Surface wind; 270°37 knots, Temperature; 13°C, Vis ibility; +10 km

## AIRCRAFT ACCIDENT REPORT

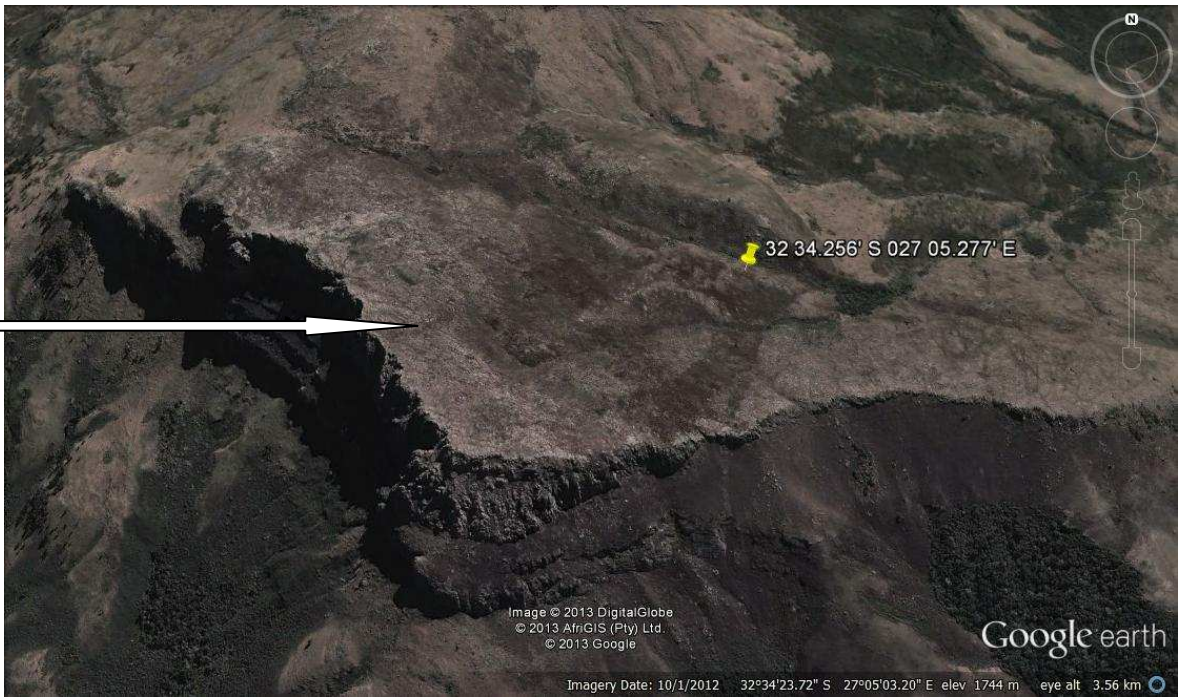
The prevailing wind at the time was reported to be from the west as indicated by the arrow.

**Figure 2.** The Google earth map provides a closer view of the mountain cliffs facing towards the southwest.

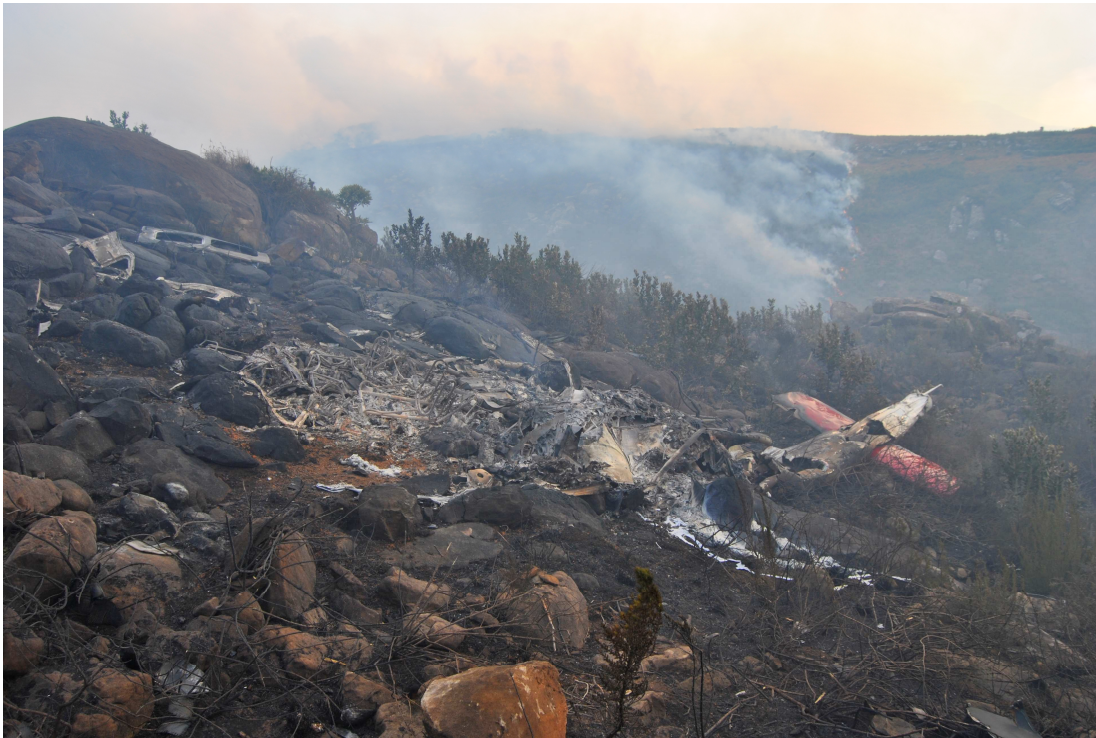
1.3.1 The helicopter was destroyed by the post-impact fire that erupted.

**Figure 3.** A photo of the accident scene with the fire still raging in the mountains behind it.

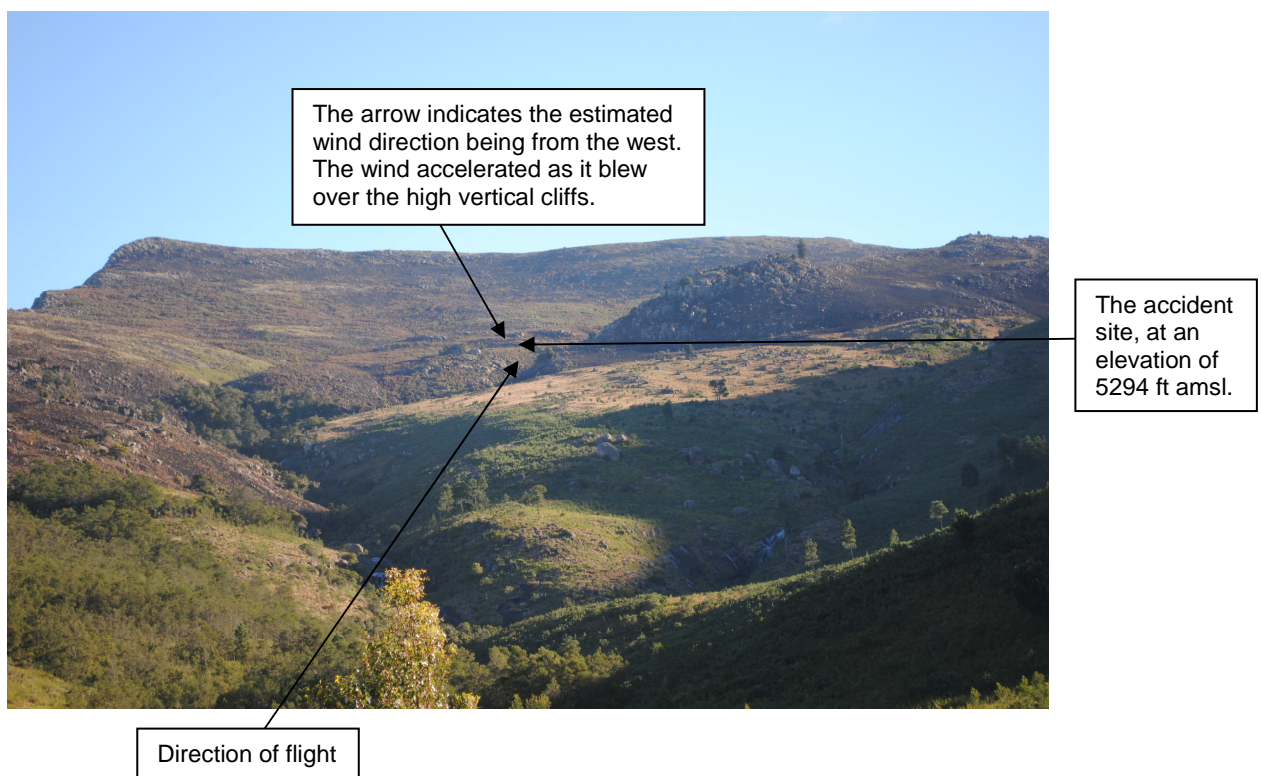
1.12.1 The helicopter impacted with mountainous terrain sloping upwards in the direction of flight looking forward from in the helicopter on a heading of  $\pm 240^{\circ}$ M.

**Figure 6.** The photo was taken to illustrate the direction of flight as well as the prevailing wind direction.

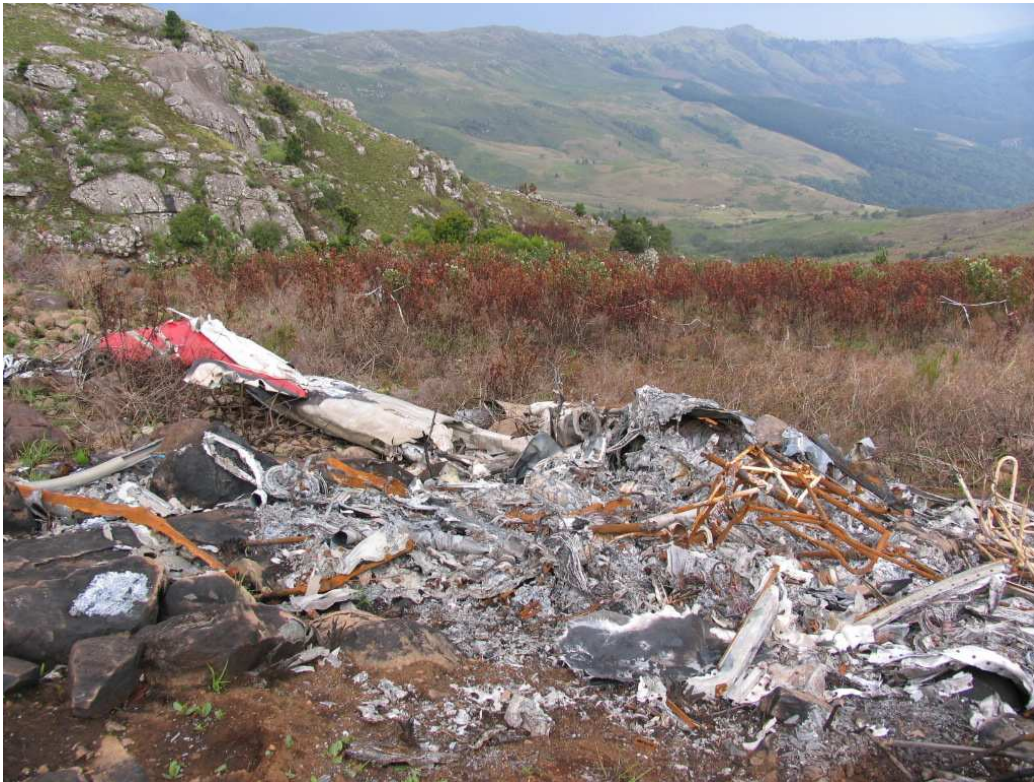
Figure 7 below provides a view of the accident site. Looking at the photo the helicopter flight path was towards the high ground (towards the accident site).

**Figure 7.** A view of the accident site.

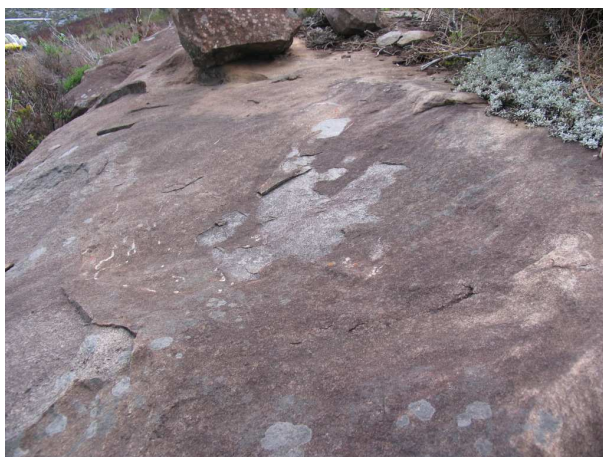
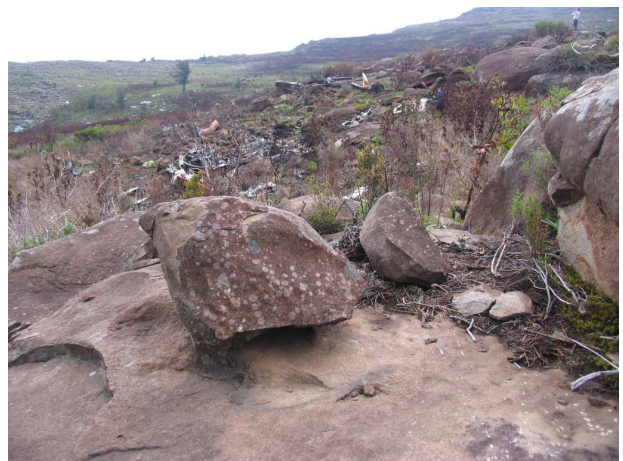
1.12.2 The first impact marking was observed to be caused by the bambi bucket that collided with rocky terrain as depicted in figure 8 (a) and (b) below.

**Figure 8.** Impact markings on a large rock (a) a view towards the accident site from the rocks that was struck (b).

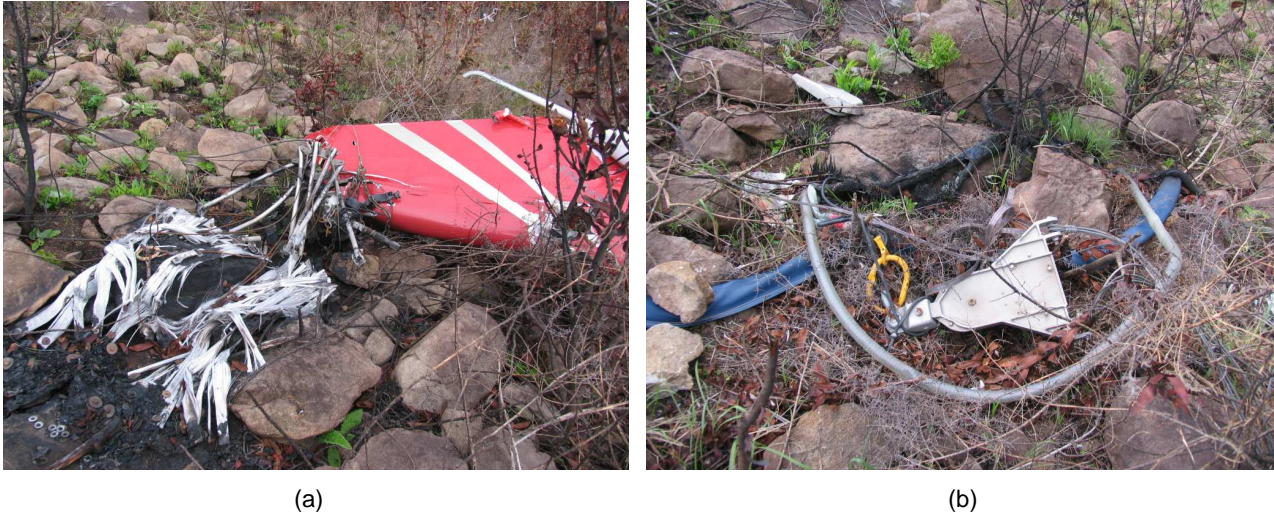
Along the impact line from thereon we found the two tail rotor blades still attached to the hub assembly, one of the blades suffered from extensive fire damage (was basically consumed to the root of the blade) and the other blade although distorted displayed minor fire damage. From there onwards we found the aft section of the tail boom (including both horizontal stabilisers and the pylon section), it was lying in

a near inverted attitude, indicative to a roll over to the right. The lower tail boom structure displayed evidence of impact with terrain. To the right of the aft tail boom section was the metal frame of the burnout bambi bucket (see figure 9a below) as well as the 5 m long cargo sling strop/cable and the cargo hook assembly. Both the cargo hook and the strop/cable where subjected to fire damage, with a section of the strop found to have melted. The cargo hook mechanism was found to be in the open/released position.

**Figure 9.** Burnt out bambi bucket next to the tail boom pylon (a) and cargo sling cabling with bambi bucket hook (b).

- 3.1.11 The bambi bucket, strop and cargo sling hook mechanism was found at the accident site lying to the right of the main wreckage. It was subjected to fire damage.

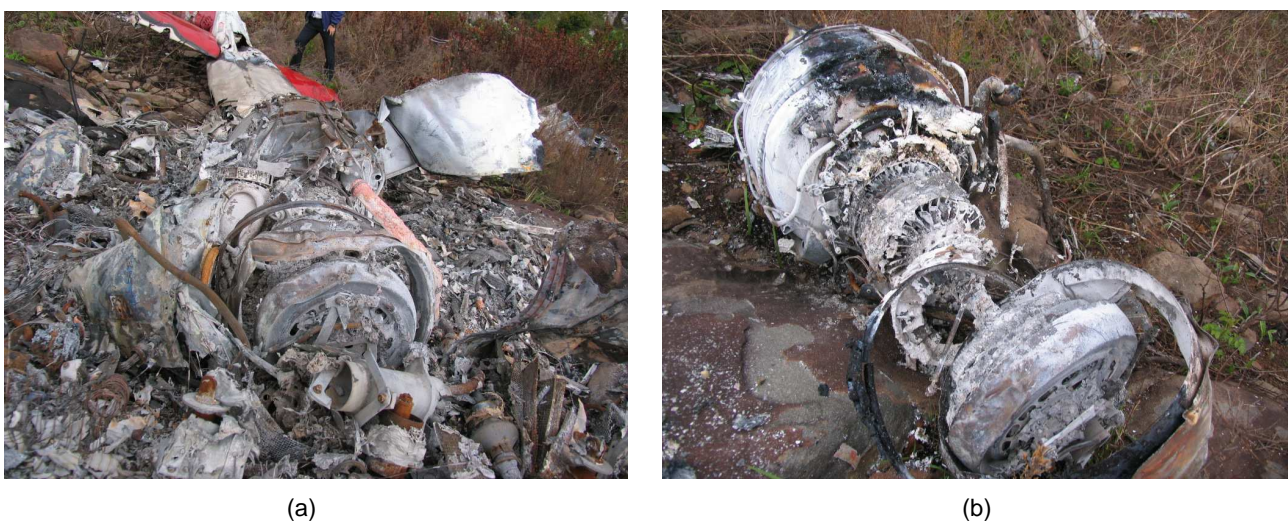
1.12.3 Forward of the tail boom section was the engine, which was subjected to intense heat from the post impact fire. The photo in figure 10(b) below displays the engine after it was removed from below the burnt out sheet metal debris. The damage sustained by the engine was of such a nature that it could not be subjected to a teardown inspection.

**Figure 10.** A view of the engine before (a) and after it was removed from the burnt out sheet metal structure (b).

1.16.1 The engine a Honeywell Lycoming T53-L-13B, serial No. LE-23434-R was found to have been exposed to the intense post-impact fire. The investigating team intended to perform a detailed teardown inspection of the engine in order to determine engine functionality however such an inspection was not viable following consultation with the engine manufacturer.

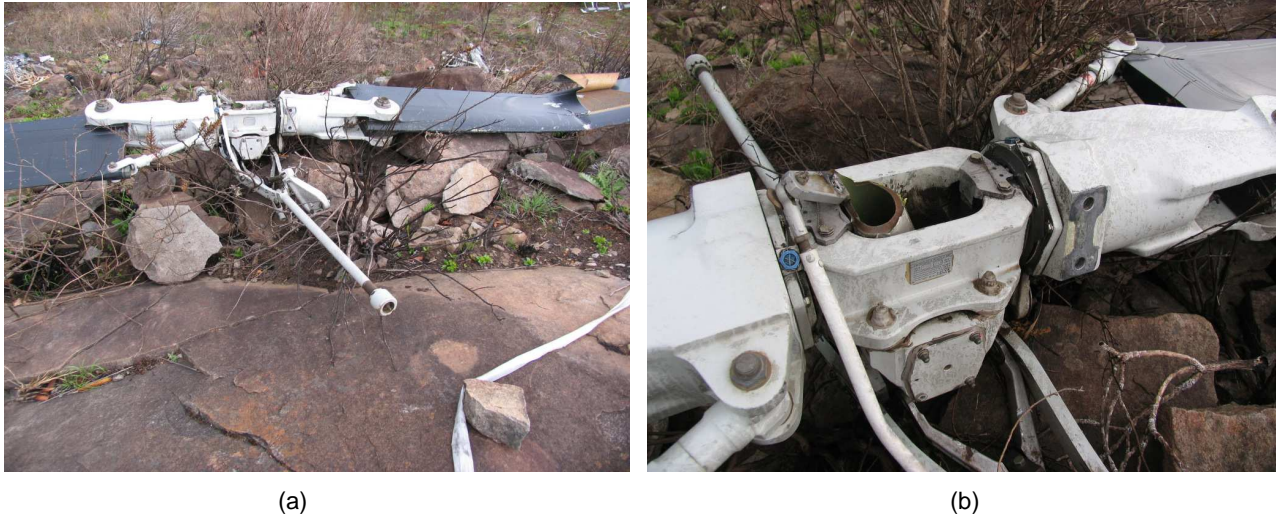
1.12.4 The main rotor head with the two main rotor blades still attached was located approximately 15 m to the right of the main wreckage. The blades displayed substantial deformation but was not exposed to any fire damage. The main rotor drive shaft sheared at a 45° angle around the circumference of the shaft which was indicative of an overload failure associated with impact. The main rotor drive shaft failure mode is visible in figure 11(b).

**Figure 11.** A view of the main rotor head with the blades still attached (a) and a closer view of the main rotor head (b).

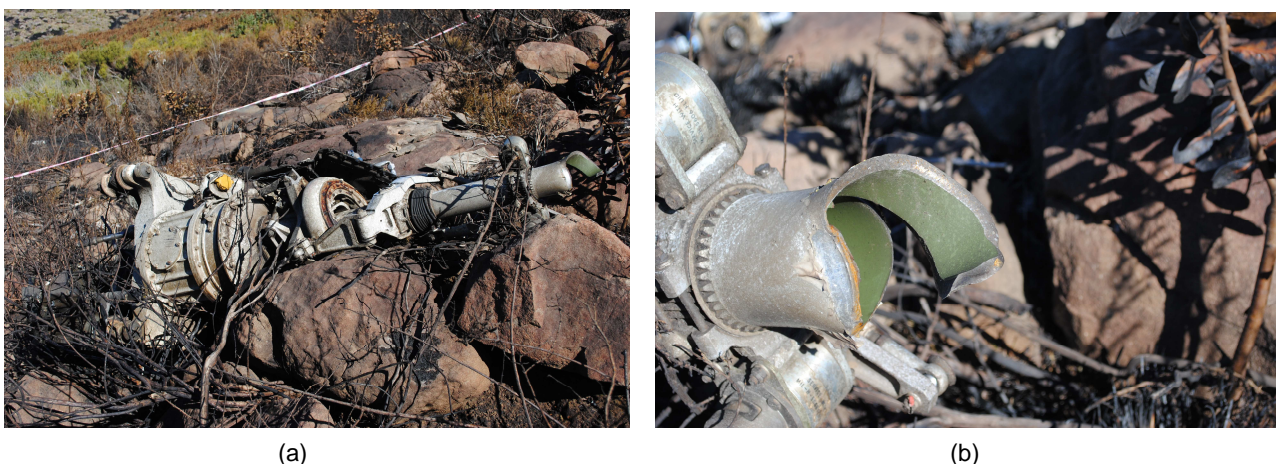
1.12.5 The main rotor gearbox and main drive shaft assembly was found to be projected in a straight line approximately 10 m ahead of the main wreckage. The main rotor drive was found to have failed in overload mode. Evidence of droop stop contact is visible on the side of the main rotor drive shaft associated with the impact sequence. The unit displayed evidence of minor scoring, caused by vegetation that burnt following the post impact fire.

**Figure 12.** A view of the main rotor gearbox assembly (a) and a closer view of the main rotor drive shaft failure (b).
