AIRCRAFT ACCIDENT REPORT AND EXECUTIVE SUMMARY

Reference:	CA18/3/2/9067	
Aircraft Registration	ZU-BSH	Date of Accident	9 August 2012		Time of Accident	1130Z
Type of Aircraft	Windlass Trike		Type of Operation	Private		
Pilot-in-command Licence Type	National Pilot License	Age	46		Licence Valid	No
Pilot-in-command Flying Experience	Total Flying Hours	71,3		Hours on Type	5	
Last point of departure	FASD, Saldana Bay, South Africa					
Next point of intended landing	FASD, Saldana Bay, South Africa					
Location of the accident site with reference to easily defined geographical points (GPS readings if possible)						
Approximately 5km north of Yzerfontein and approximately 1km inland between Yzerfontein and Saldanha Bay						
Meteorological Information	Wind Direction: 010°, Wind speed: 4 Knots, Temperature:14°C, Dew point: 7 °C					
Number of people on board	1+1	No. of people injured	1	No. of people killed	0	
Synopsis	<p>The pilot and passenger were on a private flight with the aircraft departing from Saldanha Bay enroute to Atlantis. Approximately 90 minutes in the flight the engine failed and the pilot executed a force landing. The microlight crashed into the sand dunes in the Yzerfont

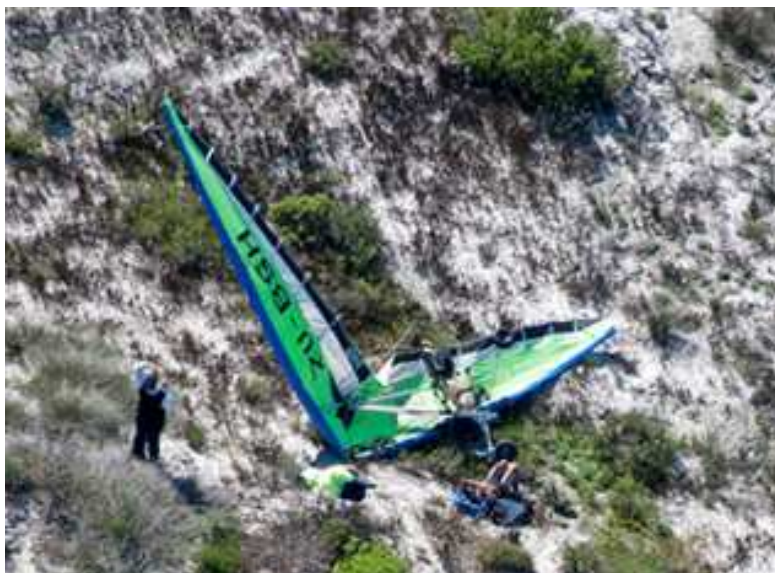
1.3.1 The aircraft was substantially damaged.

Figure 1: Shows Microlight damages

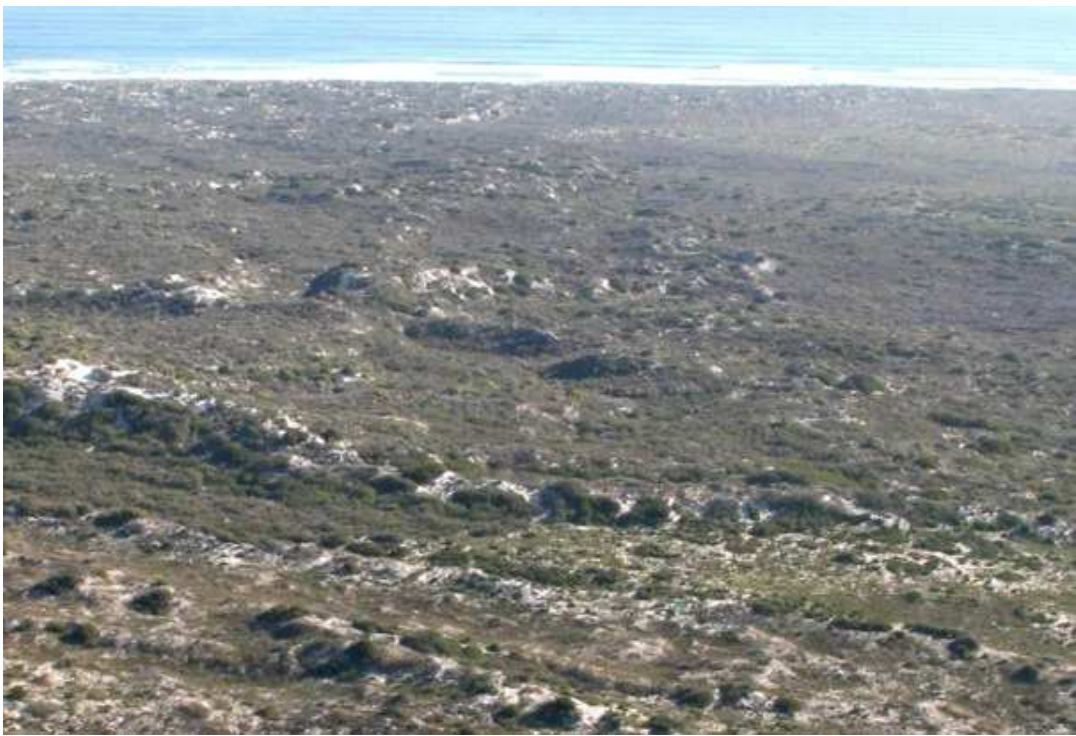
1.12.1 The pilot looked for a suitable area to carry out an emergency landing. He was therefore forced to land in the Yzerfontein Nature Reserve. The terrain however was unsuitable to carry out a landing.

Figure 2: The terrain (Yzerfontein Nature Reserve).

The terrain surface was not suitable for landing and resulted in the microlight sustaining substantial damage during the unsuccessful landing. It is believed that the weather conditions that prevailed on the morning of the accident did not contribute to the cause of the accident.

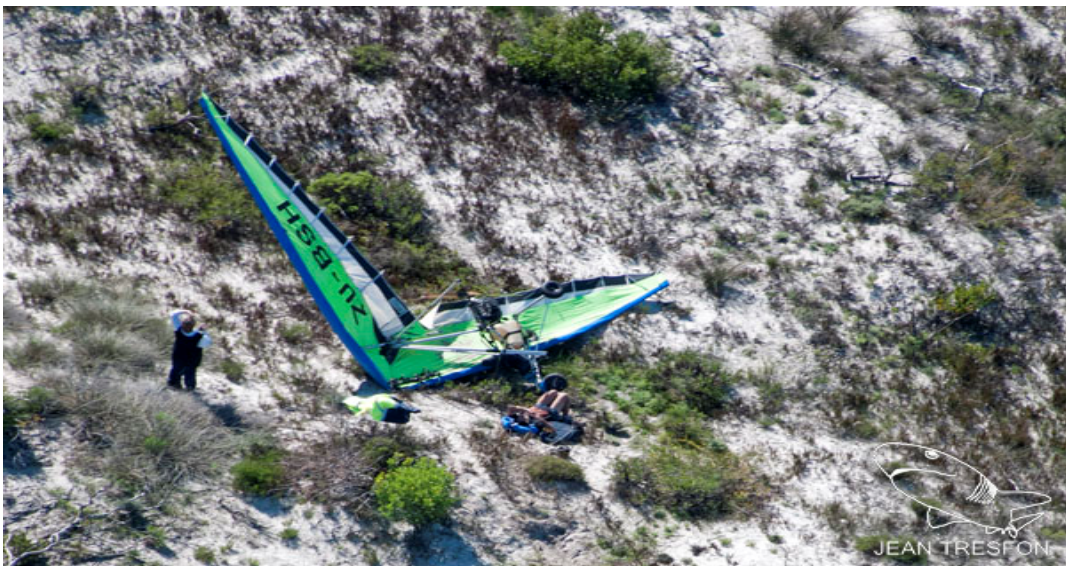
Figure 3: The microlight at the accident site.

1.12.2 During the landing sequence, the microlight crashed into the sand dunes and the wings flipped over, causing the microlight to sustain substantial damage.
