AIRCRAFT ACCIDENT REPORT AND EXECUTIVE SUMMARY

Reference:	CA18/2/3/9069	
Aircraft Registration	ZU-DOK	Date of Accident	11 August 2012		Time of Accident	1345Z
Type of Aircraft	Zenith CH 701 (Aeroplane)		Type of Operation		Private	
Pilot-in-command Licence Type	National Pilot's Licence		Age	69	Licence Valid	Yes
Pilot-in-command Flying Experience	Total Flying Hours		3 371		Hours on Type	200,4
Last point of departure	Emoyeni Airfield, Cato Ridge, KwaZulu-Natal					
Next point of intended landing	Emoyeni Airfield, Cato Ridge, KwaZulu-Natal					
Location of the accident site with reference to easily defined geographical points (GPS readings if possible)						
Emoyeni Airfield beyond the end of runway 15 at GPS co-ordinates (S29°44'58.37", E030°33'0.99")						
Meteorological Information	Wind direction: 050°; Speed: variable; Temperature 24°C; Visibility: CAVOK					
Number of people on board	1 + 1	No. of people injured	0	No. of people killed	0	
Synopsis	<p>The pilot, accompanied by a passenger, took off from Emoyeni airfield with the intention of completing a circuit of the airfield. Shortly after rotation, at approximately 40 ft above ground level, the aircraft experienced a loss of powe

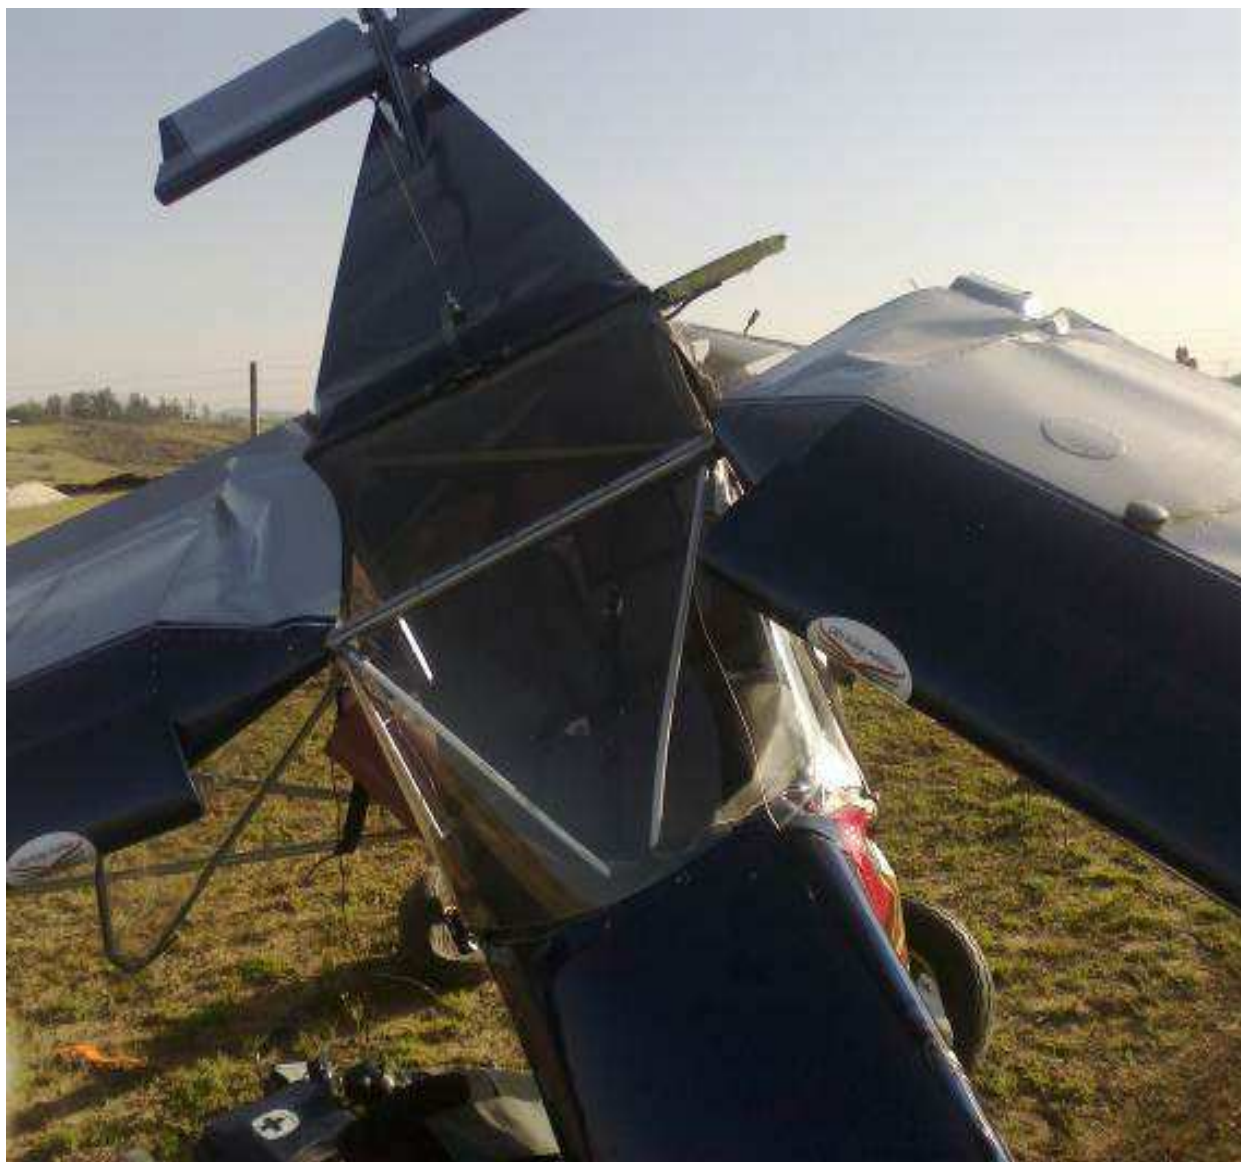
- 1.3.1. The aircraft sustained substantial damage during the accident sequence. The undercarriage collapsed, the left wing separated at the root, and the nose and propeller were damaged.

Figure 1: The damage to the aircraft.

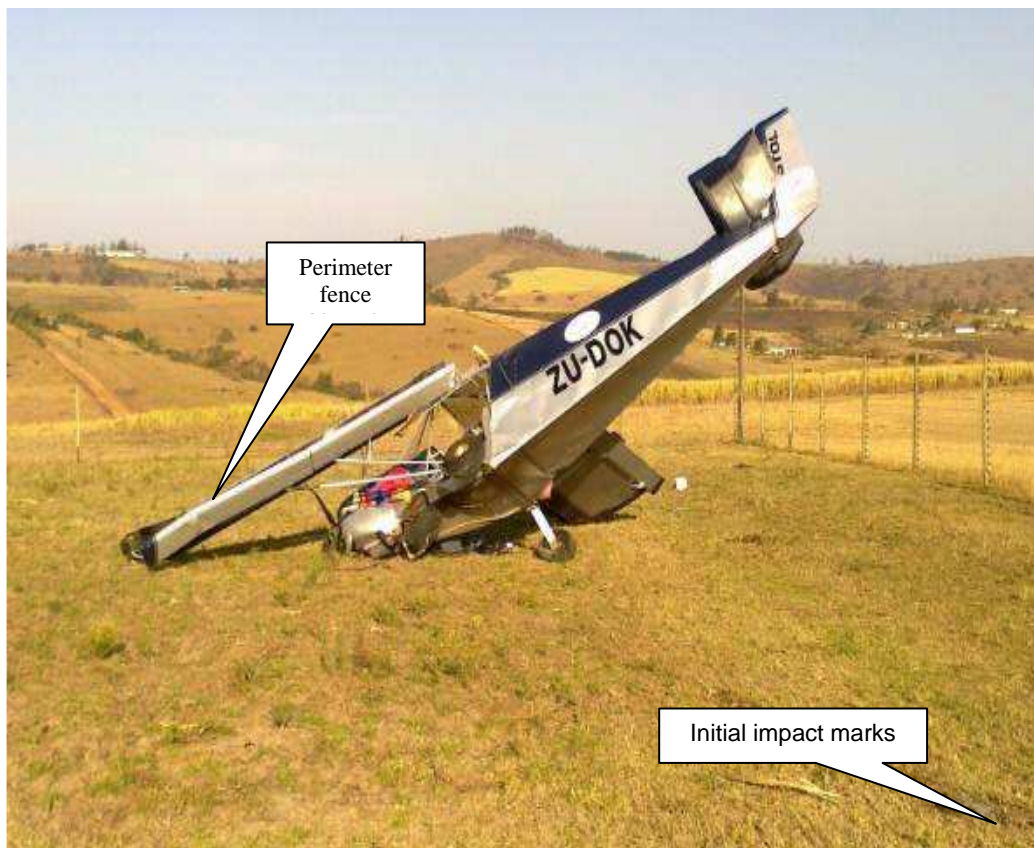
Figure 2: The aircraft came to rest and suffered severe damage.

- 1.12.3 The aircraft struck the ground with the nose gear first. The right main landing gear then collapsed and the aircraft bounced.
- 1.12.4 During the second contact with the ground, the nose wheel collapsed to the left and the aircraft lost momentum. The impact damaged the propeller blades, nose section and wings.
- 1.12.5 The wreckage was localised and largely intact.

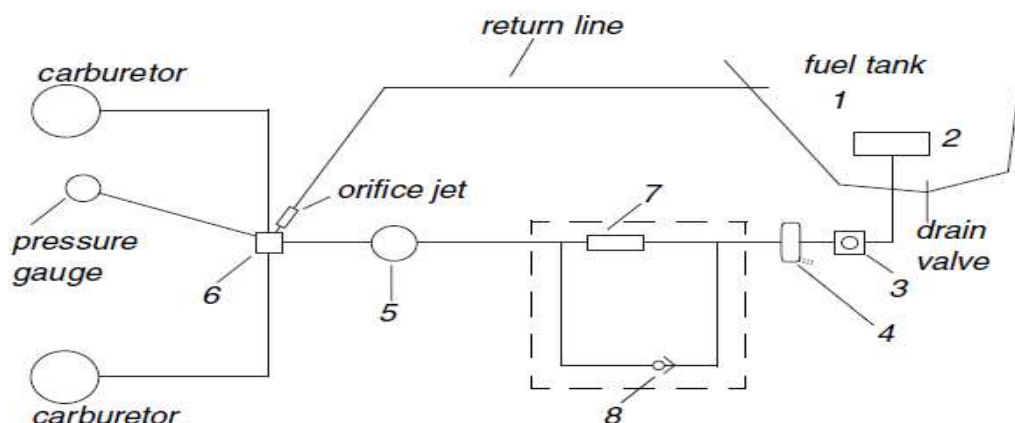
The return-line diverts fuel flows back to the fuel tank and suction side of the fuel system.

NOTE: The return line serves to avoid formation of vapour lock.

Figure 3: Shows the fuel system diagram.

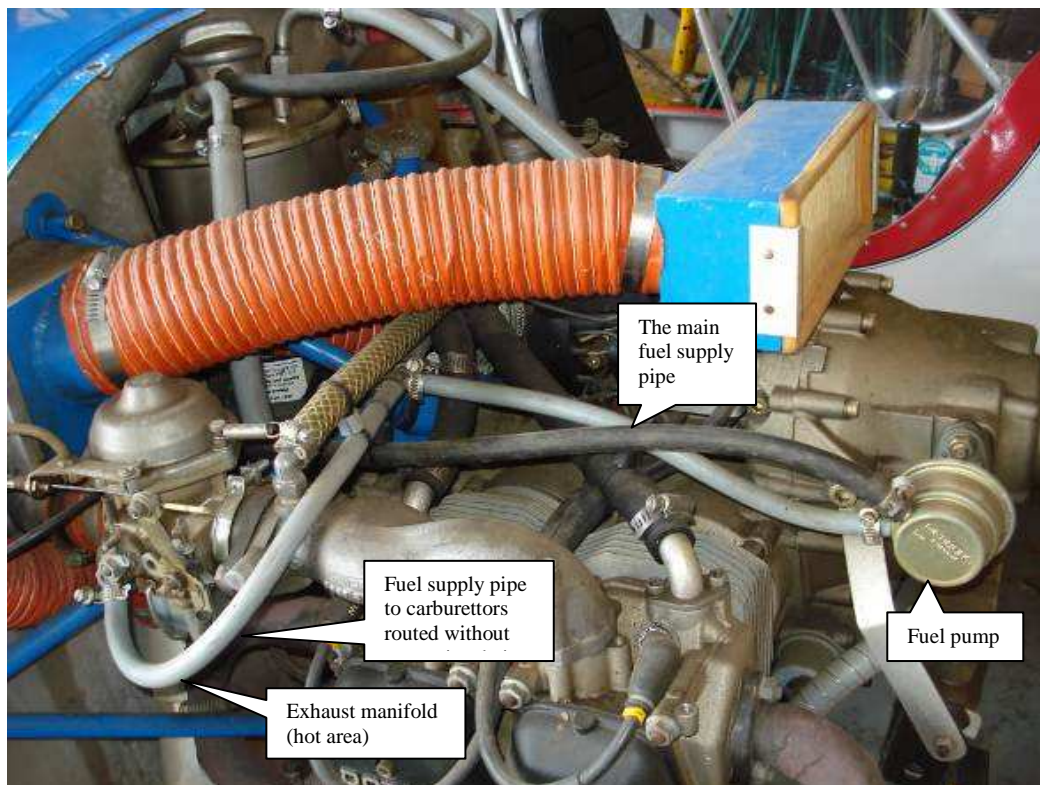
- (i) The fuel pipelines were routed next to the hot section of the engine without proper insulation.
- (ii) The fuel system was not fitted with a fuel return line to help prevent fuel vapour lock from occurring.
- (iii) The fuel system pipe lines did not have fuel restriction.

1.18.1 Heat builds up readily in small engine compartments due to insufficient air-cooling. The engine compartment of the Zenith CH 701 is small and subject to this problem. The picture below shows the fuel line routing of this aircraft.

Figure 4: The routing of the fuel lines in the engine compartment.

- 2.2 After the final circuit before the accident flight, the aircraft was allowed to cool for only 10 minutes before being started again. Because of this, the 10-minute delay at the holding point, and the fact that the ambient temperature was 24°C, the fuel in the pipe lines increased in temperature and remained so for an extended period, causing the fuel to vaporise.

- 2.3 The pilot reported that while the aircraft was climbing, the engine started running rough and then lost power completely. The vaporised fuel had brought about an imbalance of the fuel-air mixture in the intake, causing the engine to run rough. Because of the considerable heat in the fuel lines, even more fuel vaporised, forming a vapour lock, which caused the engine to lose power completely and stop.

- 2.4 If the fuel return line had been fitted, it would have reduced the chance of vapour lock formation. Vaporised fuel is extracted from the fuel line and routed back to the main fuel tank to be changed into liquid.
