| AIRCRAFT ACCIDENT REPORT AND EXECUTIVE SUMMARY |

| | | | | Reference: | CA18/2/3/9071 | |
| Aircraft Registration | ZS-EET | Date of Accident | 14 August 2012 | | Time of Accident | 0821Z |
| Type of Aircraft | Cessna 337 (Aeroplane) | | Type of Operation | | Training flight | |

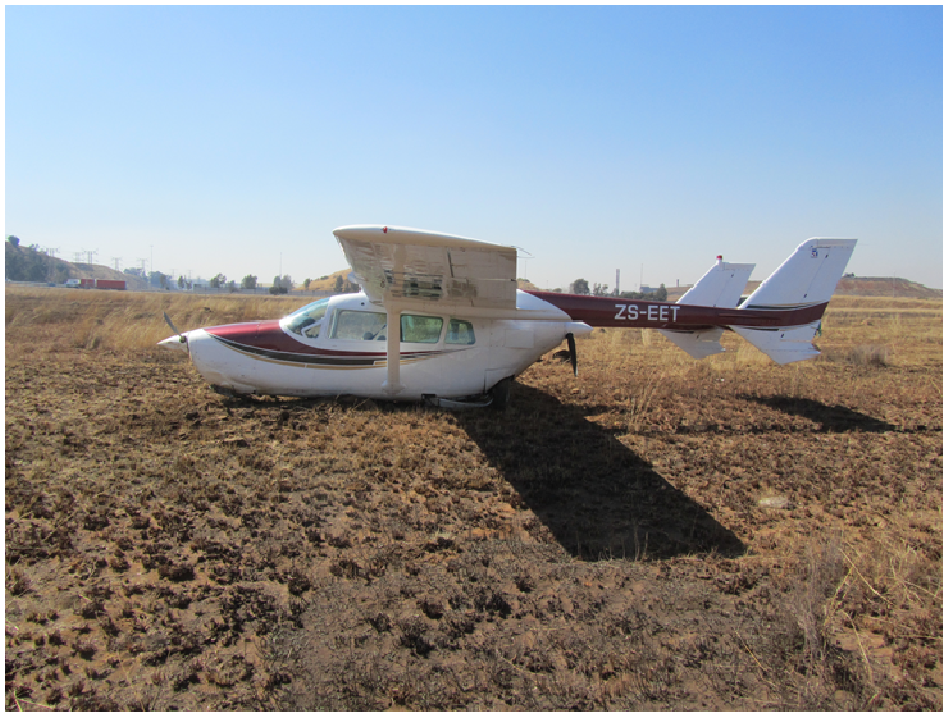
1.3.1 The aircraft sustained substantial damage following the collapse of the landing gear.

Figure 2. A view of the aircraft as it came to rest on its lower fuselage.

1.12.2 The landing roll continued for a distance of approximately 230 m when the nose gear collided with an ant hill concealed by the dry grass, this caused the nose and the main landing gear to collapse. Following the collapse of the landing gear, the cargo pod, which was attached to the lower fuselage of the aircraft became detached and separated from the aircraft. The aircraft came to rest approximately 80m from the initial impact point..

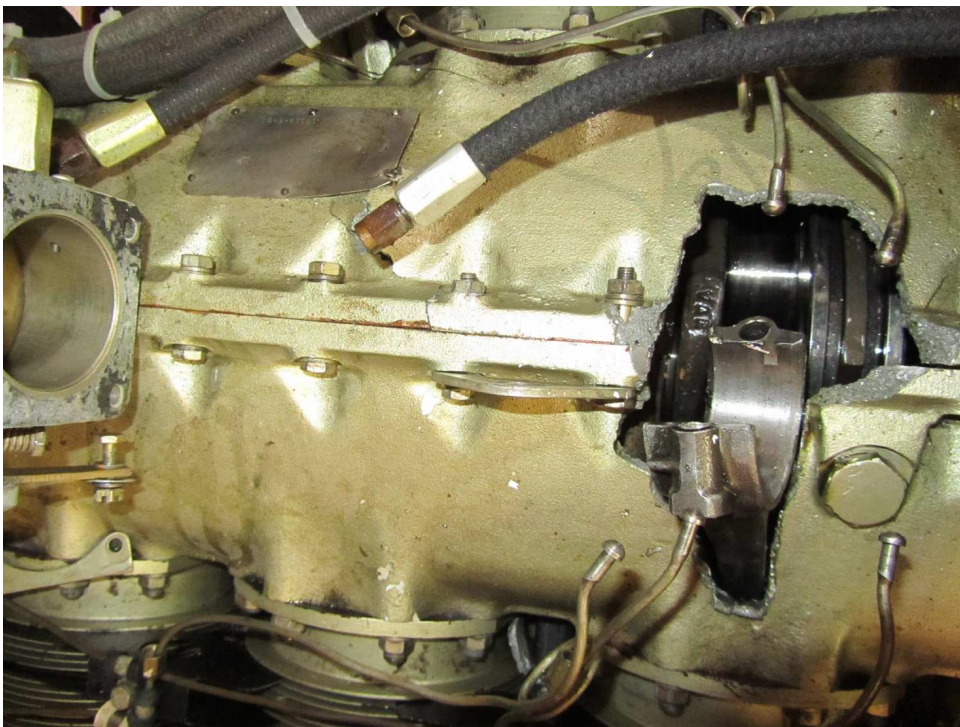
1.16.2 The connecting rod on the number two cylinder was found to have penetrated the crankcase as can be seen in figure 4 below.

Figure 4. A view of the damage caused when the connecting rod penetrated the crankcase.

The engine teardown inspection revealed that most of the connecting rod bolts were not properly tightened/torque during the engine overhaul procedure. Even though most of the parts were substantially damaged some of the connecting rod bolts displayed very little to no thread damage. Some of the bolts from some of the other connecting rods in the engine were found loose to such an extent that they could be turned by hand. The connecting rod on the number two cylinder would appear to be the first to have failed within the engine operational sequence, which resulted in an uncontained failure (penetration of the engine casing) resulting in engine stoppage.

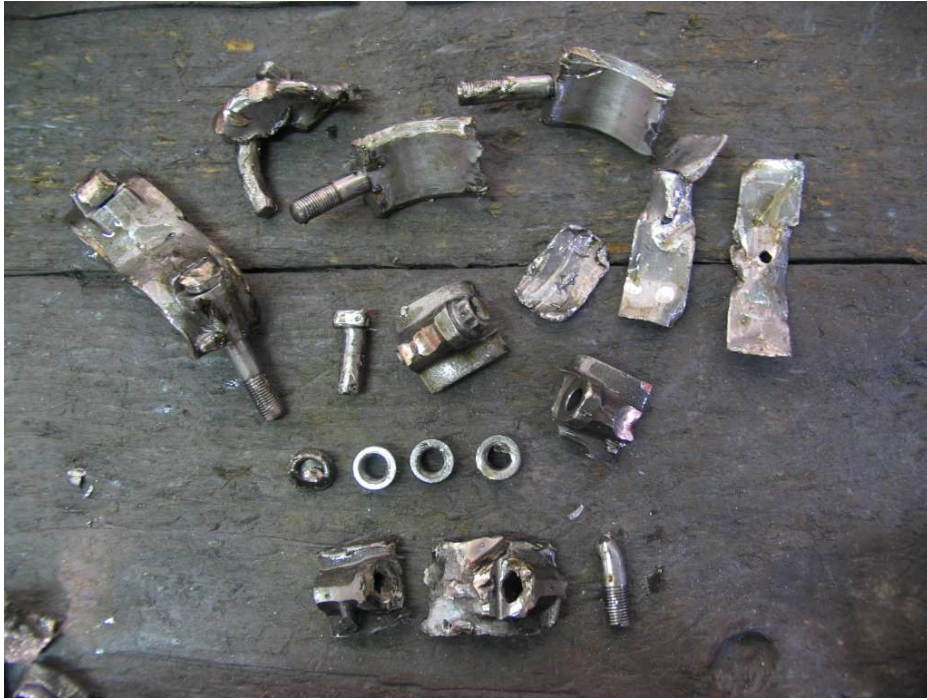
1.16.3 During the removal of the sump, the unit was found to be littered with debris from the engine, which consisted mainly of connecting rod bolts, nuts, bearings and engine casing material.

1.16.4 The connecting rod bolt displayed very little to no thread damage. Several connecting rod nuts were also recovered, they displayed very little to no thread

Figure 5. The photo shows some of the debris that was recovered from the sump of the engine.

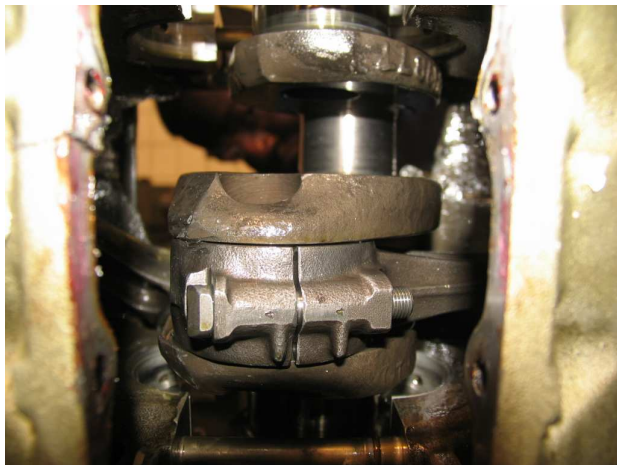
1.16.5 The photos below were taken from the number 4 and 5 connecting rods respectively. One of the nuts securing the No. 4 connecting rod, figure 6(a) was found missing from the bolt, without any thread damage to the bolt what so ever. The photo displayed in figure 6(b) display the presence of a nut, securing the connecting rod bolt on cylinder 5 but it was not properly secured.

Figure 6. The photo on the left (a) was taken of the connecting rod of cylinder No. 4 and (b) of cylinder No. 5.

- 3.1.8 The landing gear could not be retracted following the failure of the front mounted engine.
- 3.1.9 Several of the connecting rod bolts that were found in the sump of the engine displayed limited to no thread damage. Figure 6(a) on page 17 of the report display a connecting rod still in position but without a bolt to secure it.
