AIRCRAFT ACCIDENT REPORT AND EXECUTIVE SUMMARY

Reference:	CA18/2/3/9075	
Aircraft Registration	ZU-ODZ	Date of Accident	24 August 2012		Time of Accident	1505Z
Type of Aircraft	Aeroprakt A-22LS		Type of Operation		Ferry Flight	
Pilot-in-command Licence Type		Commercial	Age	44	Licence Valid	Yes
Pilot-in-command Flying Experience		Total Flying Hours	535.9		Hours on Type	Unknown
Last point of departure		Gariiep dam aerodrome (FAHV), (Free State province)				
Next point of intended landing		Upington aerodrome (FAUP), (Northern Cape province)				
Location of the accident site with reference to easily defined geographical points (GPS readings if possible)						
Farm Bywater – Niekerkshoop area (Northern Cape province) at GPS position S 29°16'15.8" E 023°03'01.2" .						
Meteorological Information		Wind: 320°16 gusting 26 knots, Visibility: 10 km, Temperature: 26°C, Dew point: 0°C, Cloud base: Nil				
Number of people on board		1+1	No. of people injured	0	No. of people killed	1+1

Name of Owner/Operator : African Parks Network
Manufacturer : Aeroprakt
Model : A-22LS
Nationality : South African
Registration Marks : ZU-ODZ
Place : Farm Bywater, Niekerkshoop area, Northern Cape province
Date

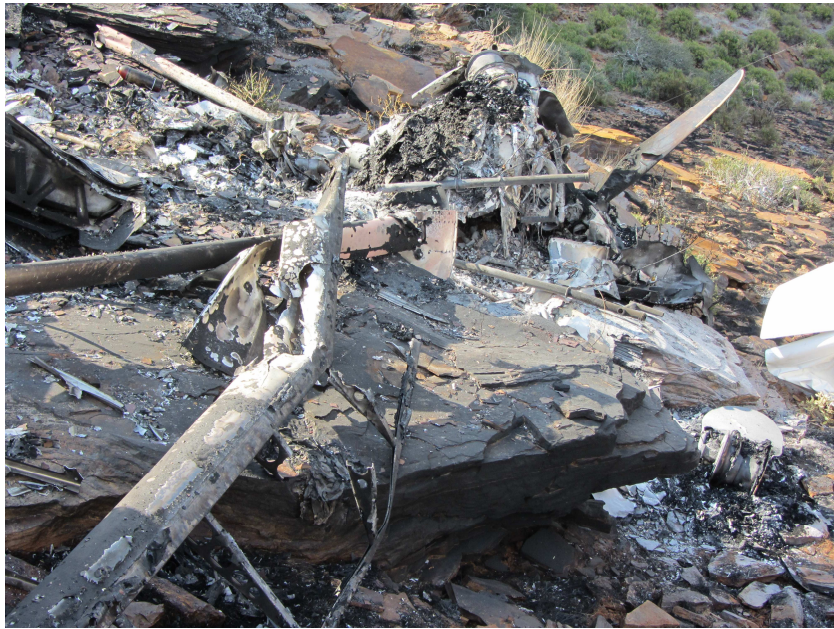
- 1.3.1 Apart from the empennage, the remainder of the aircraft fuselage was consumed by the post-impact fire.

Figure 2 A view of the burnt out wreckage.

1.14.1 Apart from the empennage section and the nose wheel, the entire aircraft was consumed by the post-impact fire that erupted during the impact sequence.

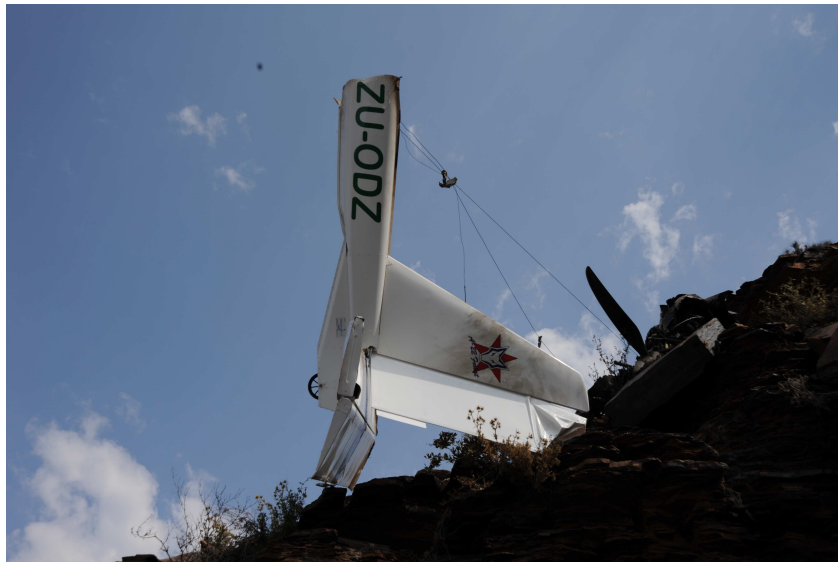
Figure 3 A view of the empennage.

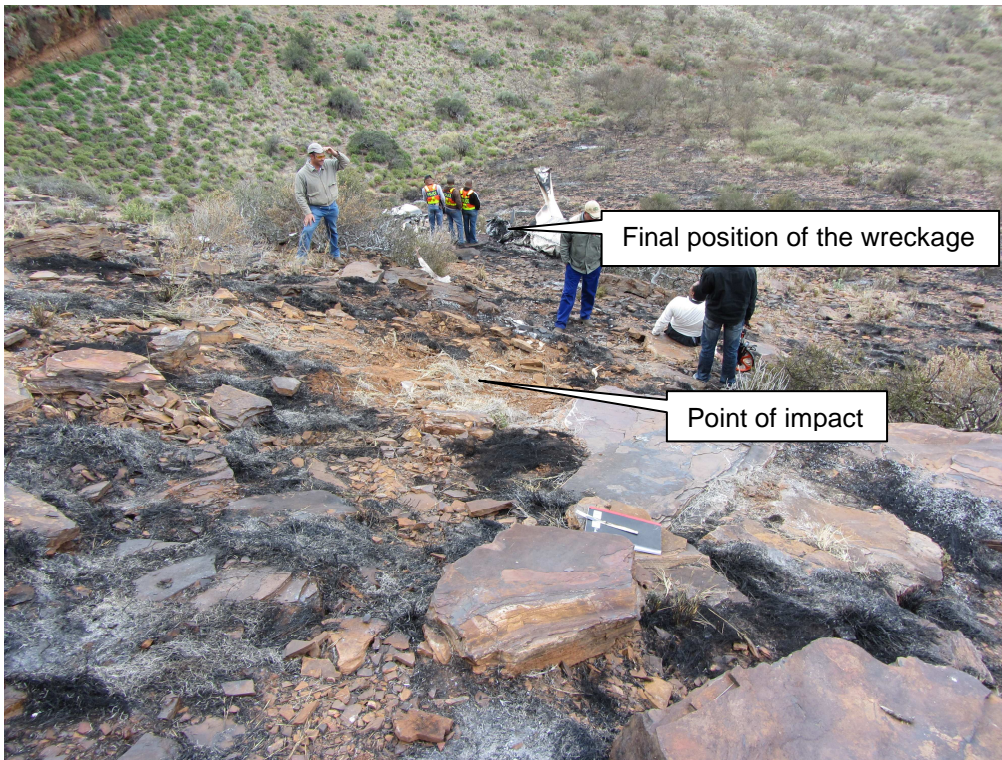
Figure 5 Point of impact and final position of the wreckage.

The point of impact was at a height of approximately 3803 feet above mean sea level (AMSL) where after the wreckage slid down the ridge and came to rest at a height of approximately 3753 feet. (50 feet below the impact point)
Evidence indicates the post impact fire did not erupt during the impact but only after the wreckage came to rest.

The aircraft was in a left wing low attitude when it collided with terrain. Impact markings indicate that the first contact with the ground was with the lower fuselage of the aircraft.

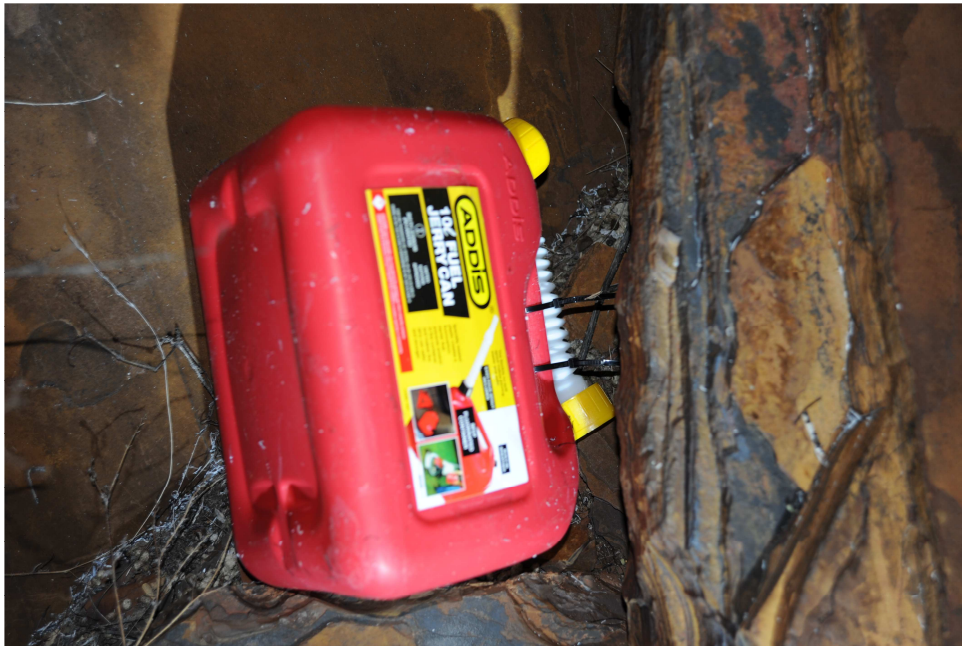
1.18.3 According to evidence found during the investigation, an unauthorised auxiliary fuel system was fitted to the aircraft during the certification flights. Information regarding the fitment of this auxiliary fuel system is restricted to invoices indicating the purchase and fitment of the system components. An e-mail was written by the deceased passenger on 19 August 2012 whereby he stated the following: *“We tried the extra tank fuelling system yesterday and today: 2*25 litres + 2*10 litres on our legs – worked very well with an electric pump system going straight to the wing tank”*. No documentation for such a modification was found and due to the aircraft being consumed by the post-impact fire, no evidence other than an empty 10 litre fuel container was found on the accident scene.

Figure 6 A 10 litre fuel container found at the scene.

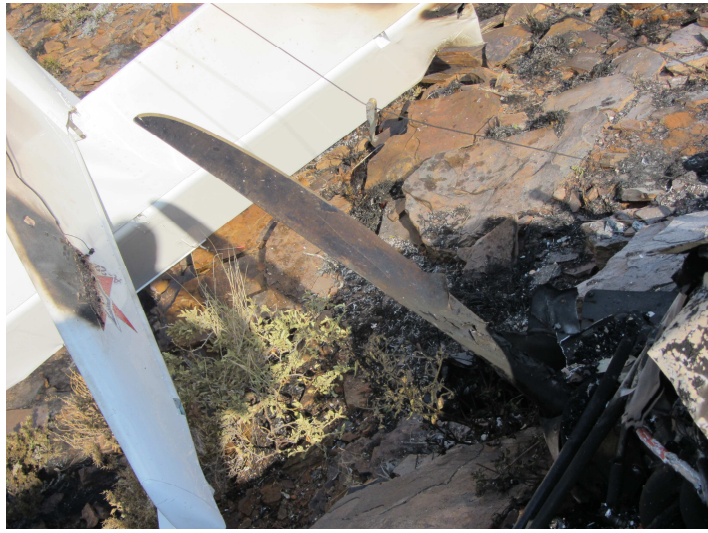
1.18.4 Evidence at the scene indicated the engine was not running when the aircraft collided with the ground. A strip down inspection of the engine revealed no abnormalities; all damage to the engine was caused by impact forces and the post-impact fire. One propeller blade was still attached to the hub of the propeller shaft with no indication of any damage caused by the rotation of the propeller. The remaining two propeller blades were found close to the wreckage in the area where the aircraft started sliding down the ridge after the collision. Neither of these propellers blades had any marks on them indicating they made contact with any object whilst rotating.

Figure 7 The propeller blade attached to the propeller shaft.

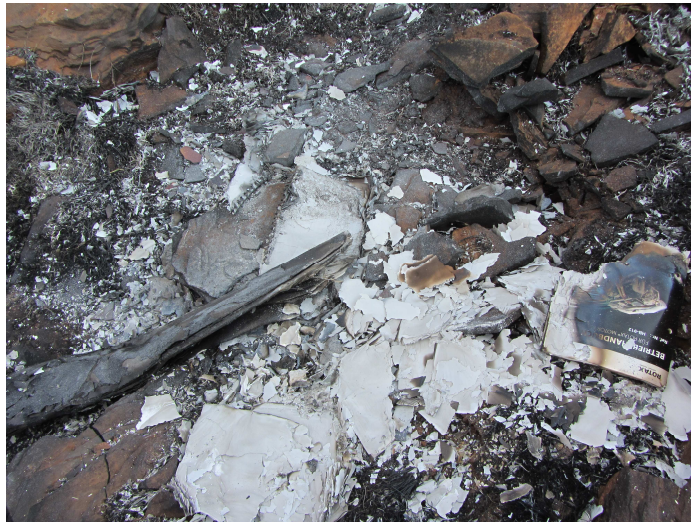
Figure 8 A second propeller found close to the wreckage without any sign of damage caused by rotation.

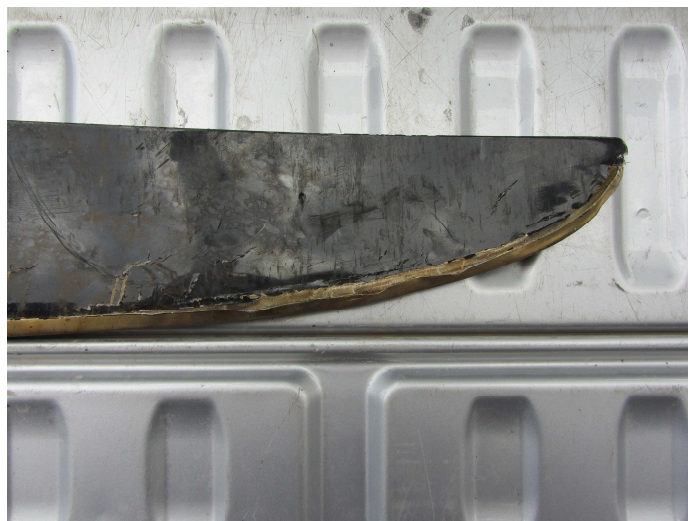
Figure 9 A third propeller blade found underneath the wreckage without any damage indicating rotation-associated with normal engine operation (to sustain flight).
