AIRCRAFT ACCIDENT REPORT AND EXECUTIVE SUMMARY

Reference:	CA18/2/3/9080	
Aircraft Registration	ZS-KMS	Date of Accident	12 September 2012		Time of Accident	0545Z
Type of Aircraft	Beech Baron 58P		Type of Operation	Private		
Pilot-in-command Licence Type	Commercial		Age	27	Licence Valid	Yes
Pilot-in-command Flying Experience	Total Flying Hours	1 145.7		Hours on Type	4.6	
Last point of departure	Pietermaritzburg airport (FAPM): Kwazulu Natal province.					
Next point of intended landing	Kruger Mpumalanga international (FAKN): Mpumalanga province.					
Location of the accident site with reference to easily defined geographical points (GPS readings if possible)						
Outside the boundary of Pietermaritzburg airport, approximately 200m from Runway 34 at GPS coordinates determined to be S29°39' 32.786 E030°24'30.527 at an elevation of 2423 feet above mean sea level (AMSL).						
Meteorological Information	Surface wind: 240°04 knots; Temperature: 19°C; Visibility: 200 metres

Name of Owner/Operator : Treated Timber Products (PTY) LTD
Manufacturer : Raytheon Aircraft Company
Model : Beech Baron 58P
Nationality : South African
Registration Marks : ZS-KMS
Place : Outside Pietermaritzburg Air

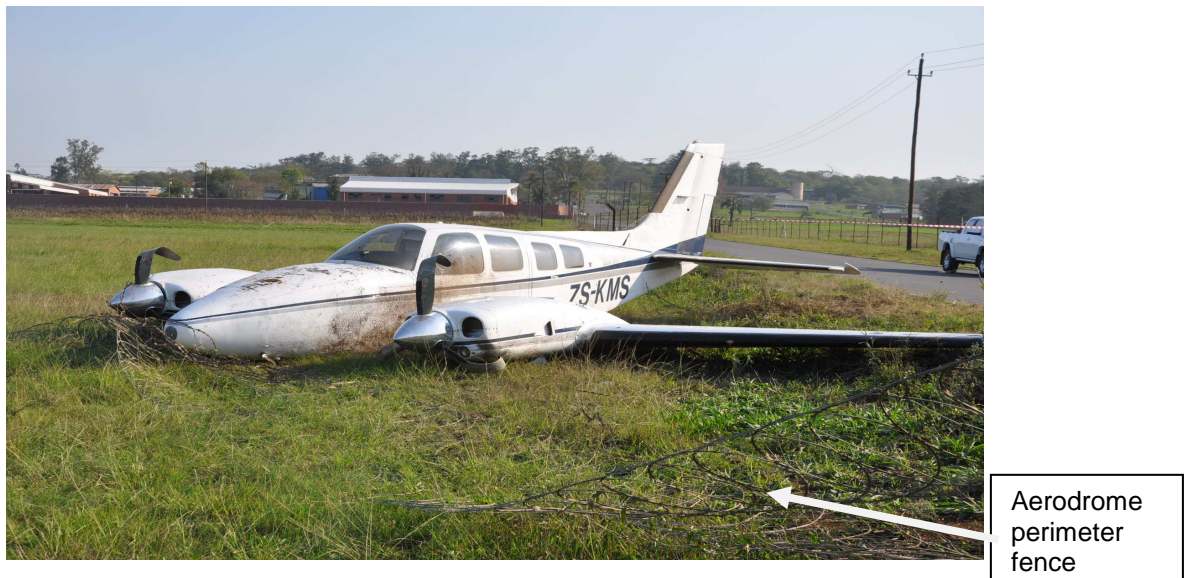
- 1.3.1 The aircraft was substantially damaged after impact with the ground.

Figure 1: View of the aircraft as found at the accident site.

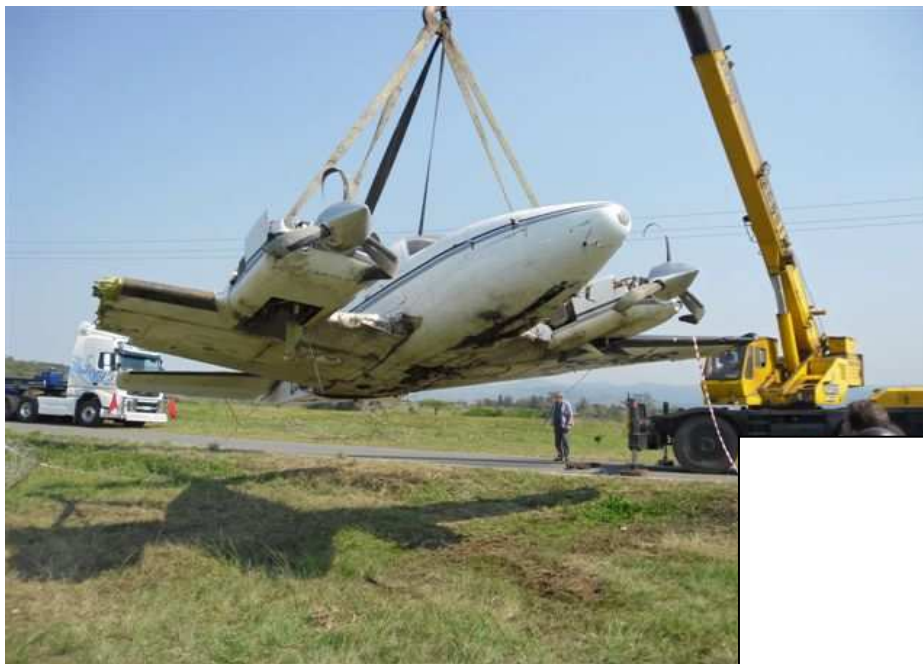
1.12.2 Flight control cable continuity and pre-impact control integrity could be established at the accident site. There was no evidence of any flight control problem or jamming. Damage was limited to the propellers, the undercarriage, the underbelly and the right wing. The flap lever in the cockpit and the flaps were found on the UP position. The cabin/ cockpit area was still intact and the battery was found in an OFF position. The undercarriage lever was on the UP position but still in transit with the fuel selector valve in an OFF position. All the aircraft seats were secured on their anchors with the safety harnesses still secured and not failed/snapped. Below is a photo of the aircraft shot during recovery.

Figure 4: View of the aircraft shot during recovery.

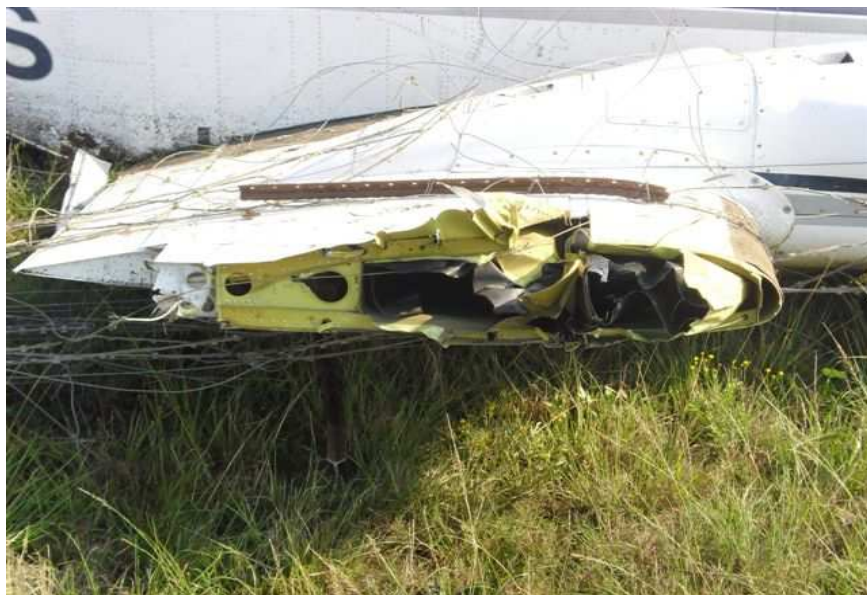
1.16.1 On-site investigation revealed that the aircraft collided with a steel pole which ripped the right wing off, and the aircraft skidded over the field for approximately 130 meters before coming to a halt. In addition the EDM-760 monitor gave indication that the aircraft has travelled 58 seconds from take-off to the first point of impact. In a nut shell the distance the aircraft has travelled and time before collision with a steel pole clearly shows that the aircraft engines were producing a significant amount of power. If that was not the case the aircraft should have come to a standstill immediately after collision with the steel pole (and not have travelled such a long distance).

1.16.2 Secondly a clear right wing tip cut is an indication that the engines were producing a significant amount of power from take-off up to the last point of impact.

Figure 5: View of the right hand wing.
