AIRCRAFT ACCIDENT REPORT AND EXECUTIVE SUMMARY

Reference:	CA18/2/3/9082	
Aircraft Registration	ZS-TV R	Date of Accident	13/09/2012		Time of Accident	±1517Z
Type of Aircraft	Beech F33A (Aeroplane)		Type of Operation	Private flight		
Pilot-in-command Licence Type		Private Pilot	Age	64	Licence Valid	No
Pilot-in-command Flying Experience		Total Flying Hours	1 047,4		Hours on Type	984,9
Last point of departure		Pietermaritzburg aerodrome (FAPM), (KwaZulu-Natal province)				
Next point of intended landing		Newcastle aerodrome (FANC), (KwaZulu-Natal province)				
Location of the accident site with reference to easily defined geographical points (GPS readings if possible)						
Ophatha, near Cato Ridge (GPS position; 29°38.679' South 030°42.236' East, elevation 1 574 feet)						
Meteorological Information		Surface wind 130/10 kts; Temperature 15°C, Dew poi nt 12°C, Overcast				
Number of people on board	1 + 2	No. of people injured	0	No. of people killed	1 + 2

AIRCRAFT ACCIDENT REPORT

Name of Owner : T.J. Janse van Rensburg
Name of Operator : Private flight
Manufacturer : Beech Aircraft Corporation
Model : F33A
Nationality : South African
Registration Marks : ZS-TVVR
Place : Ophatha, nea

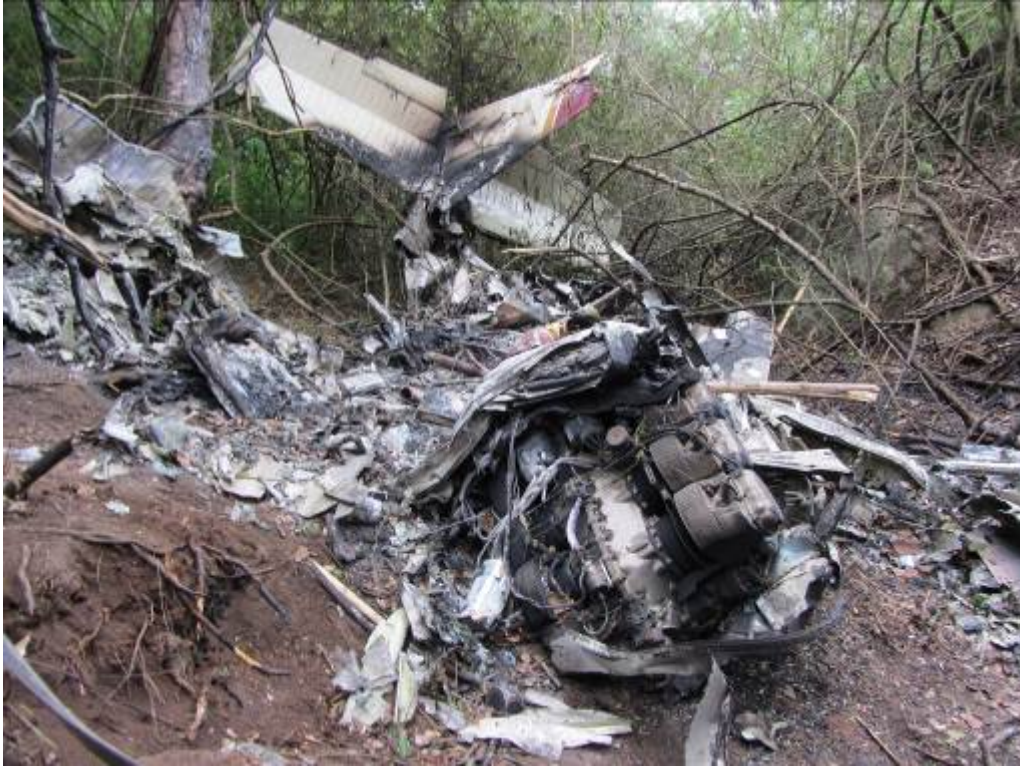
1.3.1 The aircraft was consumed by the post-impact fire that erupted.

Figure 1. View of the wreckage that was consumed by the post-impact fire

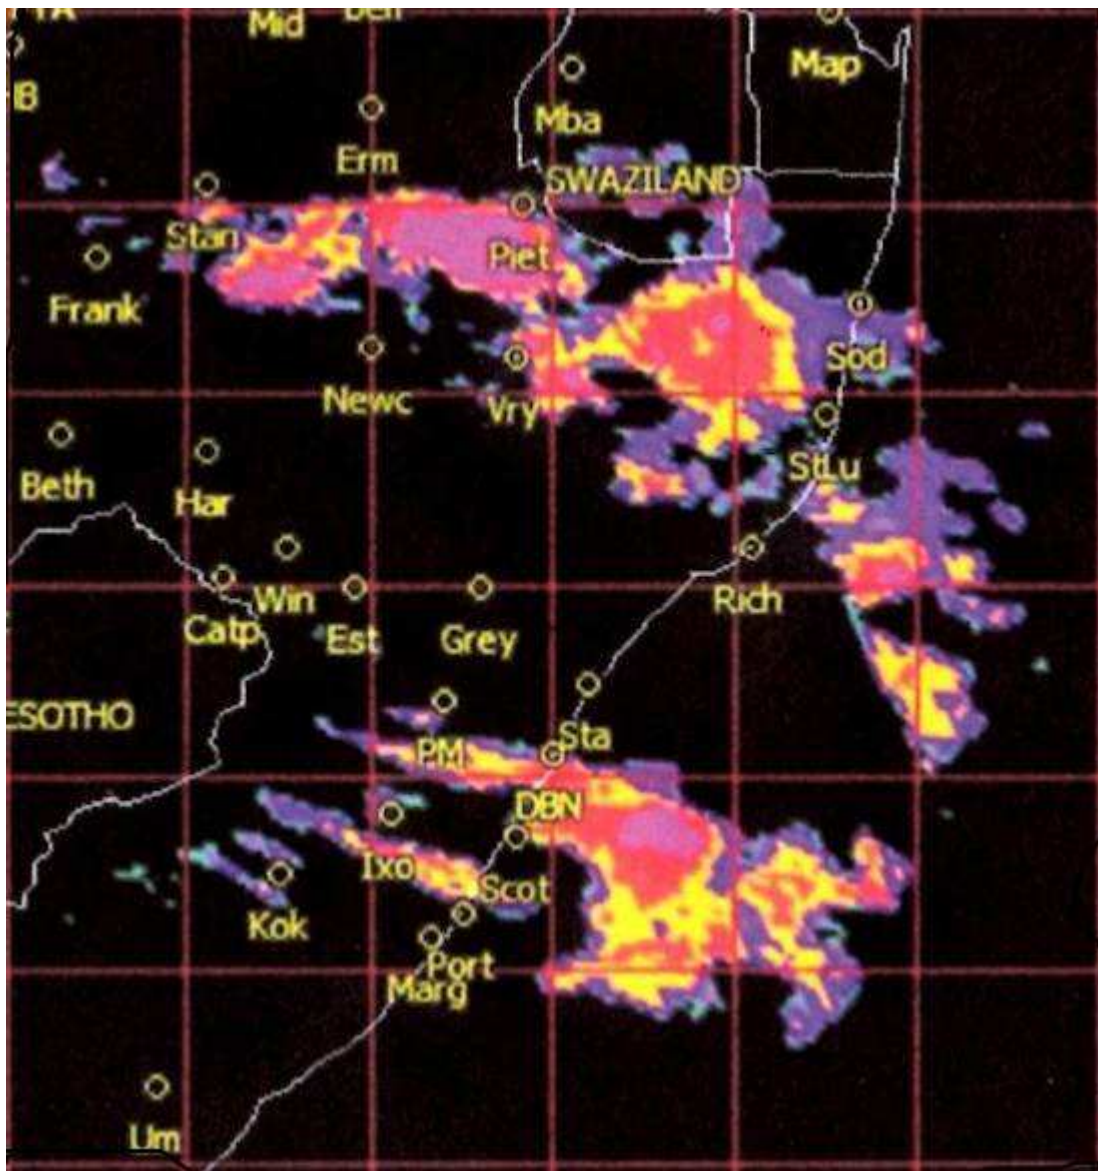
Figure 7. Infrared image taken on 13 September 2012 at 1515Z

This infrared image indicates that there was a high possibility of rain and thundershowers at the time in the areas indicated in colour on the photo.

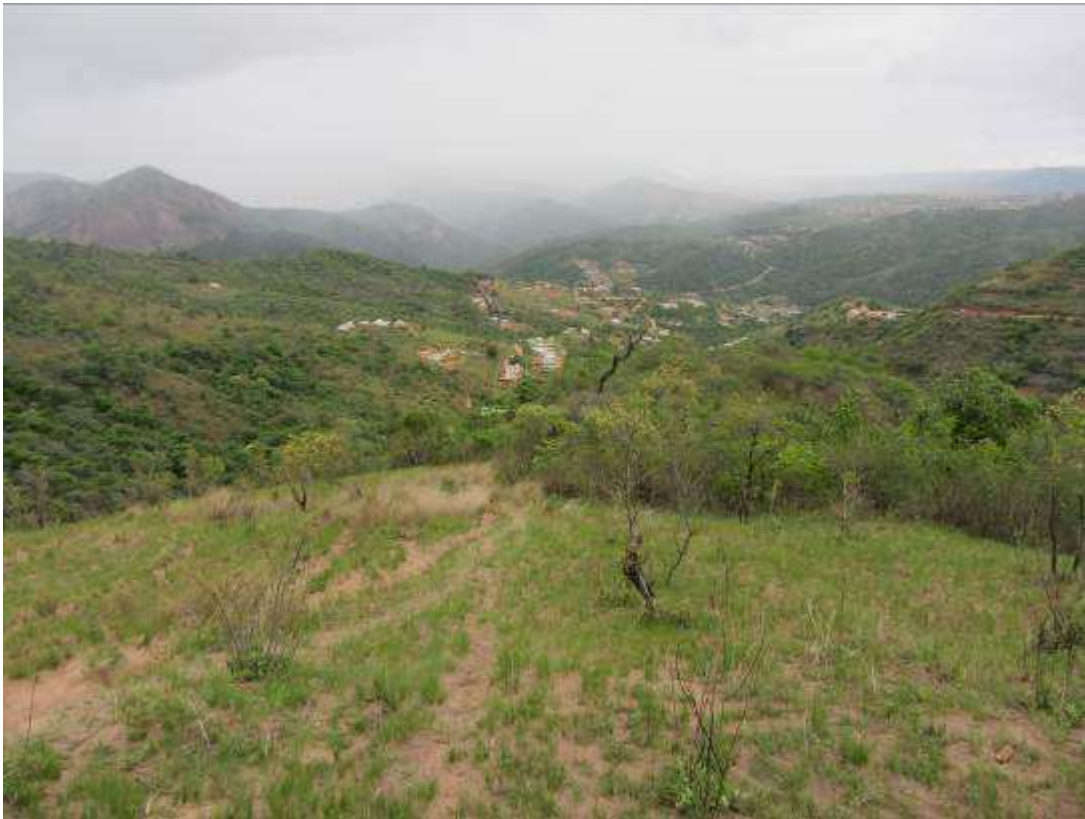
The photo in figure 8 on the next page was taken of the prevailing weather conditions while the investigating team was hiking towards the crash site. The photo shows that it was raining to the south at the time.

Figure 8. Photo of the prevailing weather conditions in the area the next day

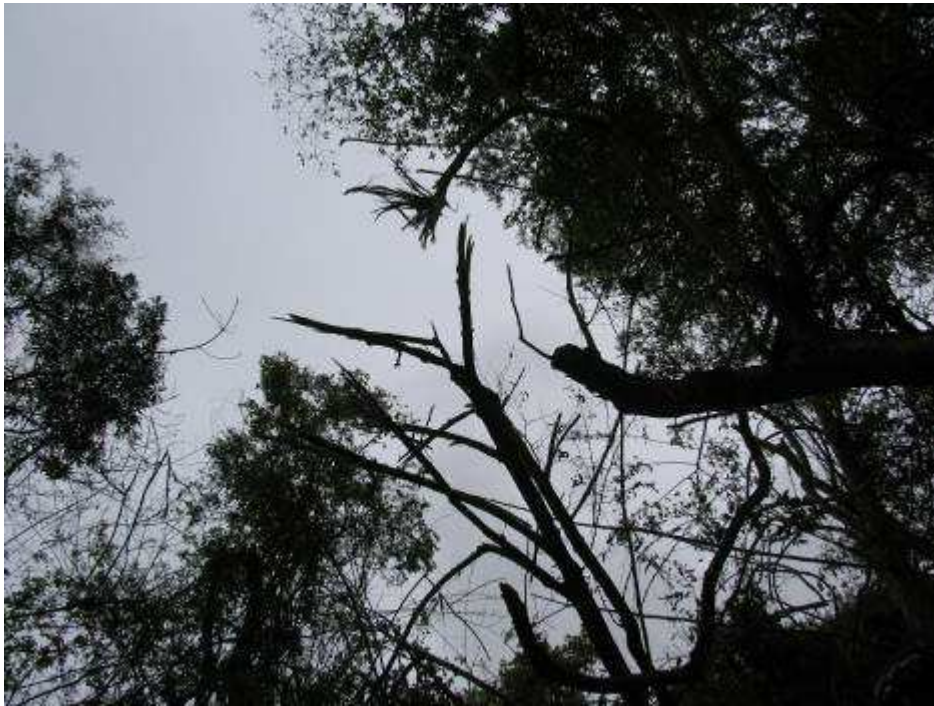
1.12.1 The aircraft crashed in dense bush in mountainous terrain. The impact sequence damaged several trees, which were approximately 10 m in height, followed by ground impact. The damage sustained by vegetation indicates that the aircraft was in a vertical trajectory during the impact sequence. The nose section of the aircraft was orientated along a magnetic bearing of $\pm 060^{\circ}M$. The impact location was 16,2 nautical miles (nm) towards the east of FAPM (their departure aerodrome).

Figure 10. Damage sustained by trees. The photo was taken on the accident site looking up towards the skyline

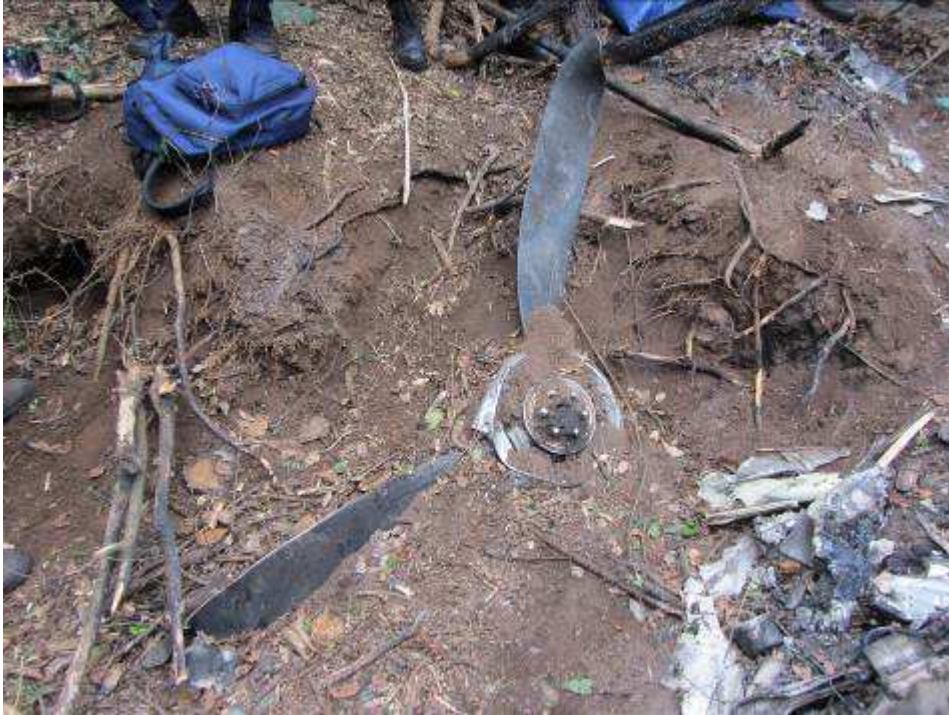
1.12.2 The propeller was found to have separated from the engine during the impact sequence, with one propeller blade being completely embedded in the sand and a second blade partially embedded. The crankshaft failed as a result of the impact, with the crankshaft flange still being attached to the propeller hub assembly. The propeller was lying approximately 2 to 3 m in front of the engine, which was still secured to the main wreckage. The propeller did not sustain any fire damage. The engine and propeller were recovered from the accident scene for examination

purposes. The crankshaft failure mode was associated with an overload/ductile failure (45° edges around the circumference of the shaft).

Figure 12. Photo of the propeller, which was partially embedded in the ground

The engine was exposed to a substantial amount of heat from the post-impact fire. It was recovered from the accident site and subjected to a teardown inspection at an approved engine overhaul facility. No evidence of mechanical failure was observed. The manifold pressure and fuel flow gauge that was recovered at the accident site indicated a fuel flow rate of approximately 11 to 12 US gallons and hour, which was within the normal engine operating range. The propeller was found to be partially embedded in the ground as it separated from the engine in overload mode.

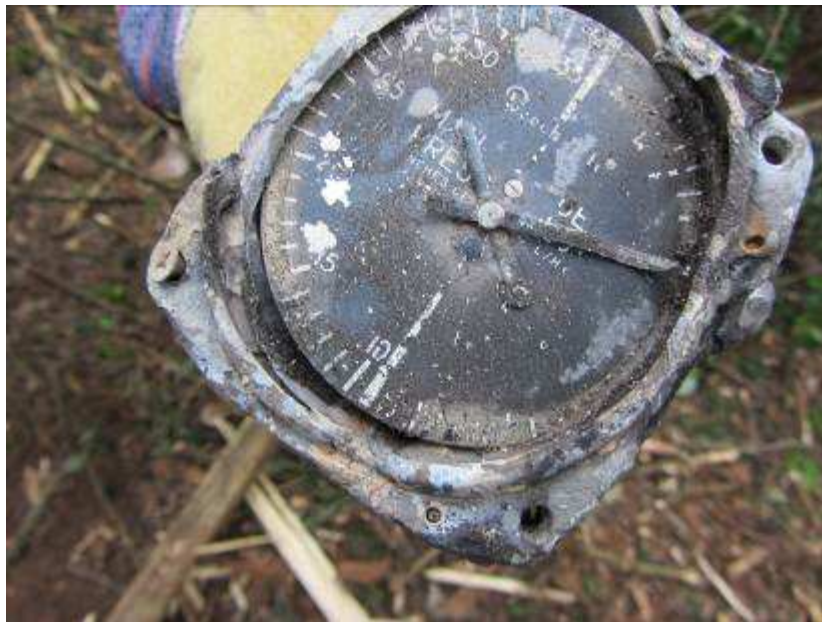
1.12.3 The wreckage was contained at one location, without any debris field. It was determined that the landing gear was in the up position. The empennage section had remained intact and both elevators and the rudder control surfaces were still attached at the respective hinging points. The fuselage, including the cockpit and cabin area as well as both wings, was consumed by the post-impact fire. The manifold pressure and fuel flow indicator was the only gauge from the instrument panel that presented a readable display. The manifold pressure indication was $\pm 28,5$ inches of mercury (needle on the left-hand side of gauge) and the fuel flow indication was ± 11 to 12 US gallons per hour (needle on the right-hand side of the gauge) this indicate that the engine was functioning during flight and fuel supply was within the expected range.

Figure 13. A photo of the manifold pressure and fuel flow gauge that was recovered on site.

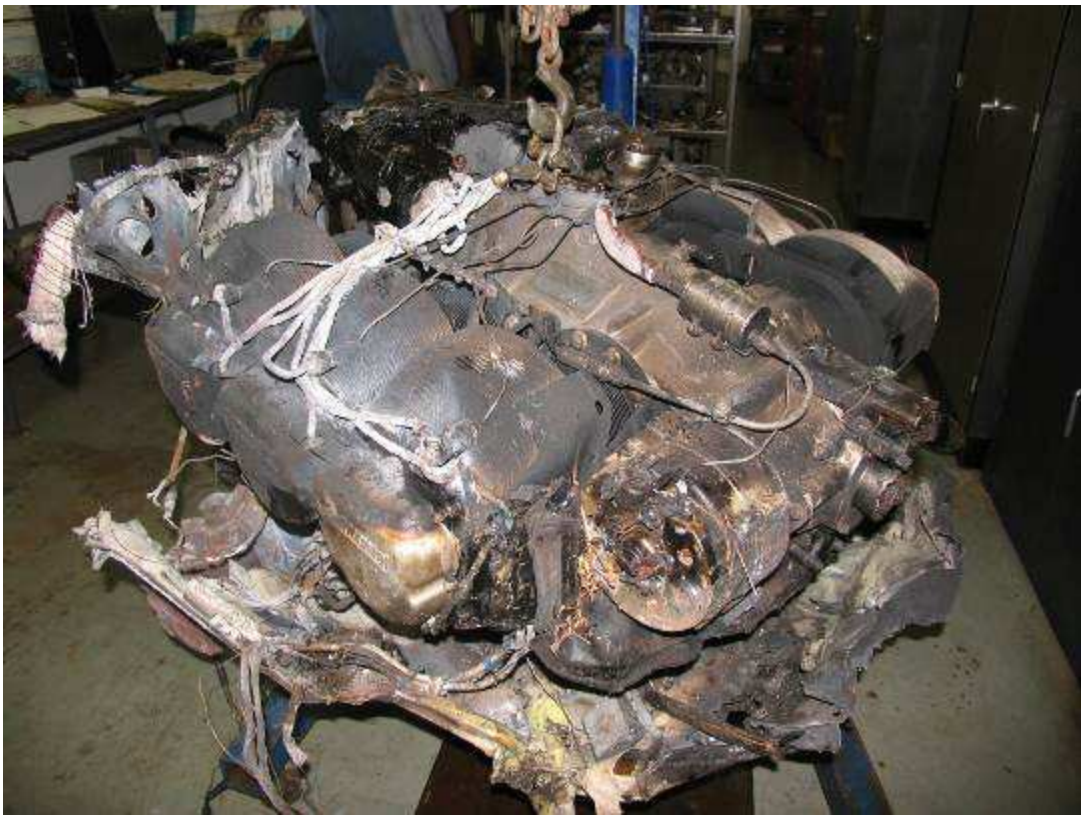
A photo of the engine prior to the teardown inspection.

Engine Model	Teledyne Continental IO-520-BB
Serial No.	578776
Fuel flow divider valve	The unit display scoring / fire damage. The unit was opened and it was found that the diaphragm inside was undamaged. The unit was free of contaminants / obstructions. All the associated fuel lines and connections

were intact.
Fuel pump	The pump sustained substantial fire damage.
Fuel filter	It was not possible to make a proper assessment of the fuel filter unit due to fire damage.
Spark plugs Champion RHB-32E	The spark plugs sustained some fire damage but it was possible to remove all of them and they were found to be in an overall good condition, displaying a light brownish colour, which was associated with normal engine operation.
HT leads	The high tension leads sustained fire damage.
Magneto's Slick Model No. 6310	Both the magnetos were still secured to the engine however, they both sustained impacted damage as well as fire damage. The right-hand unit sustained substantial more fire damage and neither of the units could be subjected to a bench test procedure, nor was it possible to check the magneto timing.
Fuel nozzles (GF 148)	All six fuel nozzles were removed from the engine and apart from scoring no damage were noted.

Fuel control unit	The unit sustained fire damage. All the cable/control linkages attached to the unit was still secured to the unit on both sides. The butterfly valve was found to be in the fully open (deflected) position.
Vacuum pump	The vacuum pump that was fitted to the engine sustained fire damage and could not be turned by hand. The aircraft was

also equipped with an additional vacuum pump (electrically driven). This unit sustained fire damage as well as impact damage and could not be tested.
Oil filter	The filter was still attached to the engine but had sustained substantial fire damage. The unit was removed from the engine and was cut open. No metal particles were observed in the filter.
Gear drive train	The gear drive train was undamaged.
Cylinders	All six the cylinders display fire damage (scoring). All the cylinders were removed and they showed signs of proper combustion and carbon deposits found to be normal on this type of engine.
Pistons & rings	The pistons were in a good condition with very little carbon build-up visible. Not any of the rings were broken on any of the six pistons.
Main bearings & Big-end bearings	All the bearings were found to be in an overall good condition and displayed evidence of adequate lubrication.
Connecting rods	All six connecting rods were found to be in a overall good condition/undamaged and the bolts properly secured.

Camshaft	The camshaft was found to be in an overall good condition including the gear drive assembly.
Crankshaft	The crankshaft was found to be in an overall good condition.
Cylinder head / valve assembly	All six the rocker covers were removed and the valves with their associated valve springs were found to be intact and in a good condition.
Oil pump	The oil pump was found undamaged and in a good condition. There was still a substantial amount of oil in the engine even though the casing was damaged on the right aft side. The

sump assembly remained intact.
Oil cooler	The unit sustained some impact and fire damage.
Alternator	The unit was attached to the engine but sustained fire damage. It was removed and the front drive gears could be inspected, with no anomalies noted.
Propeller Governor (CSU)	The unit with its control cable linkage was still attached to the engine. It sustained substantial fire damage. The attachment linkage was found to be secured.
Alternate observations	<p>The exhaust stacks were removed and inspected, it was found to display a brownish colour on the inside, which could be associated with normal engine operation.</p> <p>The most intense part of the fire was concentrated towards the left aft section of the engine with evidence of coked engine oil visible in that area. Fire damage caused to components in that area was much more severe if compared to the rest of the engine.</p>
Conclusion:	The teardown inspection of the engine did not reveal any pre or post impact mechanical failure that would have prevented the engine from normal operation.
