DUTCH
SAFETY BOARD

Crash following engine failure

The Hague, March 2016

Identification number:	2012096
Classification:	Accident
Date, time ¹ of occurrence:	15 September 2012, around 19.10 hours
Location of occurrence:	Valkenswaard area
Registration:	ES-YLS
Aircraft type:	Aero Vodochody L-39C
Aircraft category:	Single engine jet
Type of flight:	Formation flight
Phase of operation:	Cruise flight
Damage to aircraft:	Destroyed
Flight crew:	One
Passengers:	One
Injuries:	None
Other damage:	Pollution of a field
Light conditions:	Daylight

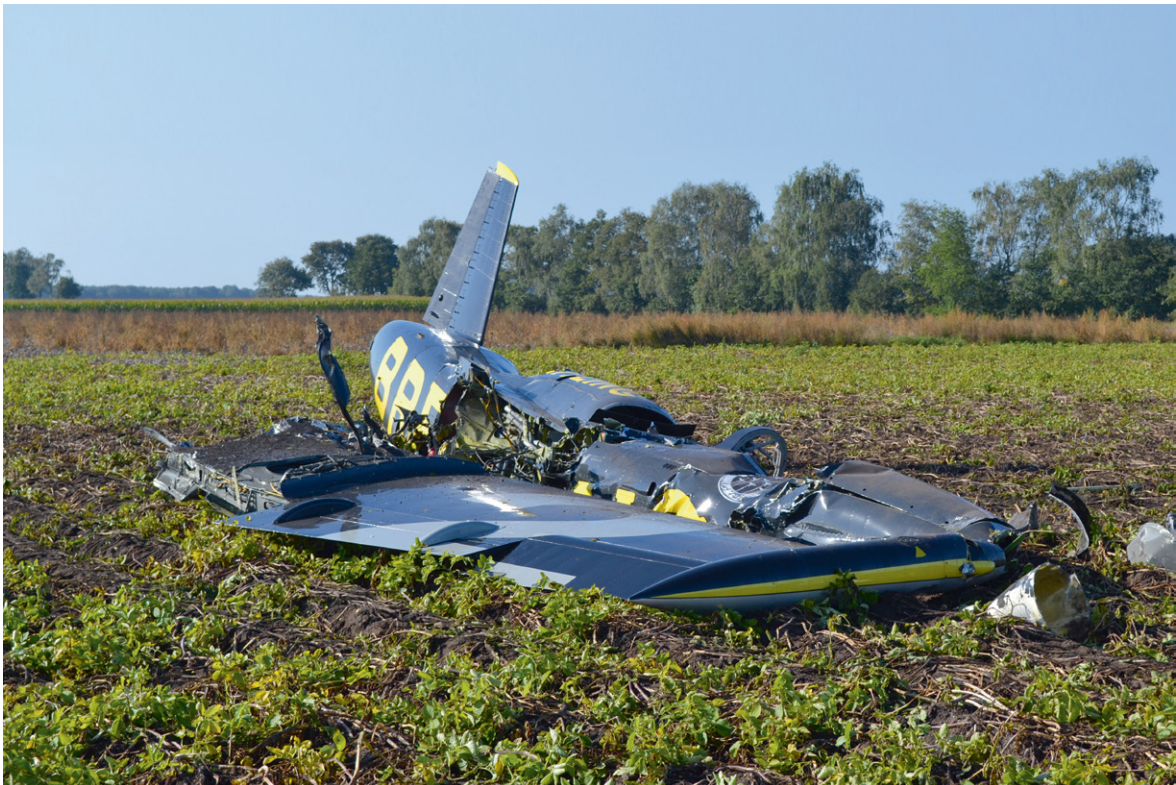
Figure 1: ES-YLS after the accident. (Photo: National police)

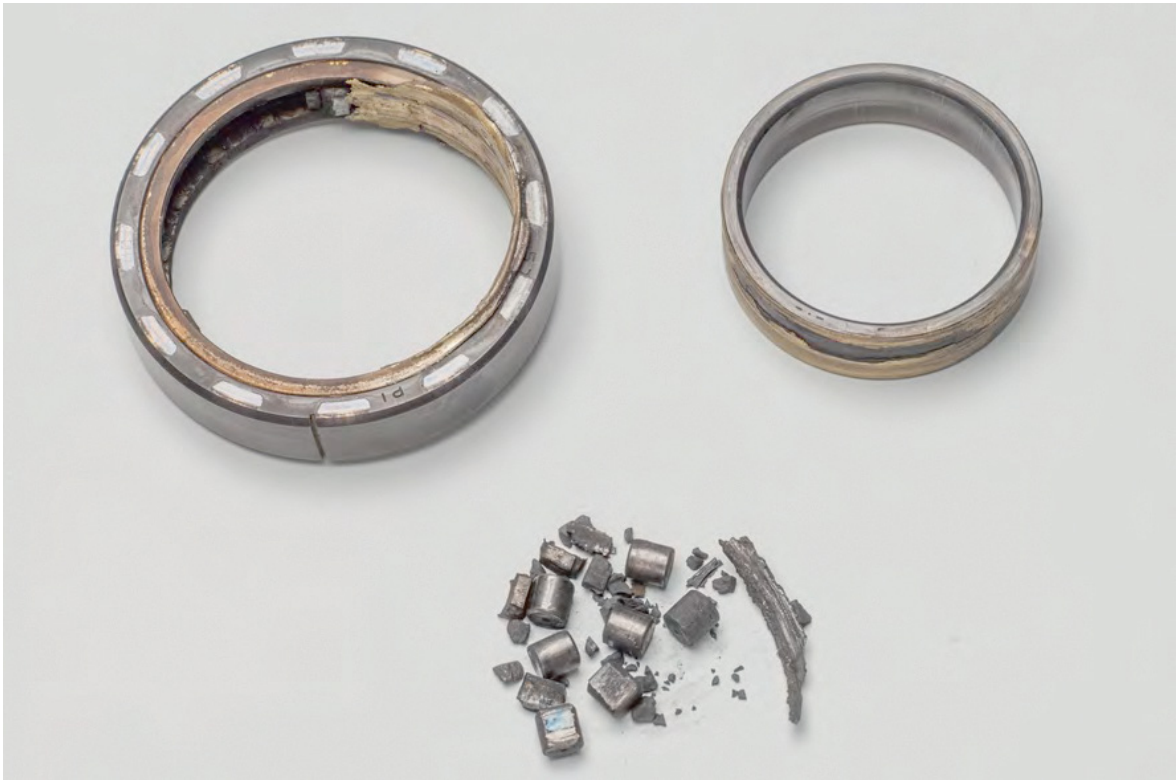
Figure 4: The failed front bearing. (Photo: NLR)

- Cracks in the bearing inner ring base material, removed material at the inner raceway, wear particles in the oil and vibrations, noticed just prior to the crash, point to the bearing as the root cause of the crash. The wear and vibrations of the bearing most likely led to more stress on the coupling bolt and reversed bending in section 2 of the coupling bolt. Failure of the coupling bolt caused rotation between the oil tube ends, leading to torsion and tensile overload at fracture 2 and 1 of the tube, respectively. The cracks in the inner ring base material, the removed material at the inner raceway and wear particles in the oil, indicate that a slowly degrading process preceded the single event.
- The markings on the bearing and the measured chemical composition of the bearing parts indicate that a new version of the bearing was installed.

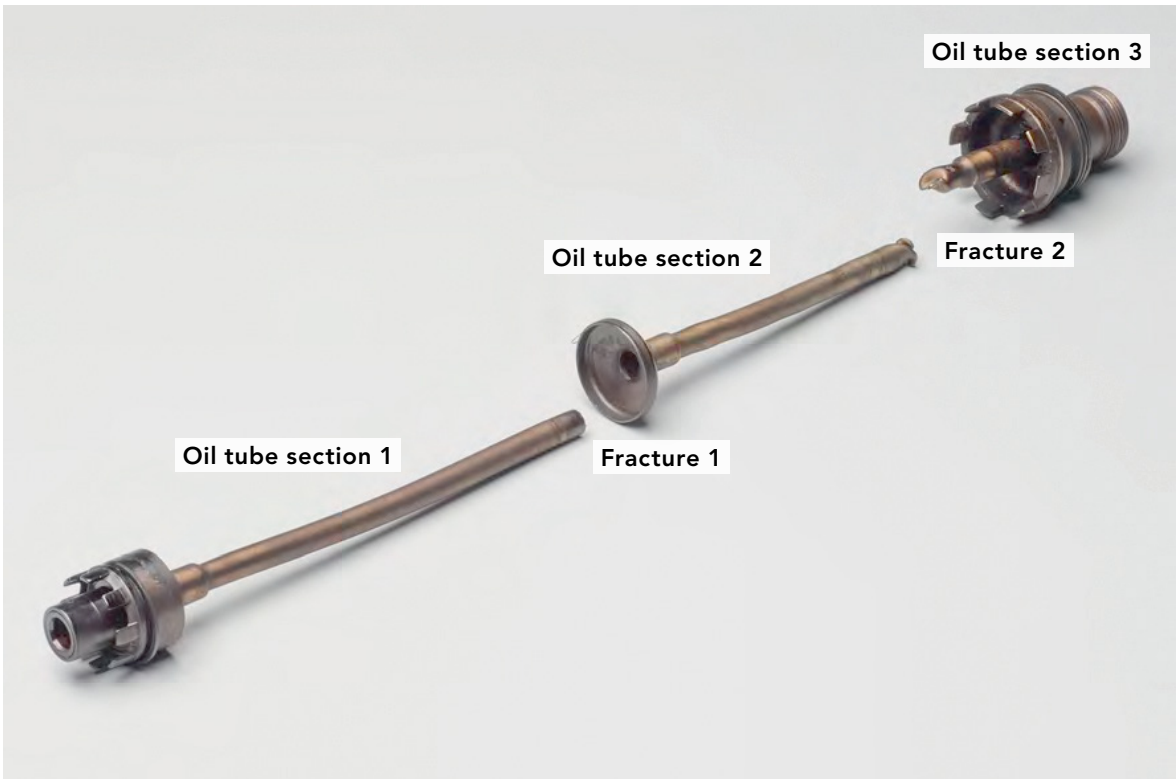
Figure 5: The twisted and broken oil tube. (Photo: NLR)

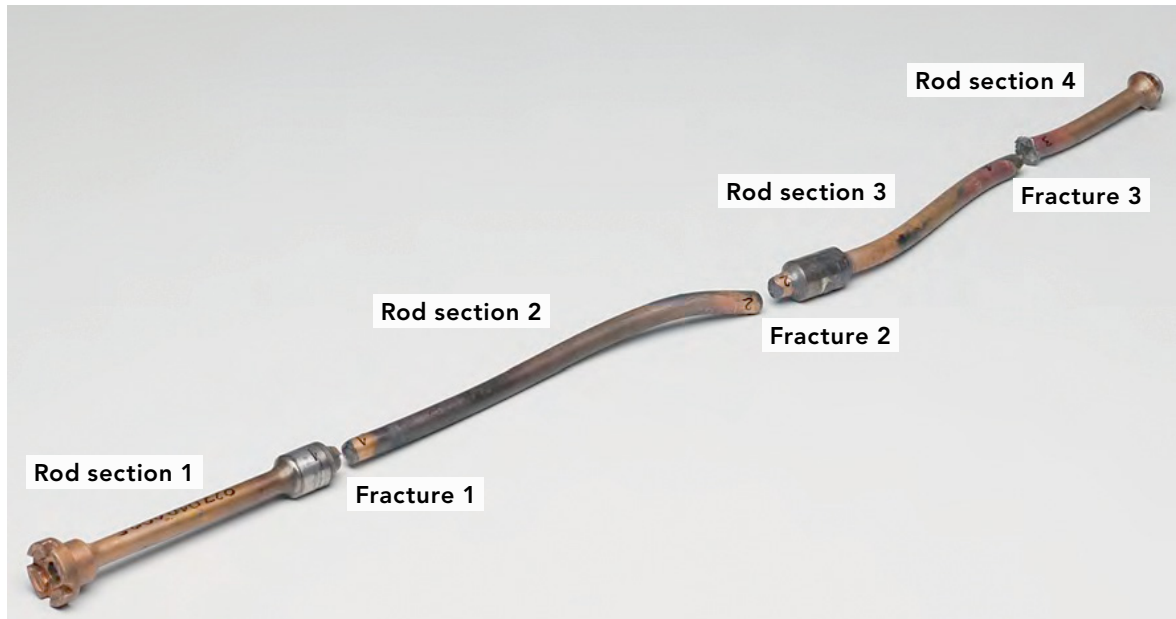
Figure 6: The bent and broken coupling bolt. (Photo: NLR)

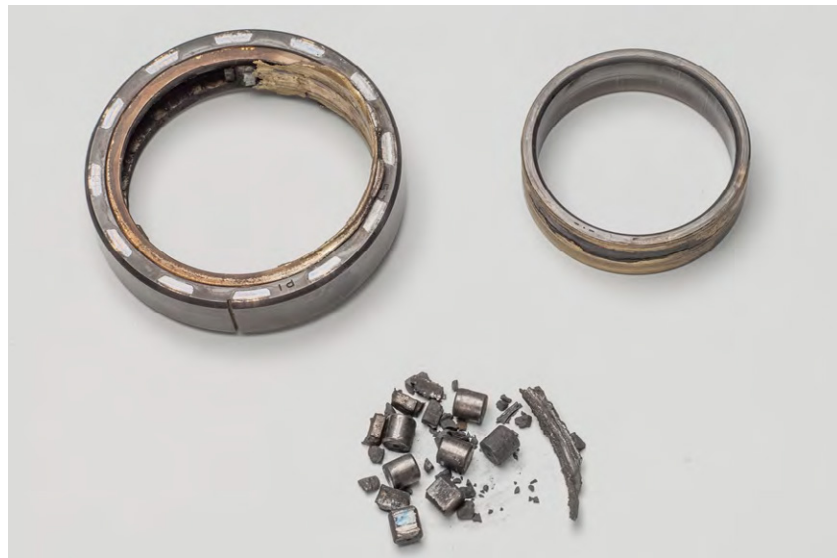
Fig. 1 shows the various parts of the bearing as received. The cage is still inside the outer ring and is smeared for about 160°. The outer raceway and the cage are very dirty and black. Several connections between the rings of the cage are not present anymore as well as some of the cylinders (see Fig. 2). Flat sides are present on all cylinders, while the remainder of the rolling surface appears undamaged. This can indicate a sudden event. The cylinders under the smeared cage are still present and the contours can be vaguely observed. 7 cylinders are received separately, while 8 empty positions can be counted on the cage. Two cutting saw markings are present on the outside of the outer ring and with a black marker the code “5-3211OR” is written on the outside of the outer ring. This corresponds to the markings that are found on the side of the outer ring:

Fig. 1 Overview of the failed bearing components

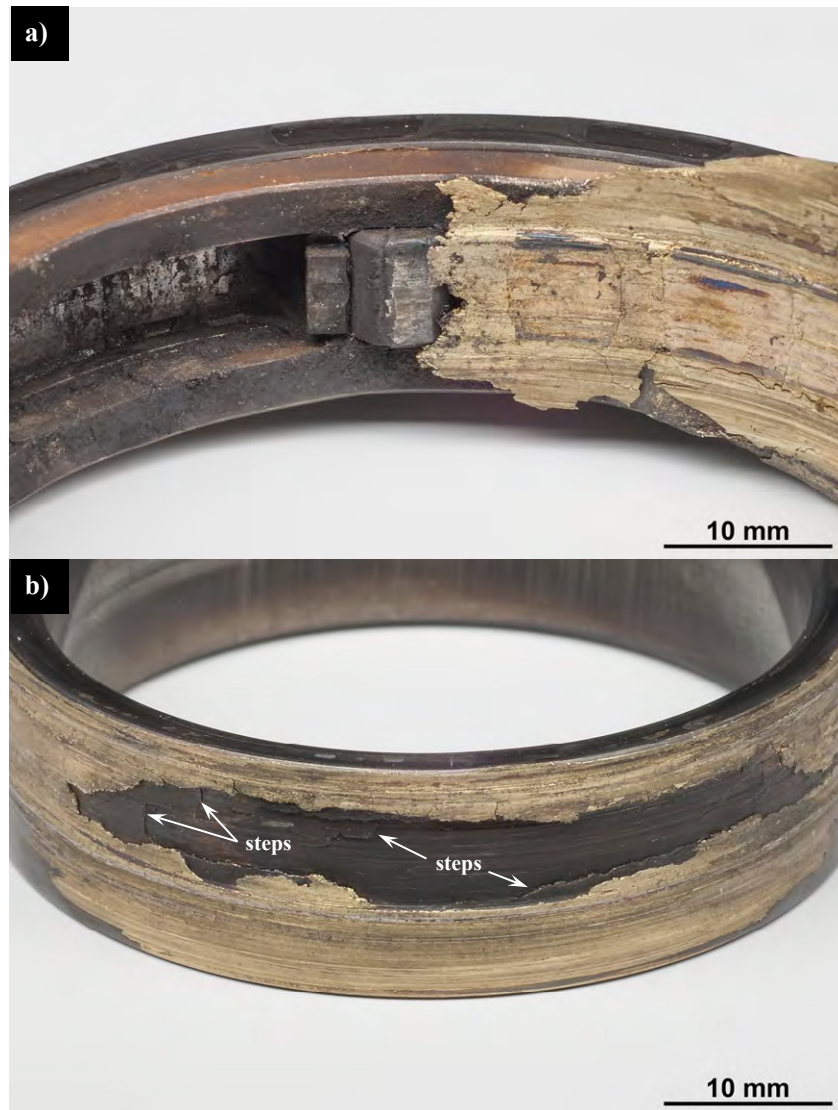
Fig. 2 shows that the cage is also smeared out on the inner ring. In the centre of the inner raceway, where no cage material is present, the surface is black and several small steps can be observed.

Fig. 2 Photographs of the a) outer ring with (smeared) cage and rollers and b) inner ring with smeared cage

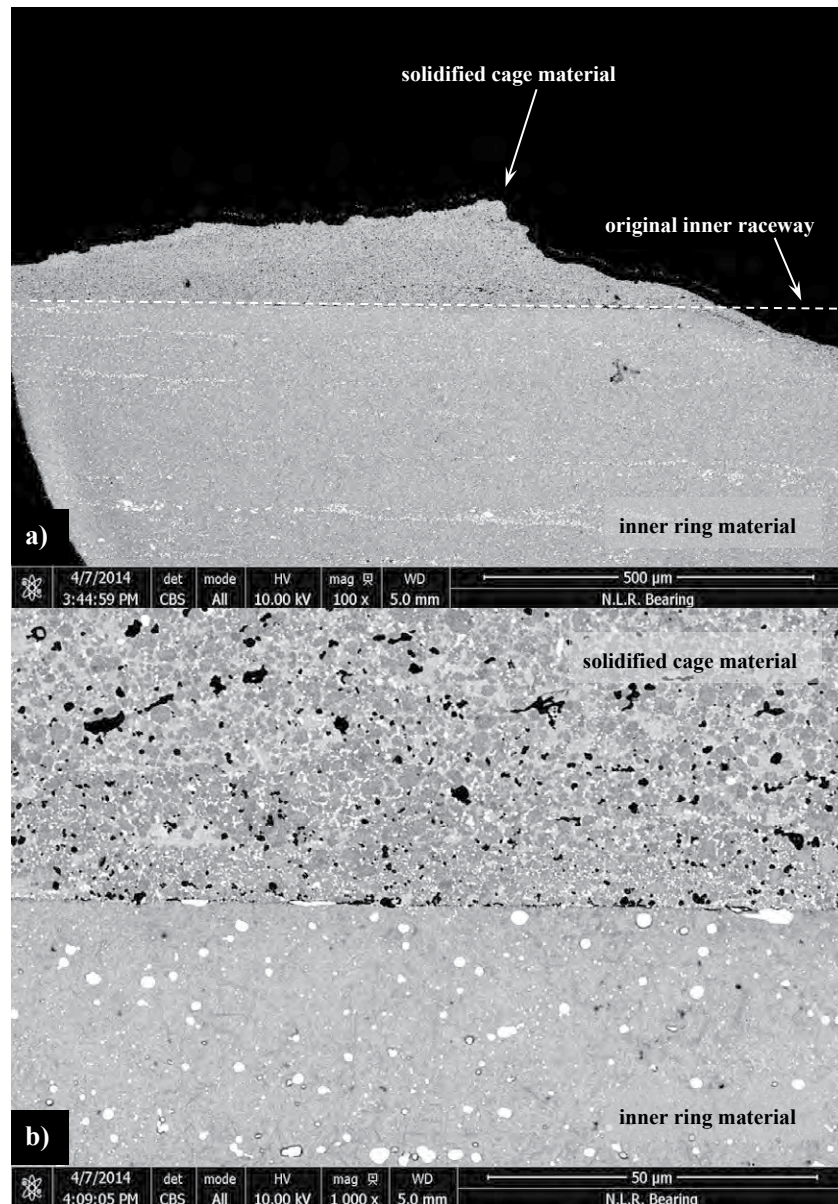
Fig. 5 Scanning electron microscopy image of the cross-section of the bearing inner ring at a) 100x and b) 1000x magnification

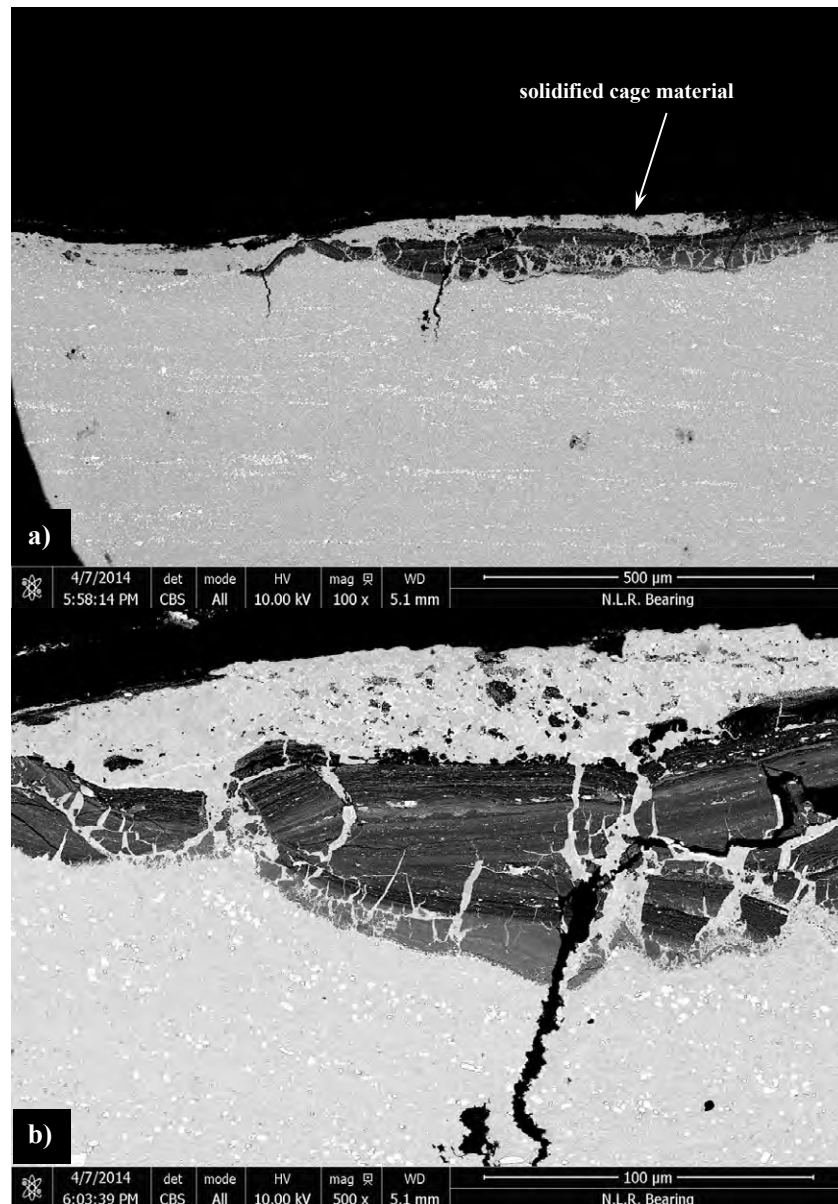
Fig. 6 SEM image of crack 1 at a) 100x and b) 500x magnification

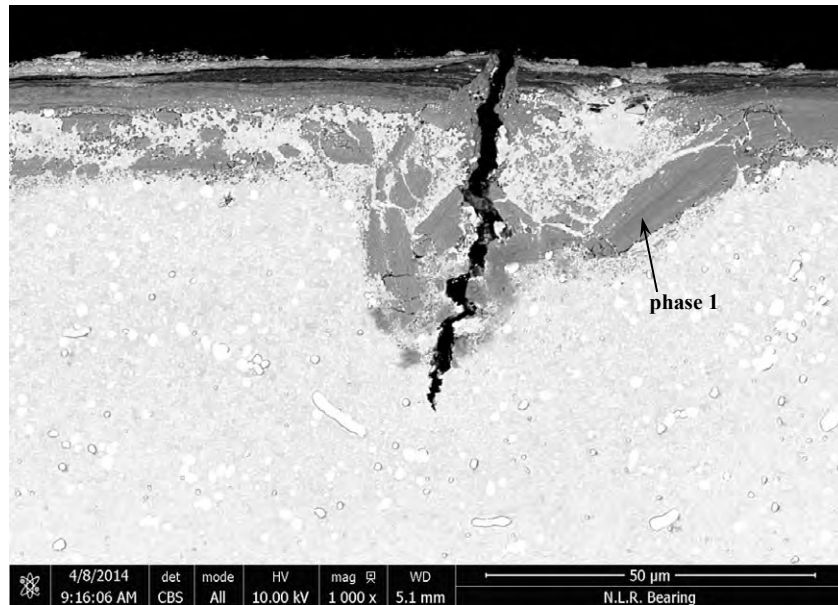
Fig. 7 SEM image of crack 2 at a) 100x and b) 500x magnification

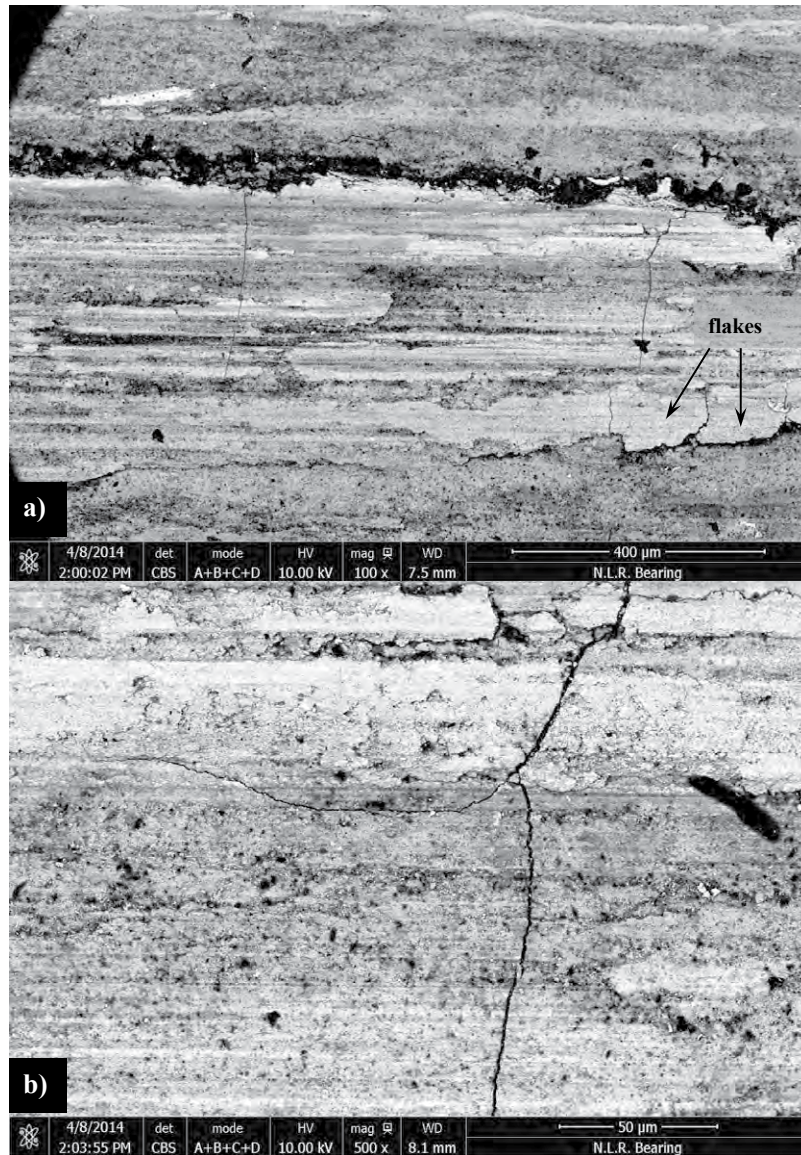
Fig. 8 SEM image of the black inner raceway surface at a) 100x and b) 500x magnification

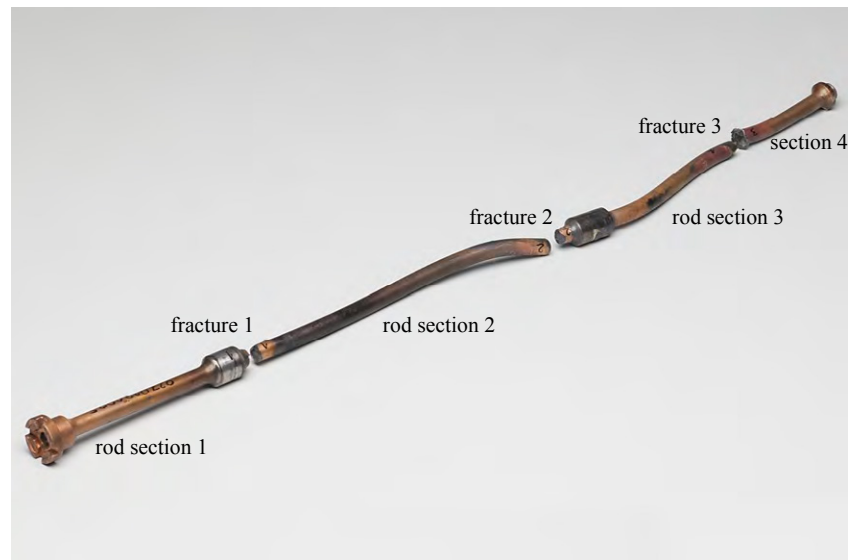
Fig. 9 Overview of the failed connector rod parts

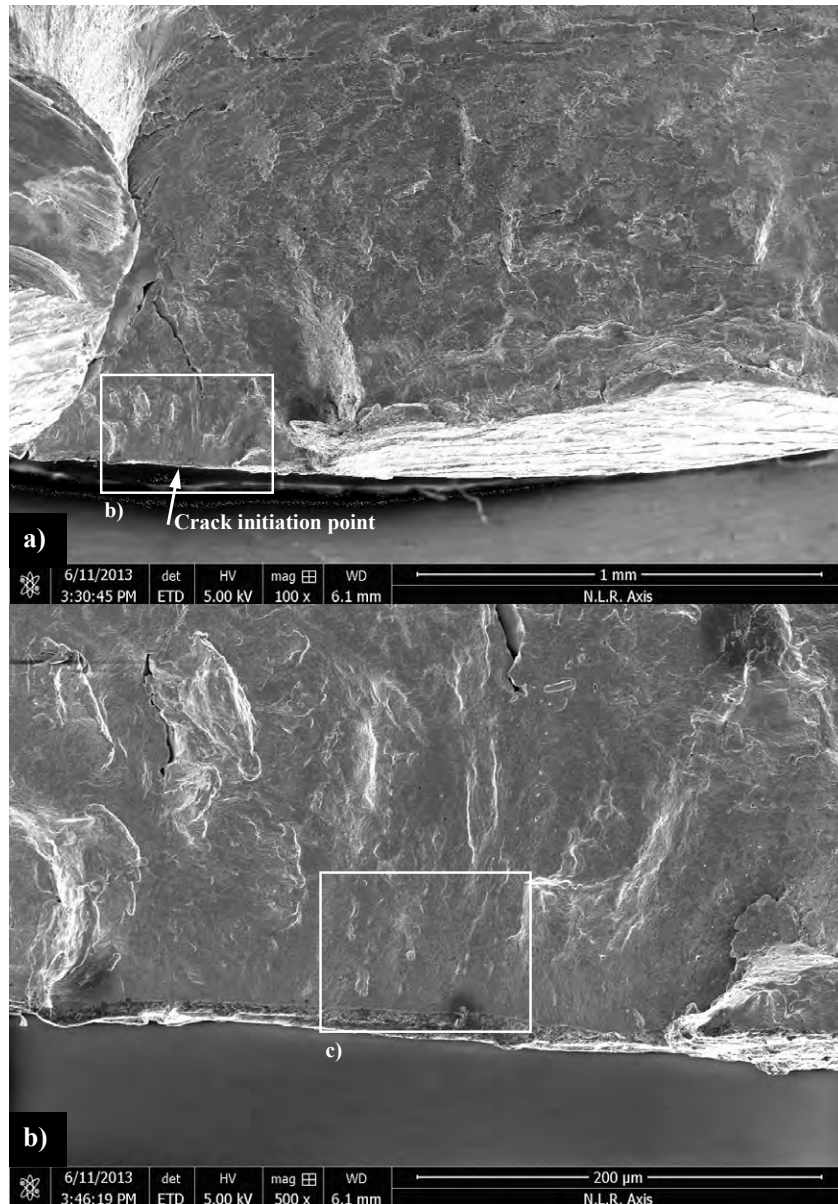
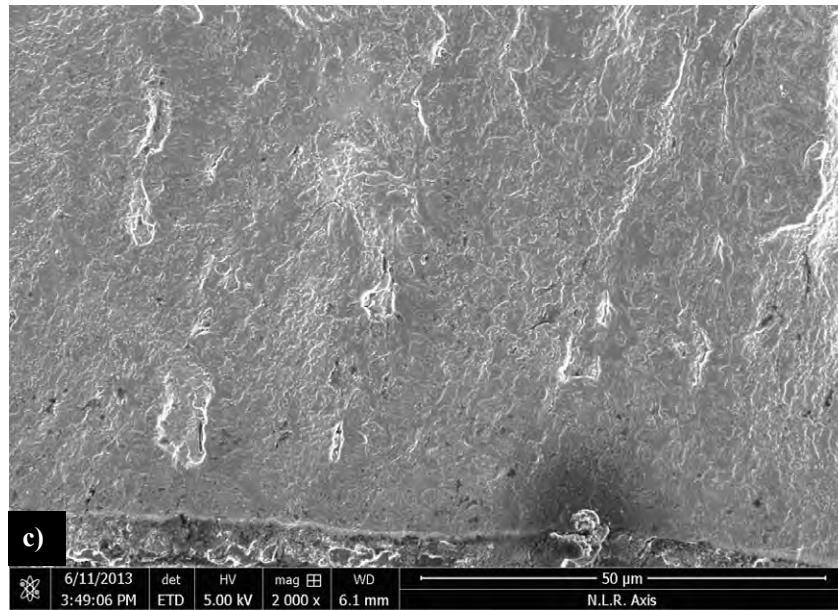
Fig. 11 SEM images of a crack initiation point on fracture surface {1,2} at a) 100x, b) 500x and c) 2000x magnification

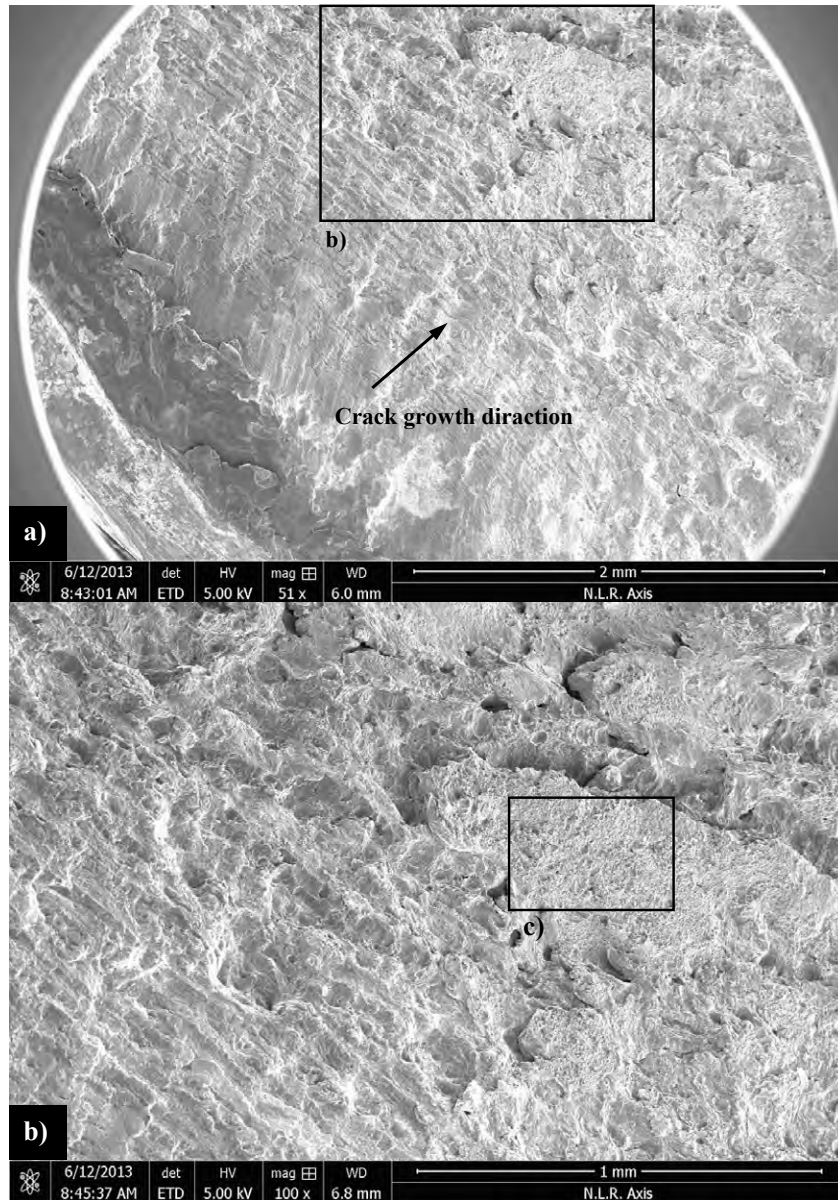
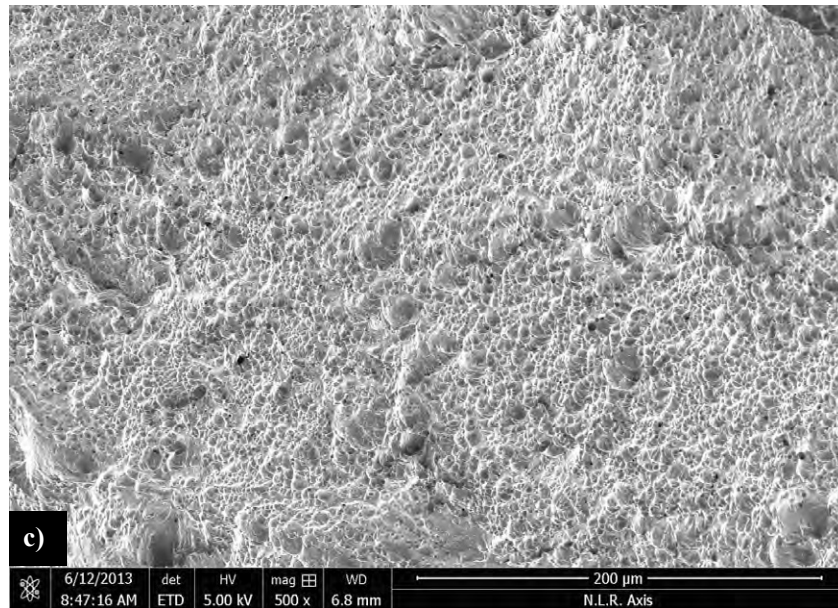
Fig. 12 SEM images of beach marks and dimples on fracture surface {1,2} at a) 51x, b) 100x and c) 500x magnification

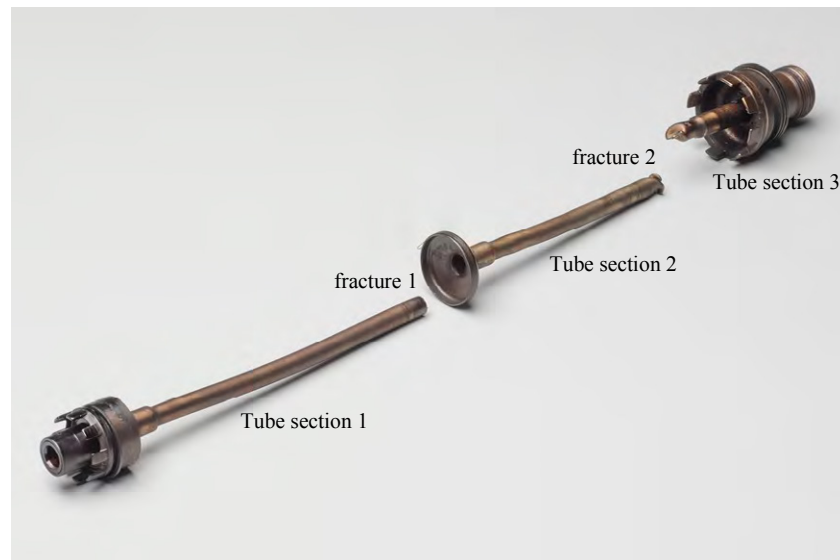
Fig. 13 Overview of the failed oil tube

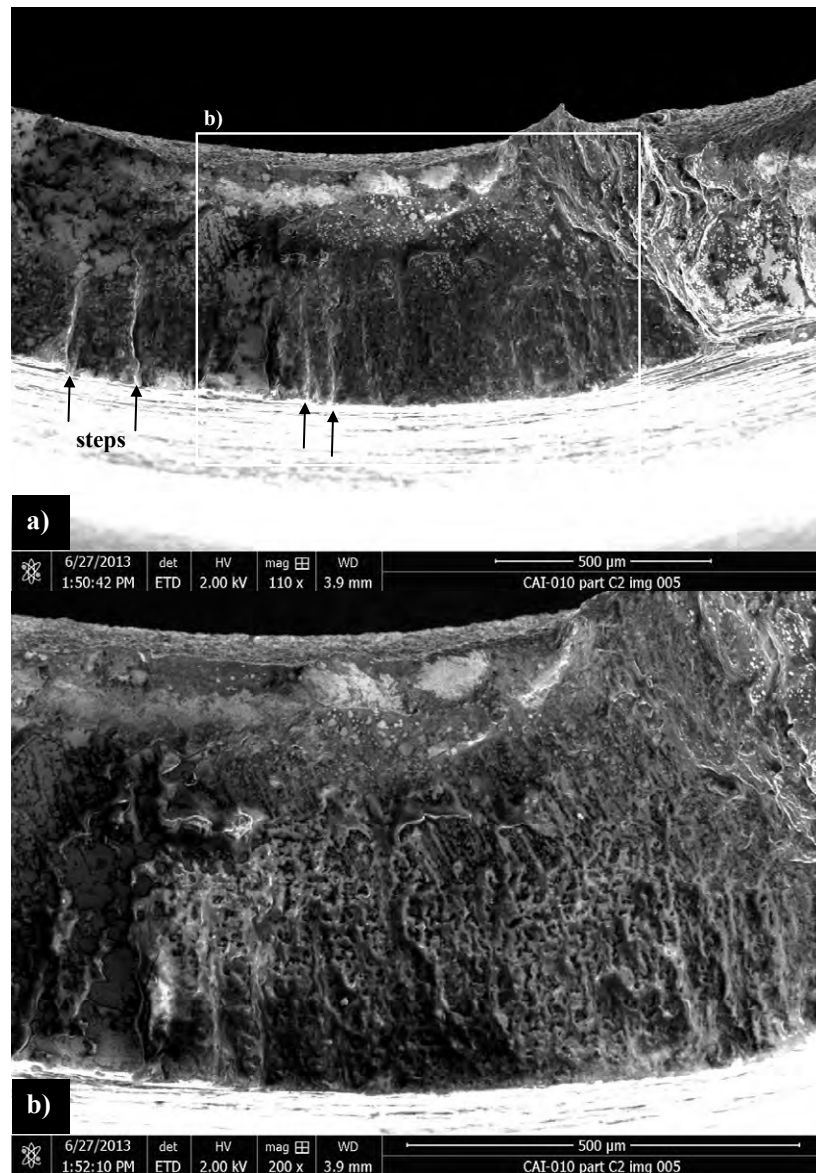
Fig. 16 SEM images showing microscopic steps and deposits on fracture surface {1,1} of the oil tube at a) 110x and b) 200x magnification (see Fig. 14 for location)

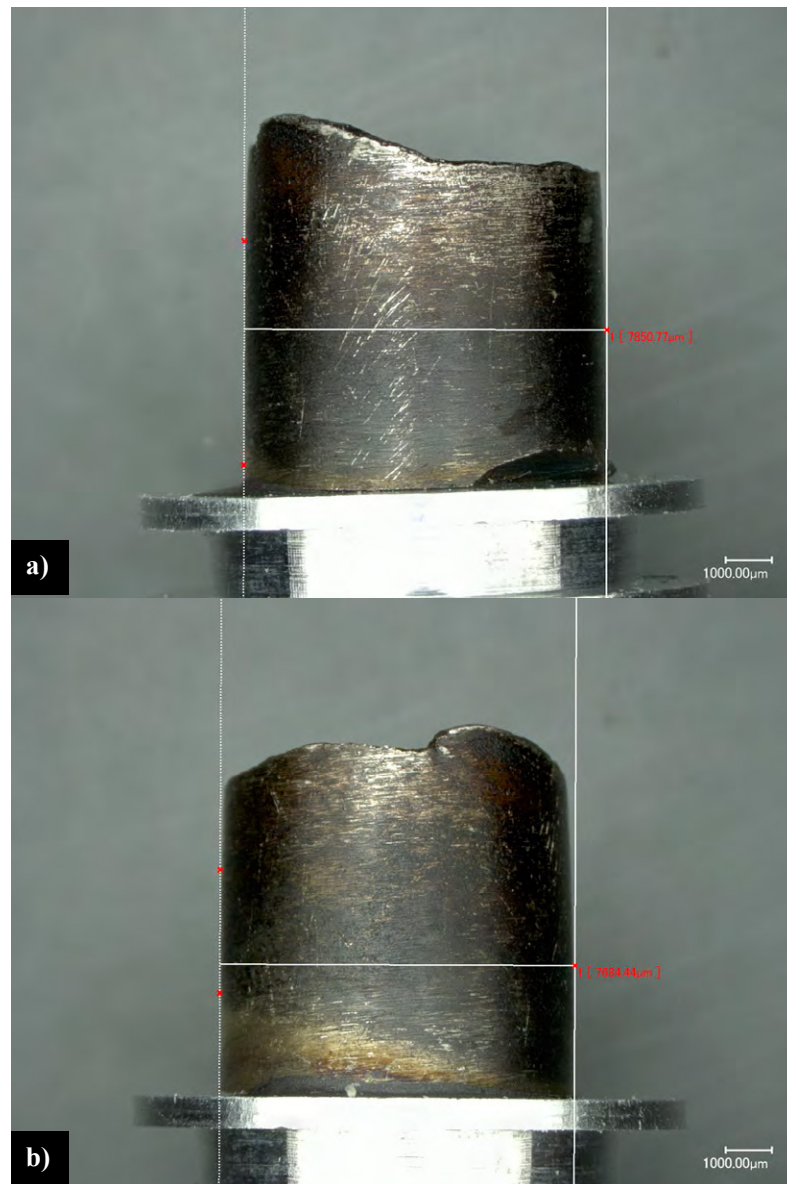
Fig. 21 Side view of the oil tube fracture surface {1,1} showing tube necking from the directions indicated in Fig. 15

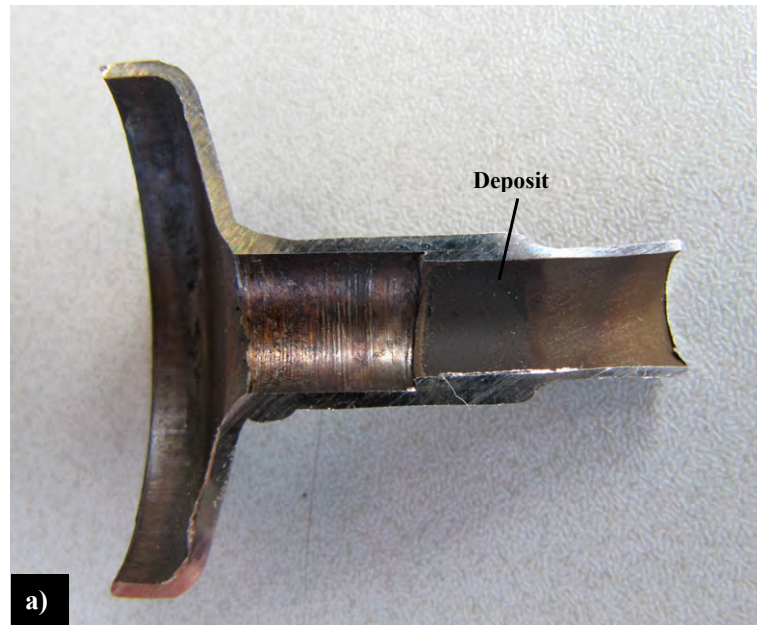
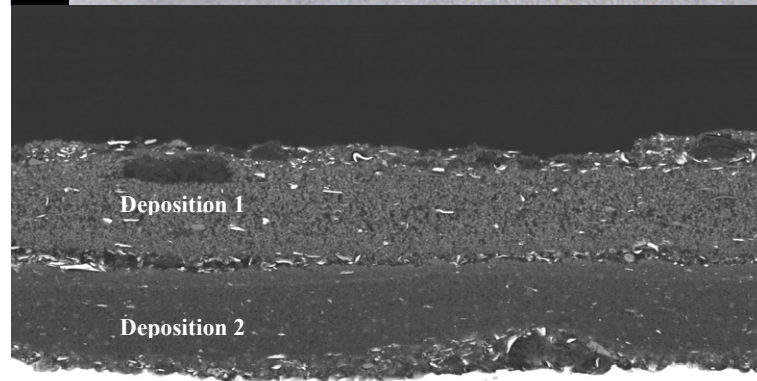
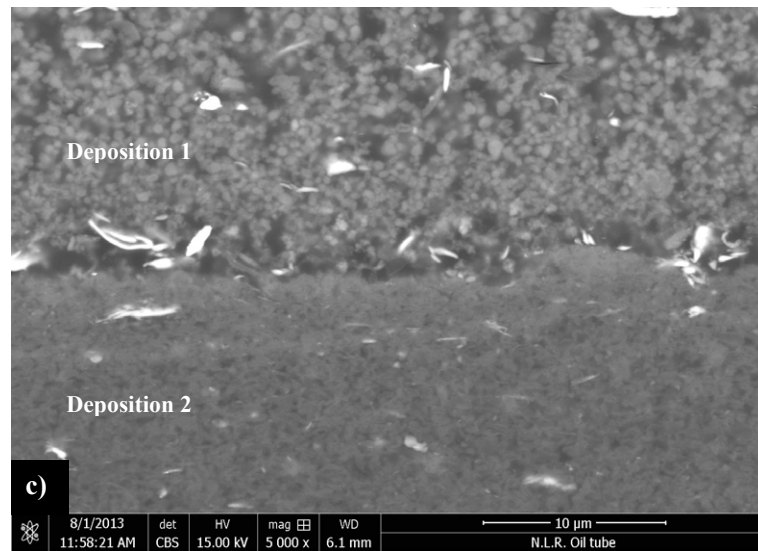
Fig. 23 a) Photograph of the remaining half of the disk and tube after sectioning.
SEM images of the cross-section of the deposition on the inside of the oil tube
at b) 1000x and c) 5000x magnification
