<b>AIRCRAFT ACCIDENT REPORT AND EXECUTIVE SUMMARY</b>
---

Reference:	CA18/2/3/9089	
Aircraft Registration	ZS-KFT	Date of Accident	8 October 2012		Time of Accident	1146Z
Type of Aircraft	Piper-34-200T		Type of Operation		Private (Part 91)	
Pilot-in-command Licence Type		Commercial	Age	20	Licence Valid	Yes
Pilot-in-command Flying Experience		Total Flying Hours	531,0		Hours on Type	66,9
Last point of departure		Runway 12 at Bethlehem Aerodrome (FABM), Free State province				
Next point of intended landing		Lanseria International Airport (FALA), Gauteng				
Location of the accident site with reference to easily defined geographical points (GPS readings if possible)						
Panorama residential area, Bethlehem at coordinates S28° 14' 55" E028° 20' 10" an elevation of 5 561ft AMSL.						
Meteorological Information		Wind: 090°/11kt; Visibility: 10 km; Temperature: 23 °C; 1/8 Cloud cover				
Number of people on board		1 + 0	No. of people injured	0	No. of people killed	0

<b>Probable Cause</b>						
<p>Unsuccessful forced landing as a result of engine power loss with failure to feather the engine Contributory factor: Fuel mismanagement</p>						
SRP Date		14 Nov 2017		Release Date		20 Februa

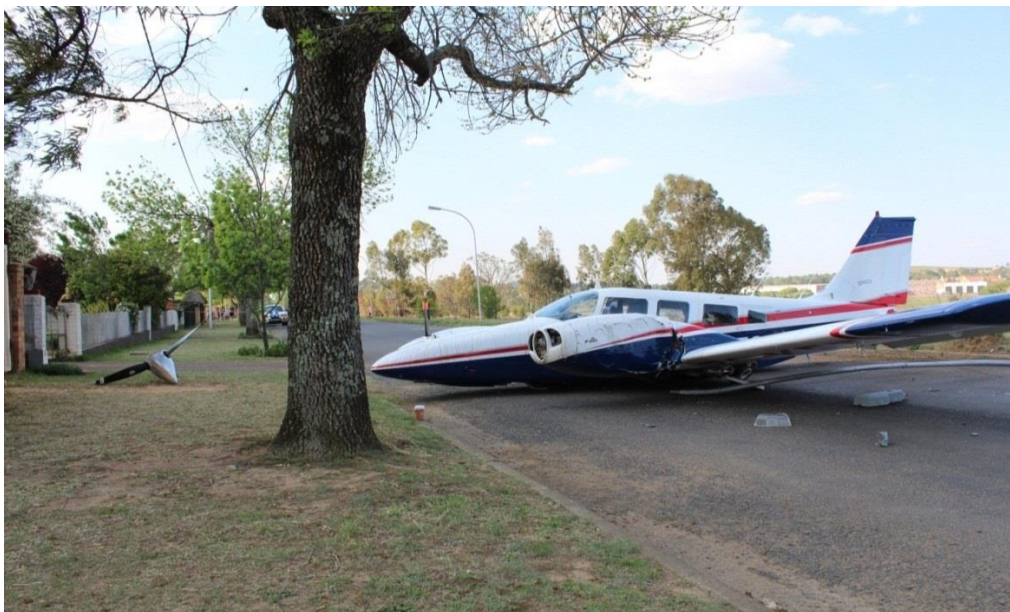
1.1.3 The pilot was not injured in the accident sequence. The main landing gear and the nose landing gear were substantially damaged during the forced landing. The left hand engine propeller was substantially damaged during the impact with the street light pole

FIGURE 1: ZS-KFT ON ROAD WITH L/H ENGINE PROP FAILED ON IMPACT WITH STREET POLE LIGHT

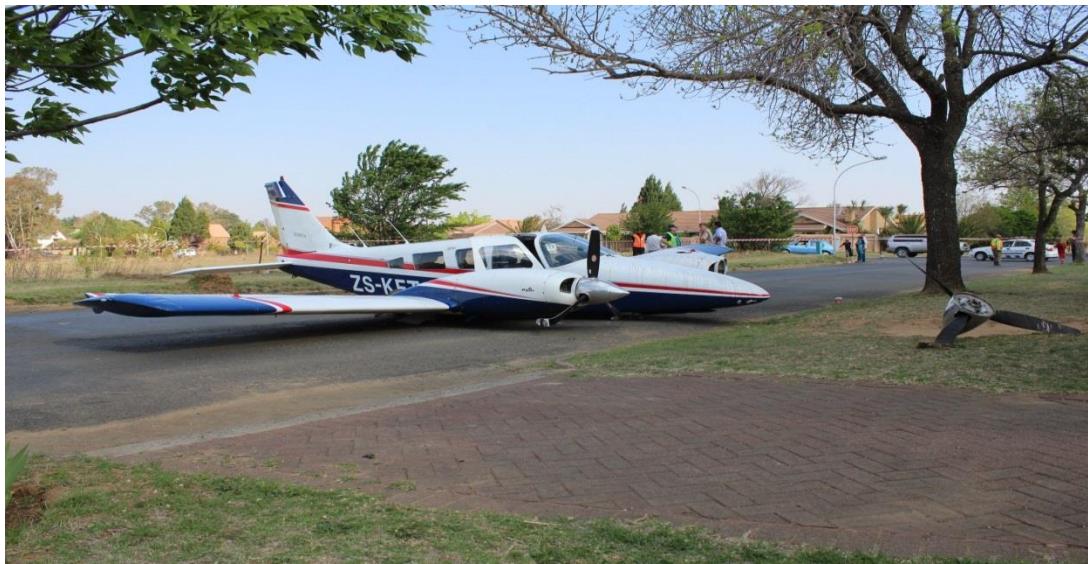
- 1.12.1 The aircraft touched down on an open field, west of the aerodrome and rolled for approximately 400 metres during the forced landing when it rolled through a ditch and collided with the fence and a street light pole. The aircraft came to rest facing in a westerly direction on the road in the Panorama residential area.
- 1.12.2 The left wing and the left hand engine propeller sustained damage when it collided with the streetlight. The propeller fitted to the left hand engine separated from the engine during the impact sequence and was located 4 m in front of the main wreckage. (see Figure 2).

**Figure 2:** Shows the aircraft after it came to rest on the street

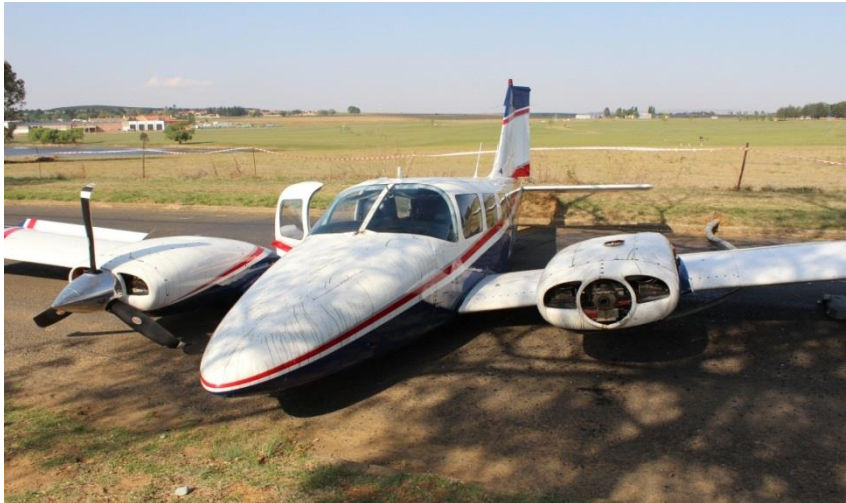
1.12.3 The right-hand propeller damage was consistent with a low power setting from the operative engine as shown below:

**Figure 3:** Damage to the left and right hand propellers

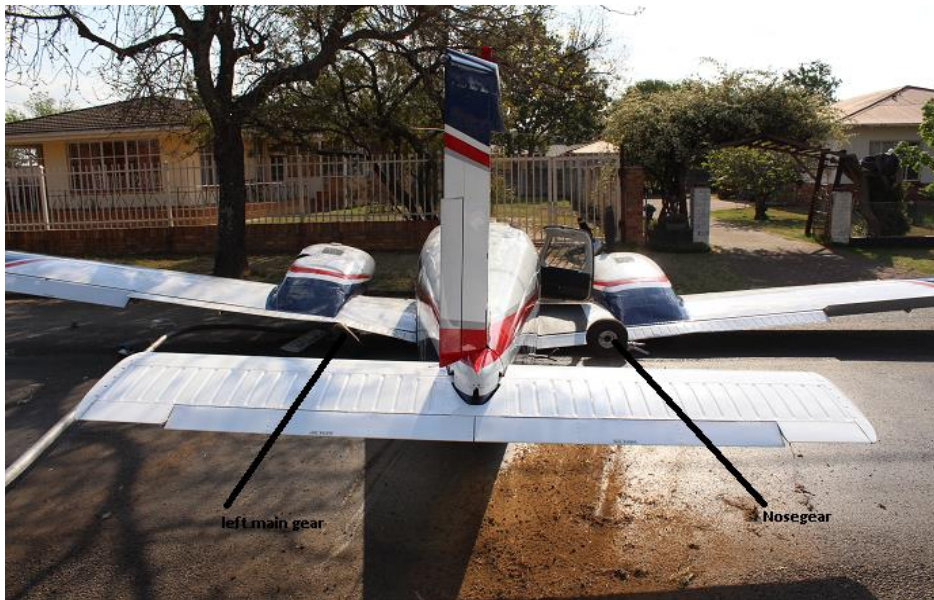
1.12.4 The nosegear broke-off and the main gear collapsed during the forced landing

**Figure 4: left main landing gear & nose landing gear damage**

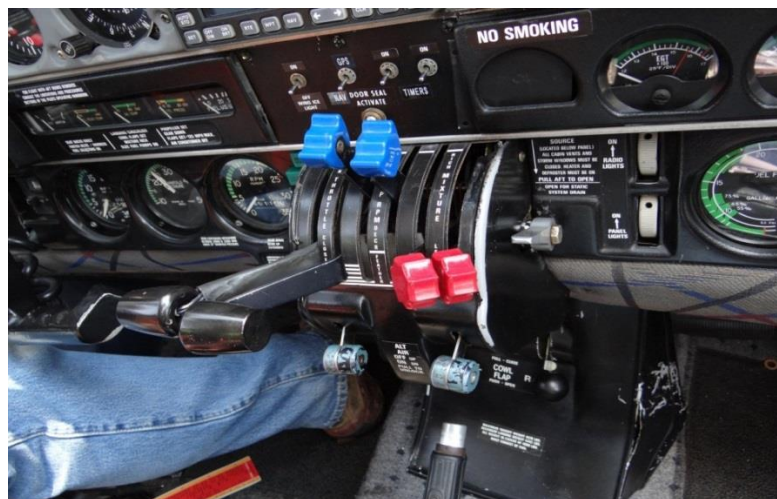
1.12.5 During the on-site inspection of the cockpit, the propeller pitch levers were found to be full forward. This is inconsistent with the settings of a feathered propeller. It was therefore concluded that the left propeller had not been feathered during the single-engine operation and the pilot could not explain why it was so. (See Figure 5 and refer to the emergency checklist, Appendix A: 'The feathering procedure'.)

**Figure 5: Propeller pitch levers on full forward**

The pilot failed to employ a proper technique to maximise the performance of the aircraft during single-engine operation by not feathering the left-hand propeller as stipulated in the pilot's operating handbook. Feathering the left propeller would have allowed the aircraft to maintain altitude with less drag and the pilot would eventually have been able to land back on the runway as he had intended doing.

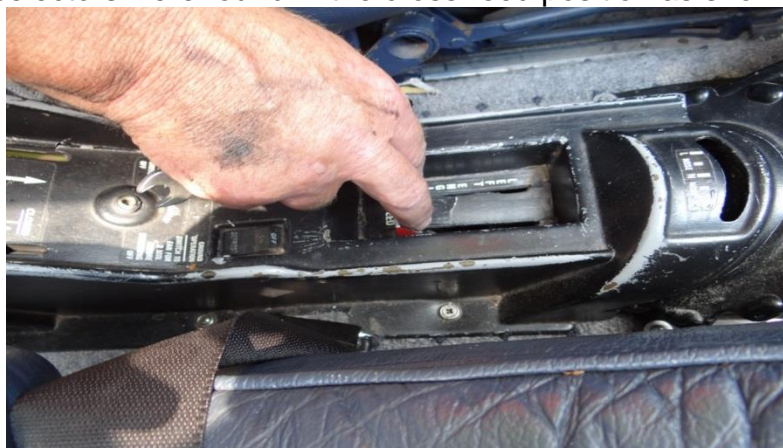
1.12.6 Both fuel selectors were found in the cross-feed position as shown in Figure 6.

**Figure 6: shows both fuel selectors on the cross-feed position**

The possibility of a power loss due to fuel selector mismanagement is considered. The fact that the fuel selectors were found in the cross-feed position, suggested that the pilot omitted to select the fuel selectors from the cross-feed to the "on" position and took off with the fuel selected in this configuration that was prohibited in accordance with the flight manual. This could also have resulted in a vapour lock in the left hand engine.
