**FINAL**  
KNKT.12.10.21.04

# KOMITE NASIONAL KESELAMATAN TRANSPORTASI

Aircraft Serious Incident Investigation Report

**PT. Sriwijaya Air  
Boeing 737-300; PK-CJT  
Tabing Airfield, Padang,  
West Sumatra  
Republic of Indonesia**

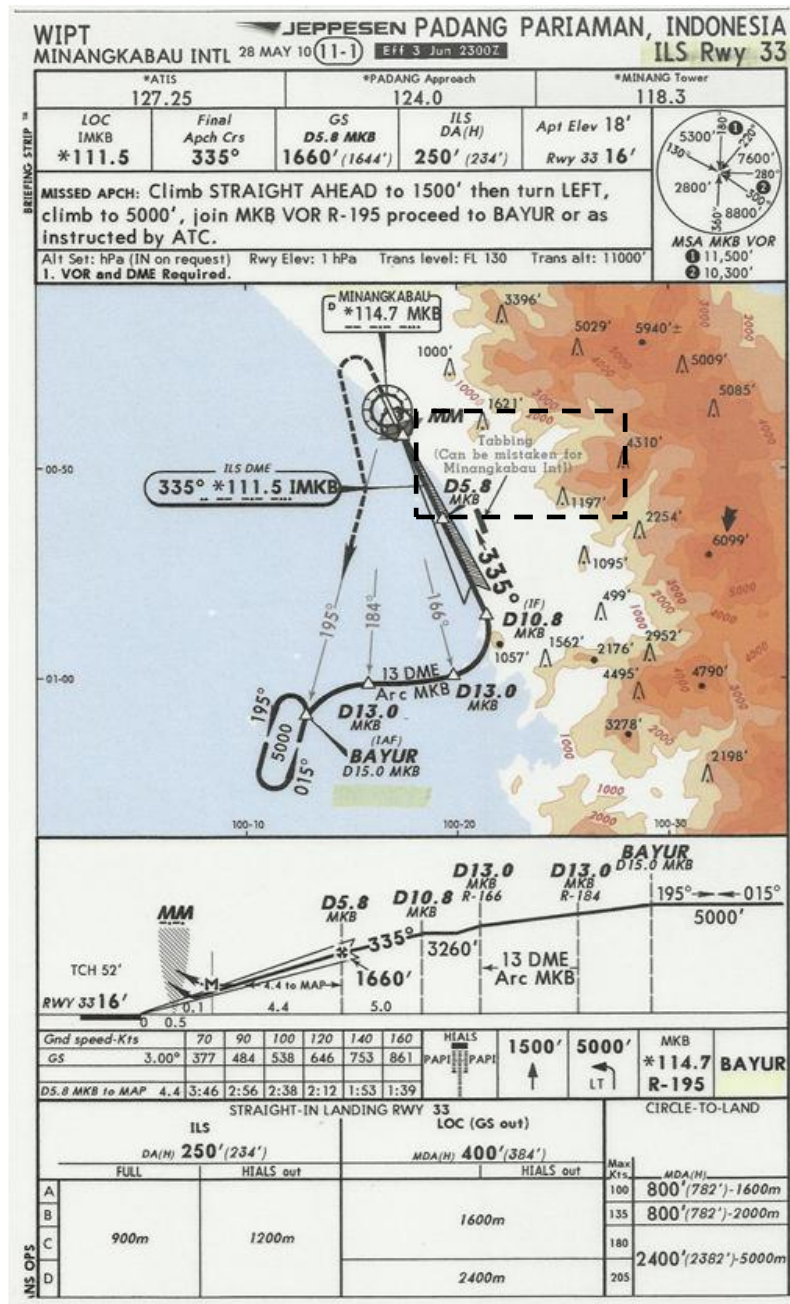
Figure 1: ILS approach chart procedure runway 33 Minangkabau Airport

The existing approach procedure of the ILS runway 33 Minangkabau Airport showed the localizer course was 335°, the Decision Altitude (DA) was 250 feet, the glide slope of 3° and vertical speed for aircraft category C<sup>8</sup> was 753 feet/minute. The chart also contained information: *Tabbing (can be mistaken for the Minangkabau Intl)*.

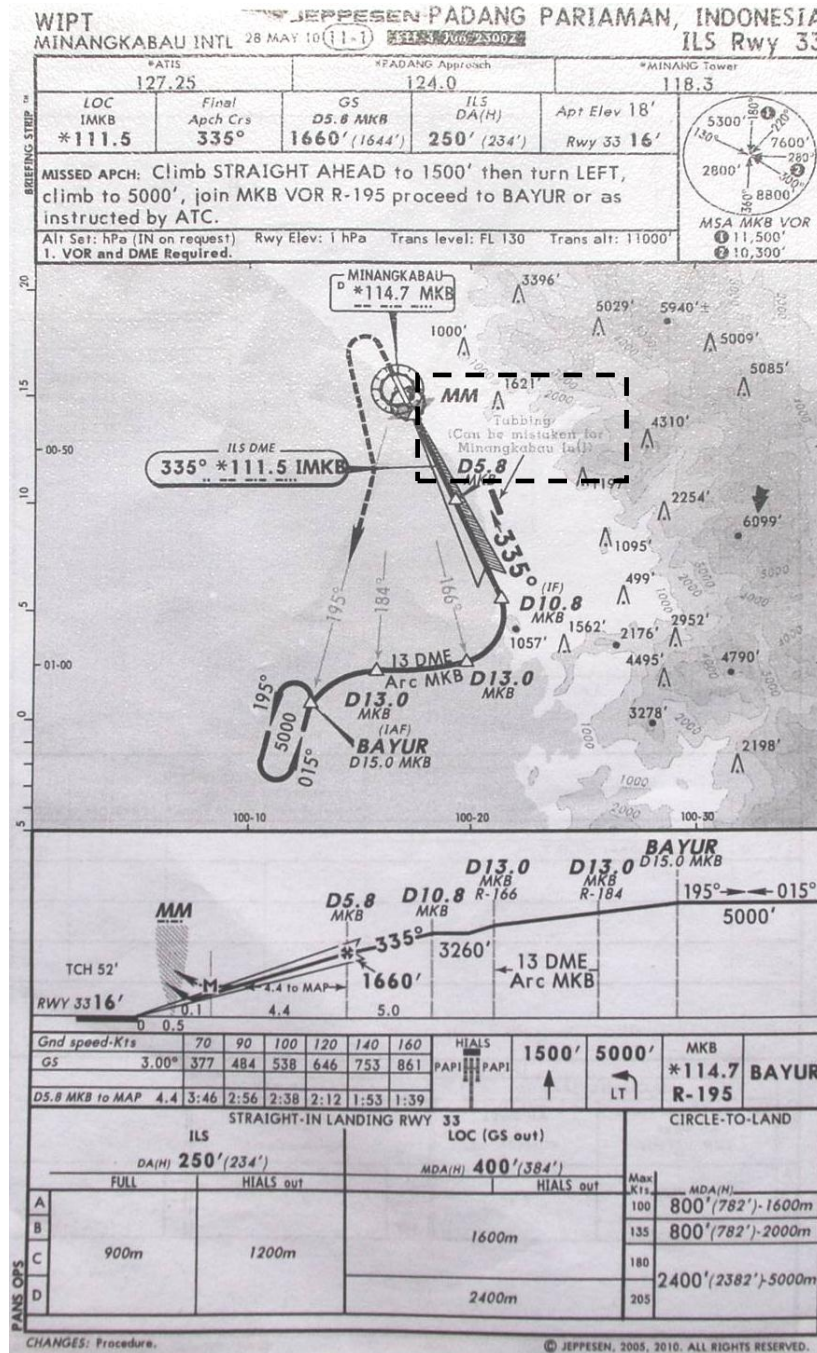
Figure 2: The photocopy of ILS approach chart procedure used by the pilot

During the flight, the pilots used a black and white photocopy of instrument approach charts procedure. The information of: *Tabbing (can be mistaken for the Minangkabau Intl)*, as shown on dash box figure 2, was not clearly readable.

- The unclear significant information in the copy (black and white) of the ILS approach chart might have missed by the pilot and might reduce the pilot awareness to the adjacent airport with similar runway direction and dimension.
- The previous experience of false VOR might have made the approach was continued in an un-stabilized approach condition.
- The information of incorrect runway was not provided during the abnormal approach as it was not observed.

To ensure additional information or caution of existing hazard is informed on published Aeronautical Information Publication, including on Instrument Approach Chart.

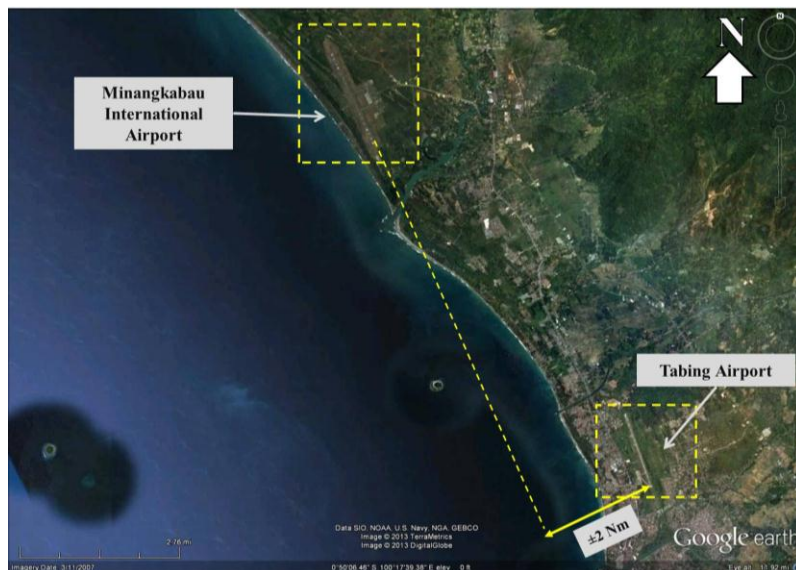
**Figure 3: The airports location**

The Tabing Airfield located 6 Nm southeast of Minangkabau airport at approximately 2 Nm right side of the centerline extension of runway 33 Minangkabau.

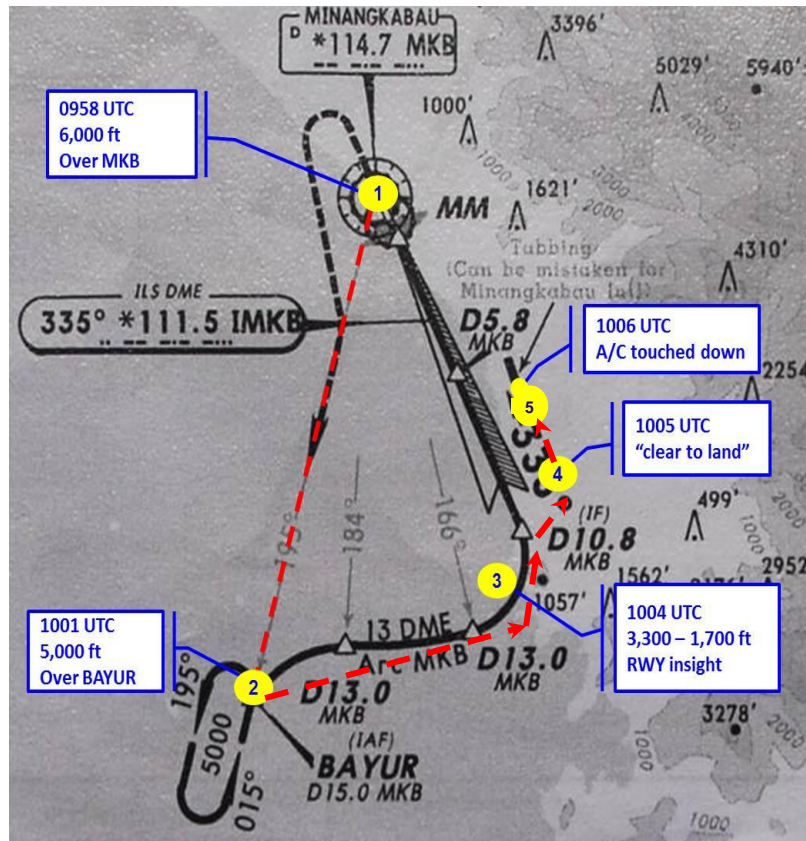
Figure 4: Predicted flight path

3. 1004 UTC, the pilot reported to Minang approach that the runway was in sight. The runway was approximately 10° to the right from the localizer and visually above the glide. The PIC assumed that the ILS runway 33 was error, and decided to continue visual approach. The pilot then selected the vertical speed to 1,700 feet/minutes, disengaged the autopilot and performed a side slip to align with the runway.
4. At 1005 UTC, the controller issued landing clearance.
5. At 1006 UTC, aircraft touched down at Tabing Airfield.

Referring to the information above, the predicted flight path superimposed to the available instrument chart showed in the following figure. The numbers (yellow circles) indicated sequence of event as described above and the red dash lines indicated the predicted flight path.
