AIRCRAFT ACCIDENT REPORT AND EXECUTIVE SUMMARY

Reference:	CA18/2/3/9106	
Aircraft Registration	ZU-MDI	Date of Accident	21 November 2012		Time of Accident	1530Z
Type of Aircraft	Falcon 402		Type of Operation		Private	
Pilot-in-command Licence Type		Private Aeroplane	Age	44	Licence Valid	Yes
Pilot-in-command Flying Experience		Total Flying Hours	950		Hours on Type	30
Last point of departure		Lanseria Aerodrome (FALA)				
Next point of intended landing		Wonderboom Aerodrome (FAWB)				
Location of the accident site with reference to easily defined geographical points (GPS readings if possible)						
Right hand side of runway 29 at Wonderboom						
Meteorological Information		Surface Wind: Westerly, 8kts. Visibility: CAVOK. Temp: 25°C.				
Number of people on board	1 + 2	No. of people injured	0	No. of people killed	0	
Synopsis						
<p>The pilot accompanied by two passengers took off from Lanseria Aerodrome to Wonderboom Aerodrome (FAWB) for an Approved Person to conduct an annual inspection. The right hand undercarriage failed to extend during landing at FAWB. It was revealed that the rod end failed due to prior undetected damage, when the gear was selected "down" for the landing.</p>

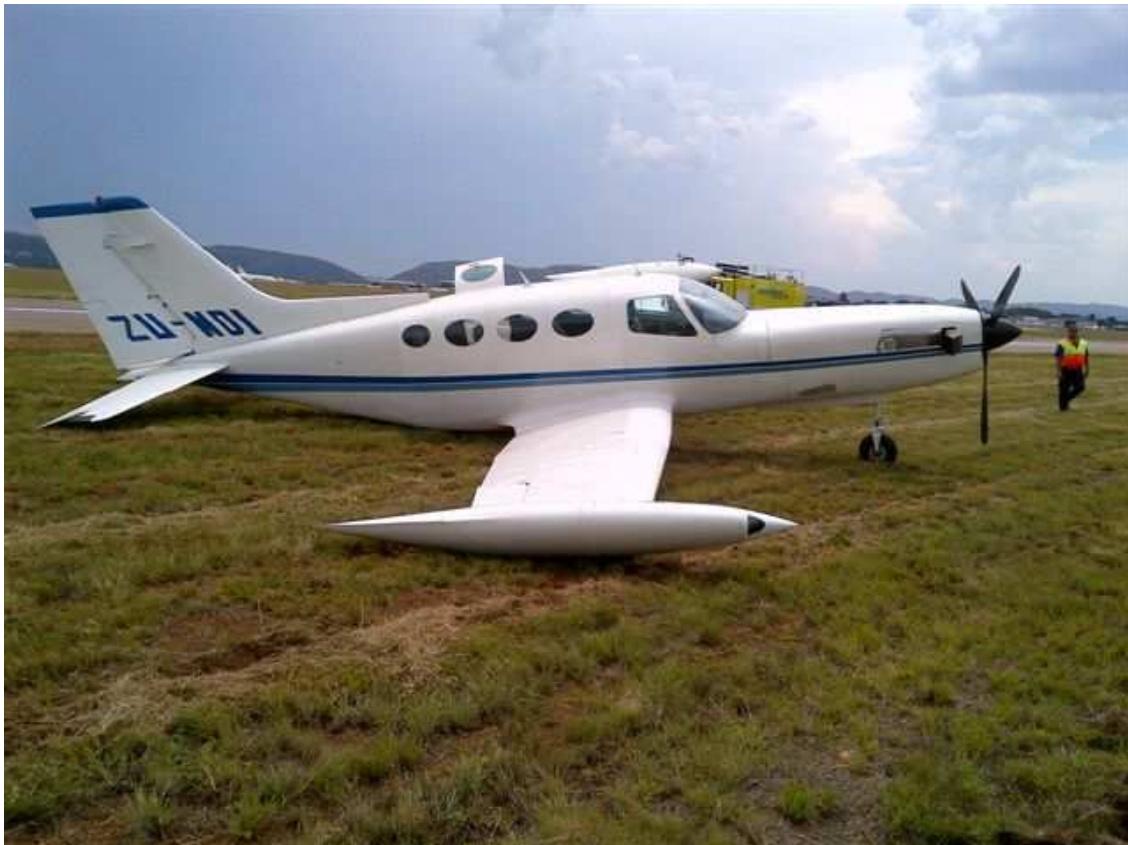
1.1.3 The aircraft sustained damages to the right hand undercarriage, flap and the left wing tip.

1.12.1 During the flight while in the circuit the pilot noticed the red light illumination which indicates undercarriage unlocked, he elected to extend them manually. During touch down the aircraft veered to the right hand side of the runway and the right hand main undercarriage collapsed.

Figure 1: Wreckage of the aircraft

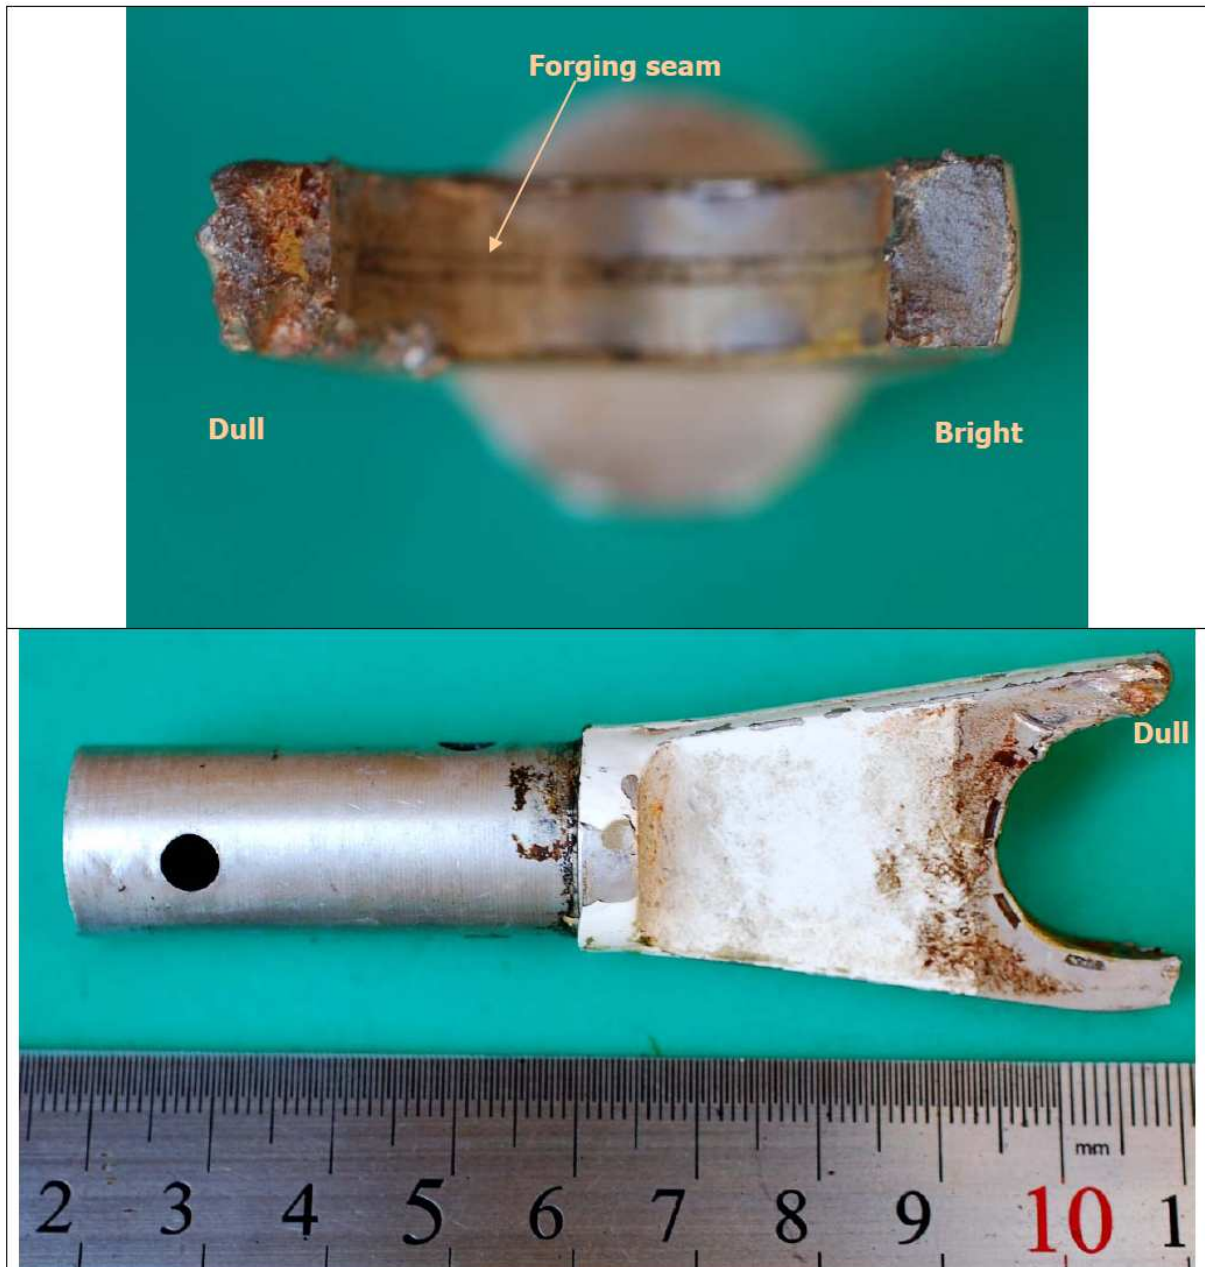
One failed tie-end remnant of the Cessna 402 landing gear, containing two fracture surfaces (only the one side of each fracture) was received (see Figure 1). The opposing fracture surfaces (the other part of the tie-end) were not provided. The two fracture surfaces are referred to as bright and dull as indicated in Figure 1.

From the visual examination of the failed component it was apparent that the appearance of the two fracture surfaces was significantly different (Figure 1). The one fracture surface appeared dull and red-brownish whilst the other was bright and grey-ish in colour. Close-ups of the respective fracture surfaces as viewed during stereo microscopy are provided in Figure 3 and Figure 4 for respectively the dull and bright surfaces. The dull fracture surface was soiled with some contaminant in the form of a yellowish residue (bottom-middle section) as shown in Figure 3. The edged was significantly tapered and showed clear evidence of mechanical rubbing damage (see Figure 5 for a side view of the same section). The fracture surface of the bright surface (Figure 4) was more rectangular and grey-ish, reminiscent of an unsullied fracture surface. At the top end of the fracture surface (Figure 4) the coating layer is clearly evident.

Figure 1: As-received condition of the landing gear tie end remnant with two single sided fracture surfaces respectively referred to as dull and bright.

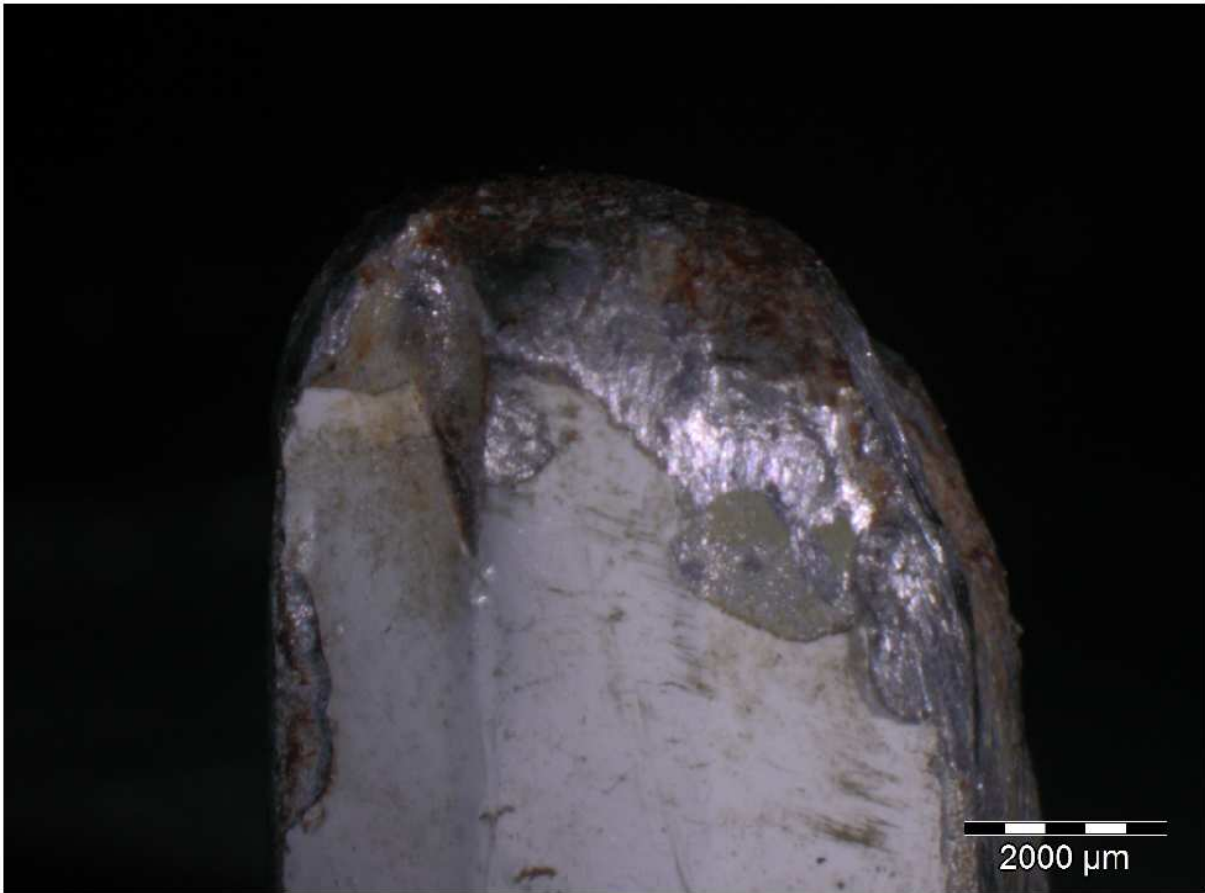
Figure 5: Side view of dull fracture end, showing additional mechanical damage to the side walls.

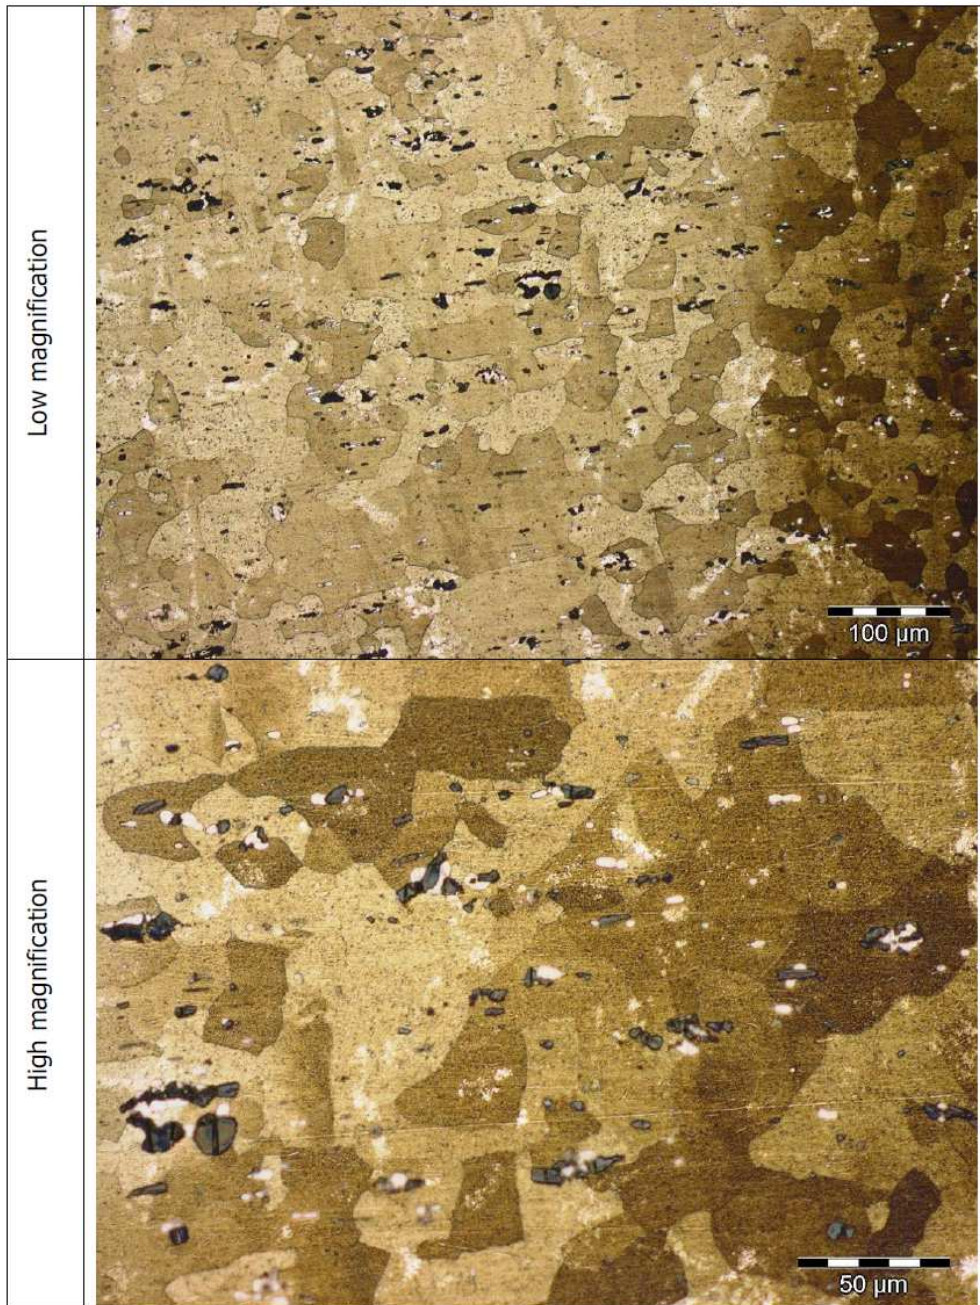
The microstructure of the failed component showed that a significant volume of precipitates were present (as expected for the type of alloy). The microstructure at various magnifications is provided in Figure 6. Significant plastic deformation was also identified at the fracture end. No Anomalies were observed.

Figure 6: Microstructure of the dull fracture cross-section at various magnifications after etching with Keller's reagent.

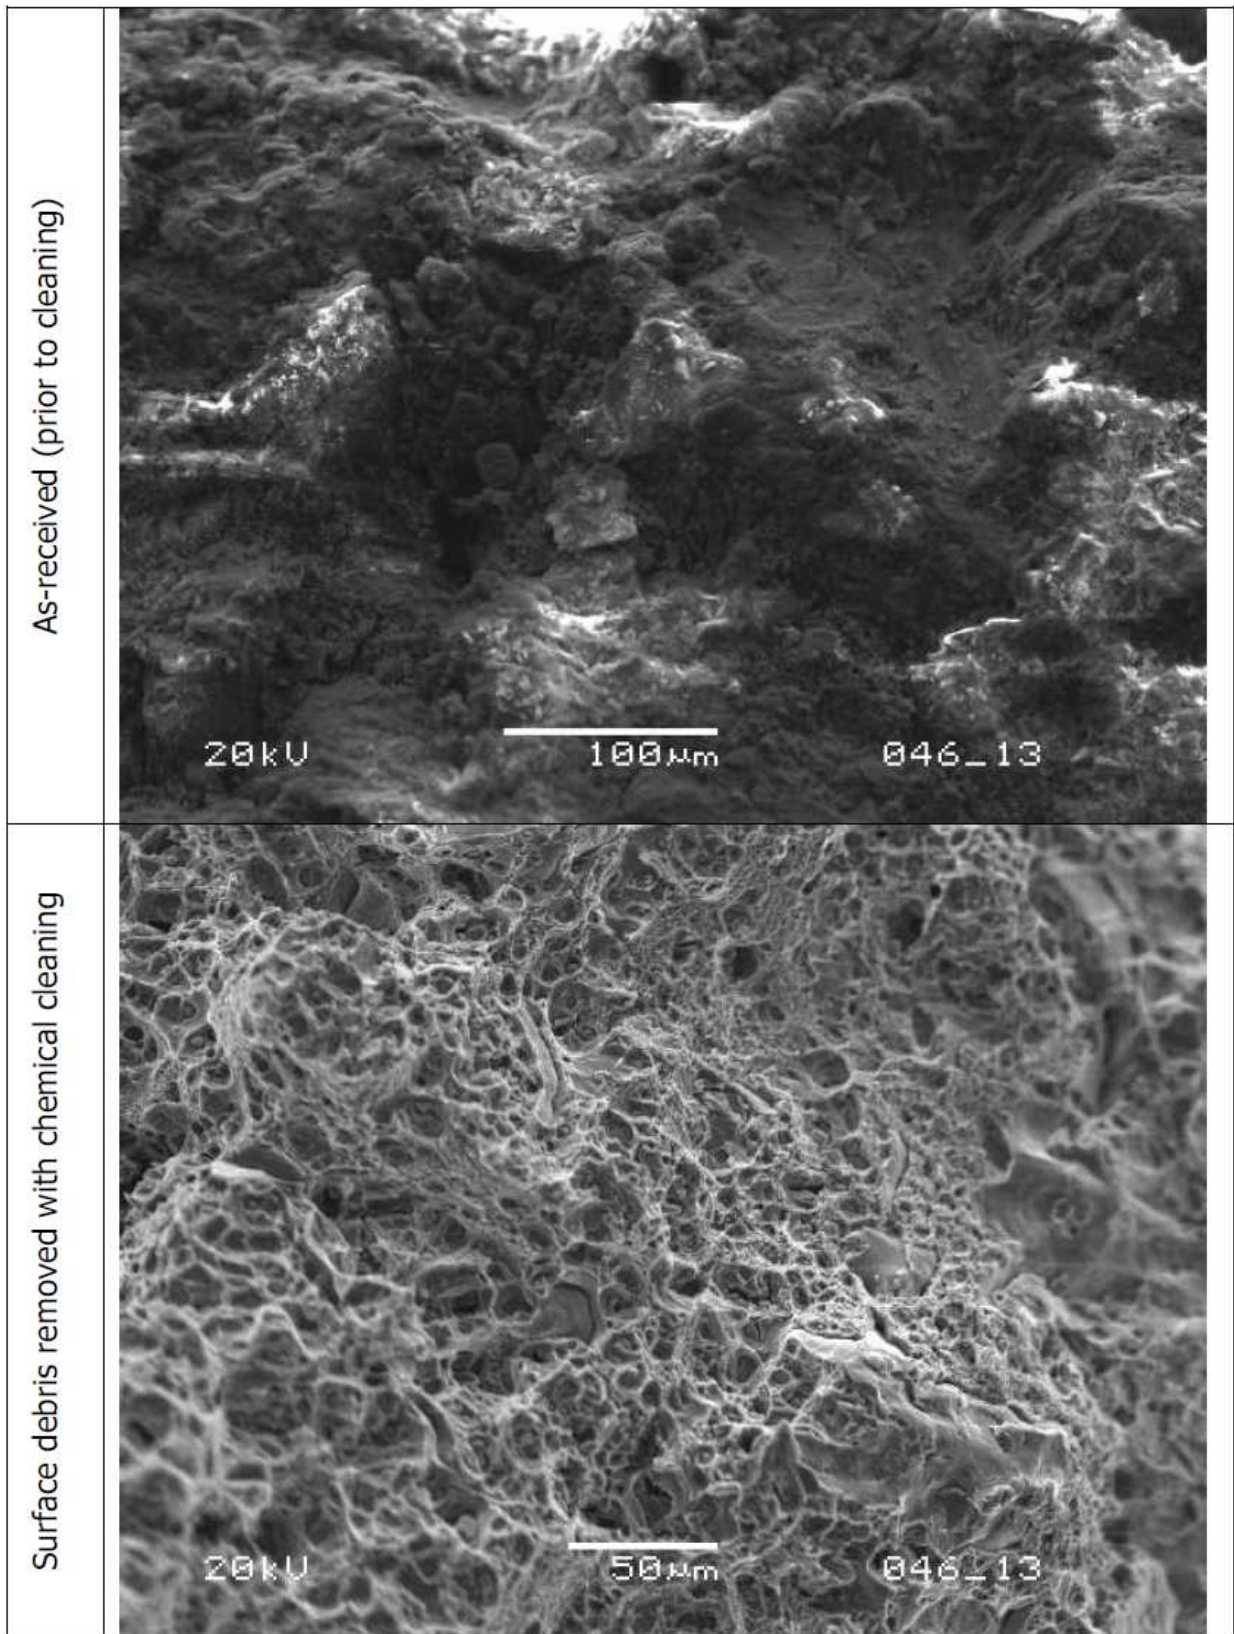
Evaluation of the dull fracture surface, initially in the as-received condition (to aid surface analyses) did not yield any failure features. The Fracture surface was significantly covered with debris or contamination (as shown in the top section of Figure 7) which made it impossible to distil any details of the fracture mode. Subsequent to performing various surface analyses in order to characterise the fracture surface and identify the debris, the sample was chemically cleaned in a citric acid solution in an ultrasonic bath. Following the cleaning the sample was again assessed by means of Scanning Electron Microscopy, and a section (predominately coinciding with the area where the yellow debris covered the surface –see Figure 3), void coalescence and ductile tearing was observed (bottom image of Figure 7). Other sections of the cleaned surface was smooth and also showed some rubbing and smearing damage similar to that observed in Figure 8. The remainder of the fracture surface (apart from the ductile overload section) was thus too damaged to allow proper characterisation of the original failure surface.

A portion of the dull fracture surface did contain evidence of ductile overload (i.e. excessive loading or force) (Figure 7) however, this could in theory be the portion that was failed in overload after some initial fatigue crack propagation that severed the remainder of the fracture surface. However, no failure characteristics typical of fatigue degradation were observed. The rubbing, smearing and fracture surface degradation makes it impossible to establish what the original fracture surface characteristics are. It is also plausible that the gear mechanism was impinged during previous operation or damaged or crushed during repair or inspection work, which could have caused the mechanical degradation as noted in Figure 8 too. Another alternative is that this mechanical damage was incurred as subsequent damage during the landing incident. However the last statement is in contradiction with the well preserved bright fracture surface of the same component. Perhaps photograph(s) and/or reconstruction of the scene of the landing incident can clarify whether the alternative scenario is possible or not. Moreover, comparing the mating fracture surfaces of the other portion of the tie-end (not received) would facilitate a check for consistency of the findings.

Figure 7: Various regions of the dull fracture surface before and after cleaning.

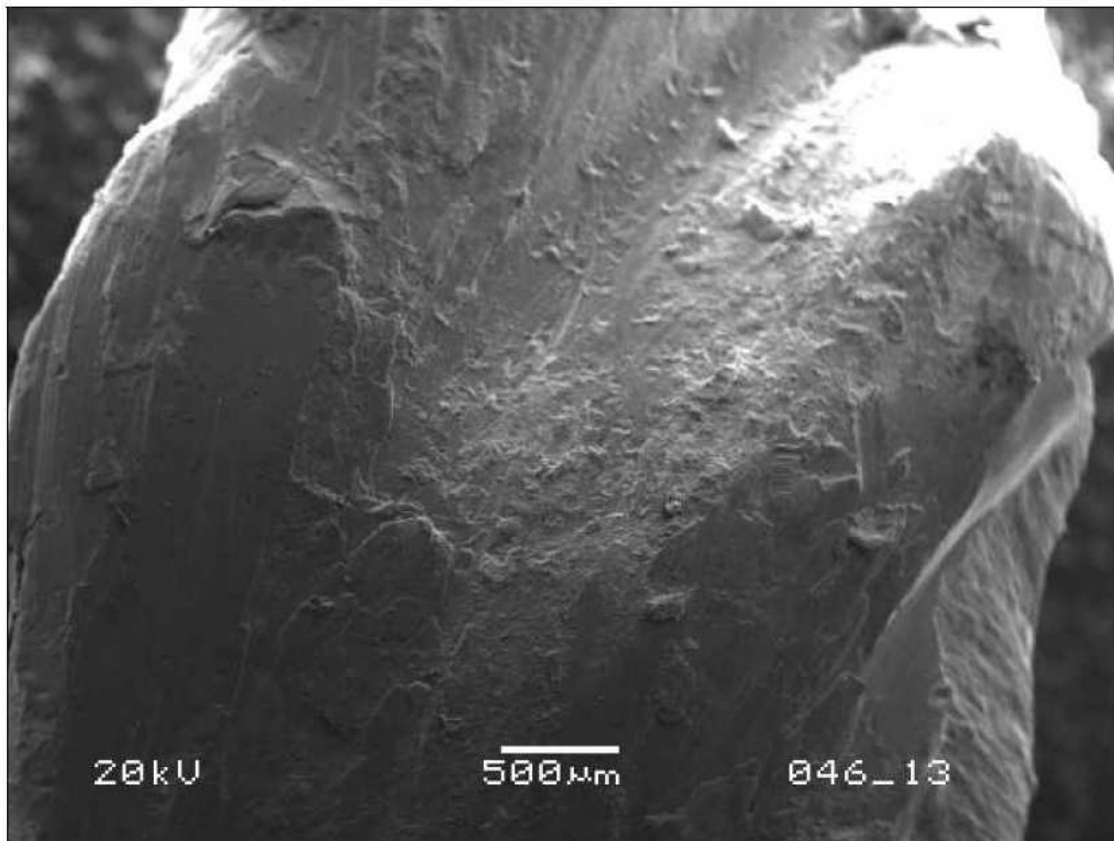
Figure 8: Side view of dull fracture end showing significant rubbing and forging damage.

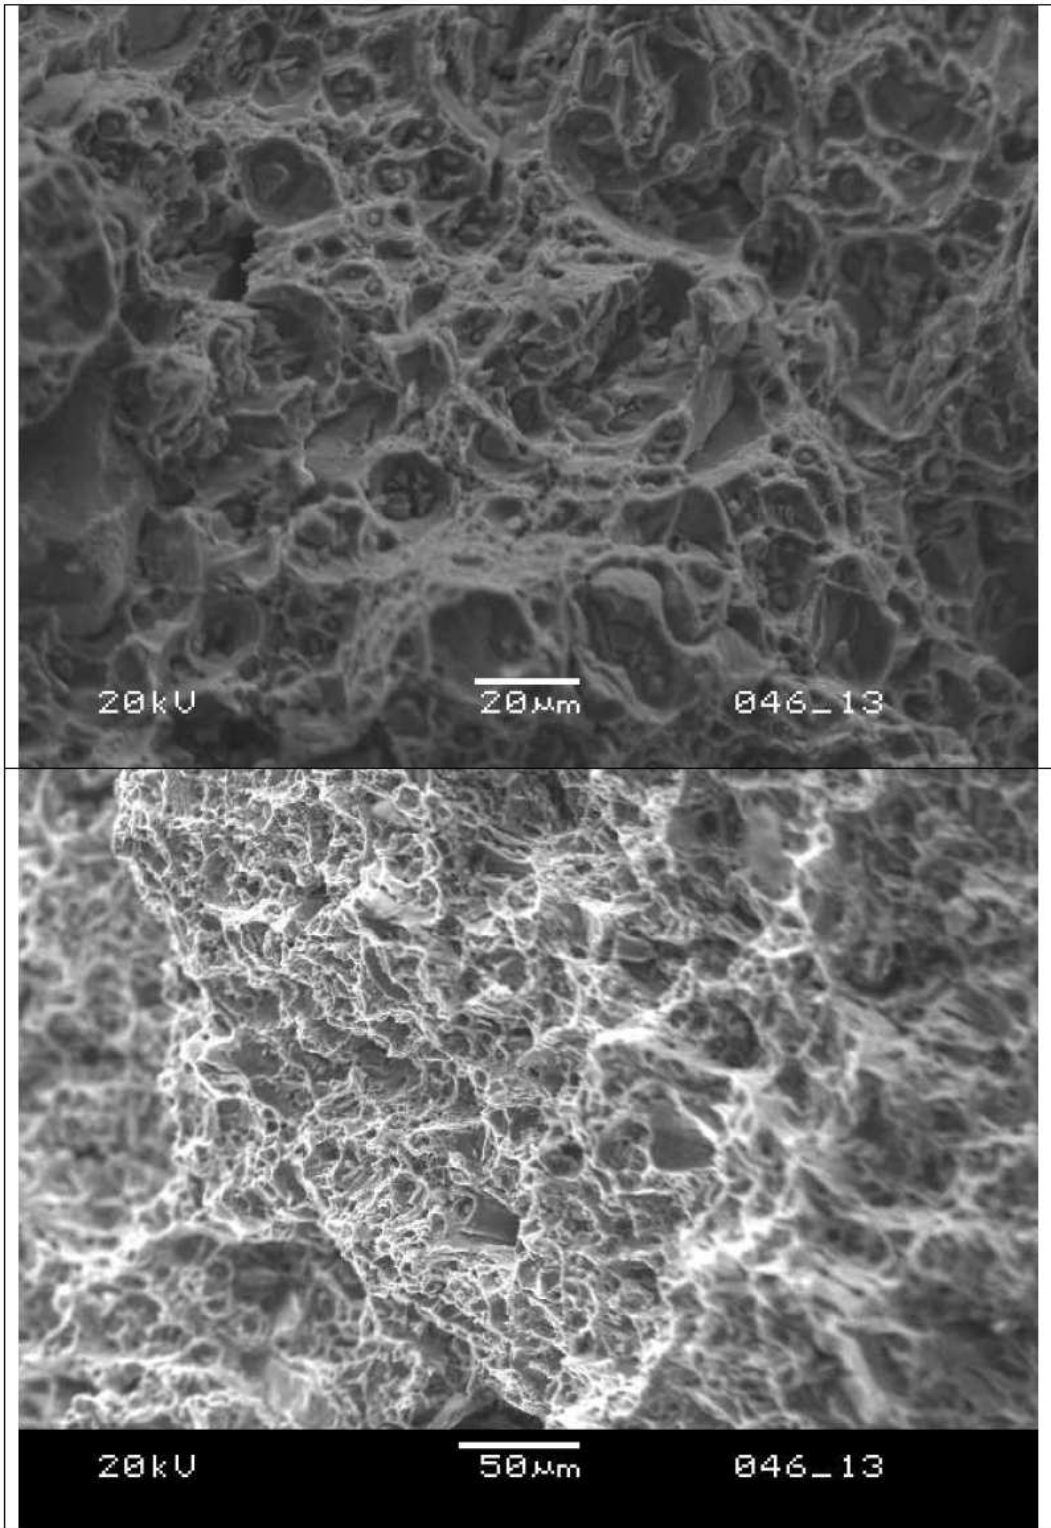
The bright fracture surface was also examined and most of the fracture surface was characterised by micro void coalescence and ductile overload failure (Figure 9). In some instances the precipitates could be discerned within the ductile failed cups. It was not necessary to clean this surface since, in the as-received condition, the characterisation could easily be performed.

The dull fracture surface failed in overload as attested by the micro void coalescence and cup and dimple fracture surface (Figure 9).

Figure 9: Various regions of the fracture surface of the bright fracture surface, as-received.
