AIRCRAFT ACCIDENT REPORT AND EXECUTIVE SUMMARY

Reference:	CA18/2/3/9111	
Aircraft Registration	ZU-OIL	Date of Accident	28 November 2012		Time of Accident	0700Z
Type of Aircraft	Jabiru SP 2000		Type of Operation		Private	
Pilot-in-command Licence Type		Private	Age	22	Licence Valid	Yes
Pilot-in-command Flying Experience		Total Flying Hours	107.7		Hours on Type	56.3
Last point of departure		Rustenburg Aerodrome (FARG) North-west Province				
Next point of intended landing		Springs Aerodrome (FASI) Gauteng				
Location of the accident site with reference to easily defined geographical points (GPS readings if possible)						
Runway 03 at Springs Aerodrome at GPS co-ordinates S26°1500 E028°2400. Cloud CAVOK						
Meteorological Information		The weather was fine: Temperature 18°C; Wind 060/3-5kt				
Number of people on board	1 + 0	No. of people injured	0	No. of people killed	0	
Synopsis						
<p>The pilot who was the sole occupant on board the aircraft, departed from Rustenburg Aerodrome (FARG) to Springs Aerodrome (FASI) on a private flight.</p> <p>The pilot stated that the flight from Rustenburg to Springs with a flight time of approximately 1 hour was uneventful. However, as he reduce

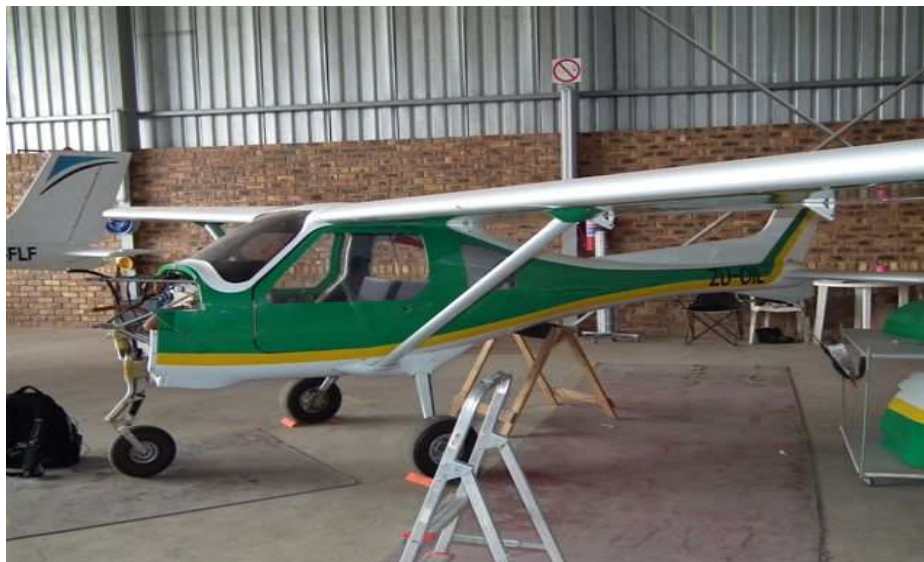
Figure 1: Shows the aircraft recovered at Springs aerodrome.

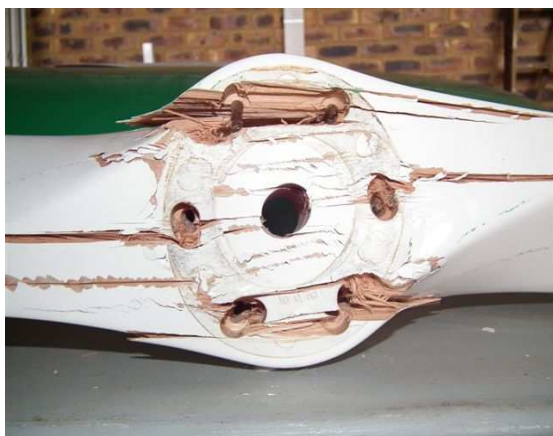
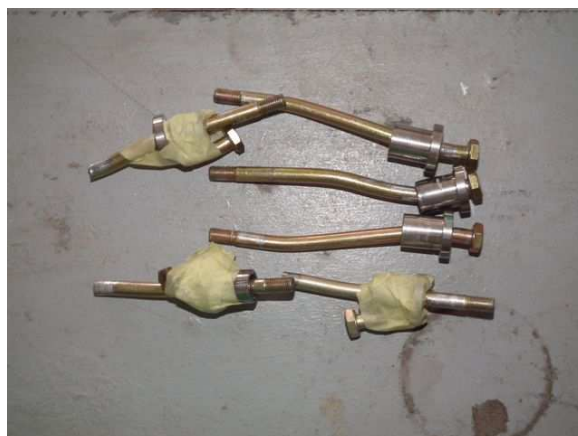
Figure No 2 & No 3: Shows damage to the propeller and the bolts bent during sudden stoppage of the engine in flight.

- The propeller blades were found substantially damaged when the engine failed and came to an abrupt stop during flight. Unable to rotate the engine in a clockwise direction.

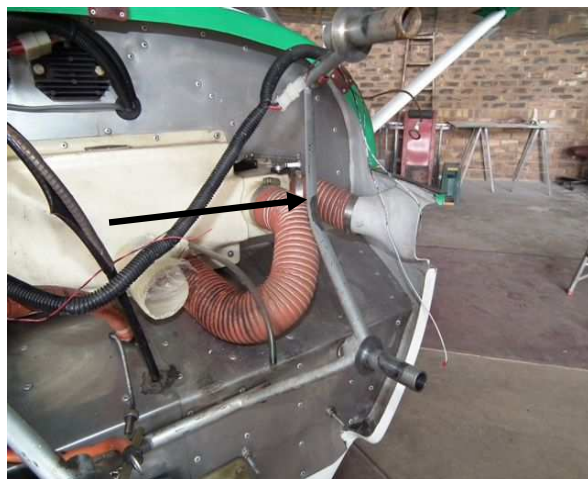
1.3.1 The engine was subjected to an in-flight contained engine failure. As a result, the engine mounting cradle that supports the engine was distorted, and the bulkhead behind the engine dented. The propeller was also substantially damaged when the engine suddenly stopped due to a mechanical failure.

Figure 4: Shows the engine cradle bent.

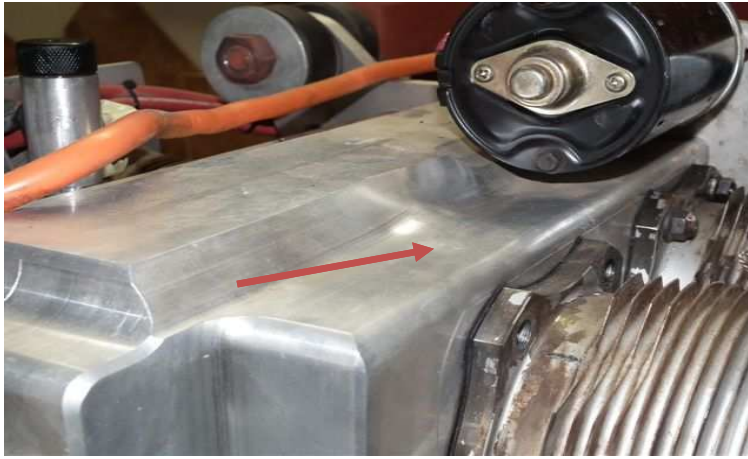
- No. 2 cylinder gudgeon pin showed evidence of migrating forward out of the piston attachment hole as strike marks from the gudgeon pin were evident on the forward side of the crankcase. One gudgeon pin retainer wire circlip was located in the engine sump.

Figure 5: Shows the hump caused when No. 2 cylinder piston and associate parts failed.

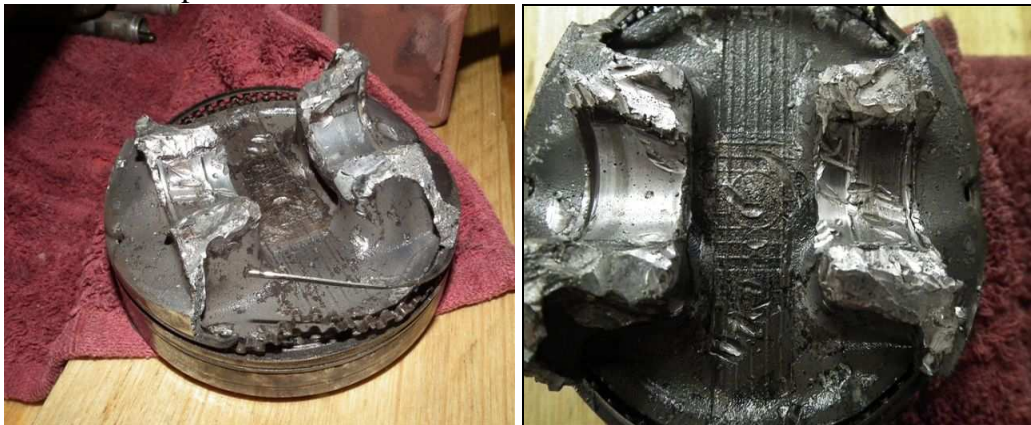
- No. 2 cylinder head was removed and evidence found that the inlet valve came into contact with the piston crown and subsequently severed from the connecting rod at the gudgeon pin holes. The piston crown showed evidence of the inlet valve contacting the piston top in a rotating manner after the piston crown severed from the connecting rod. The lower part of the piston was completely broken as well as damage to the oil rings and grooves.

Figure 6 and 7: Shows damage caused No 2 engine piston.

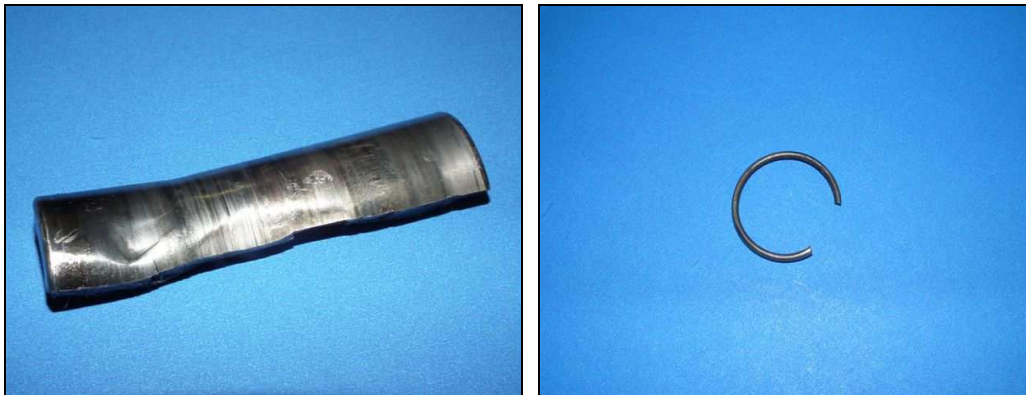
- The connecting rod was found bent into a “U” shape at the upper end of the left hand side of the crankcase. 3 Pieces of the gudgeon pin was also located in the engine sump and the pin broken lengthwise.

- Conclusion: Piston No. 2 forward gudgeon pin wire retainer circlip became adrift causing the gudgeon pin to migrate forward out of position and subsequently caused substantial damage to the engine and the engine to stop abruptly. The sudden stop caused damage to the propeller as well as distortion of the engine cradle and engine mounting.

Figure 8 & 9 :Shows piece of gudgeon pin and gudgeon pin retainer circlip
