Aircraft Serious Incident Report

In-Flight Engine Shutdown

United Airlines Flight 890

B777-200, N206UA

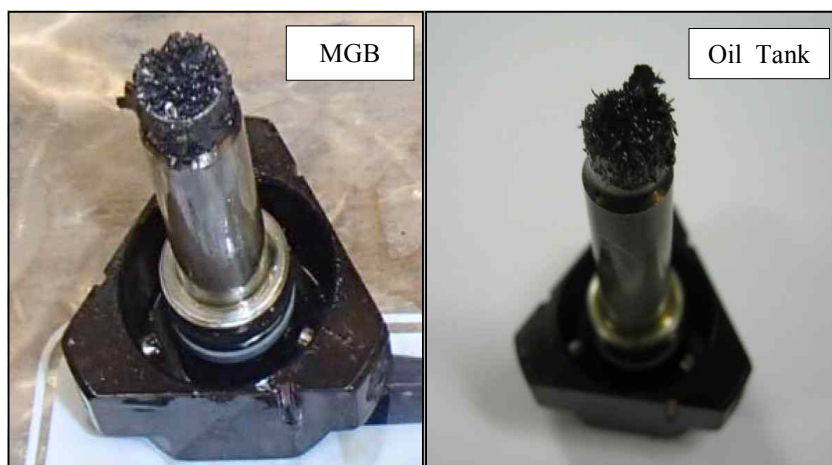
[Figure 3] Magnetic Chip Detector (MCD)

As shown in [Figure 3], magnetic chip detectors (MCD)²⁵⁾ installed in the MGB and oil tank exhibited a large quantity of metal chips.

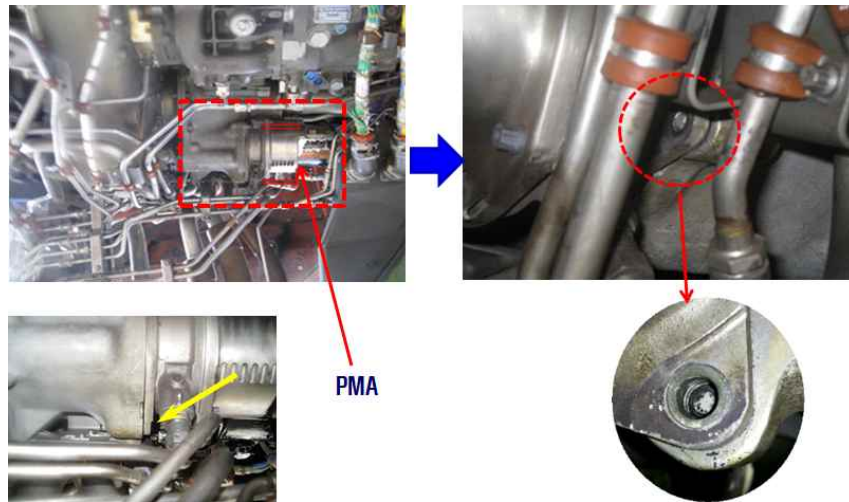
[Figure 4] PMA Attachment Bolt

As shown in [Figure 4], out of three permanent magnet alternator (PMA) attachment bolts, one at the 6 o'clock position (yellow arrow) was fractured, and the bolt head part of the fracture was missing.

Apart from the damaged teeth of the PMA gearshaft, PMA shaft roller bearings and support housing were generally in good condition. However, damage to the teeth of the PMA gearshaft could have caused vibration in the PMA housing, which could have caused the fracture of one PMA attachment bolt.

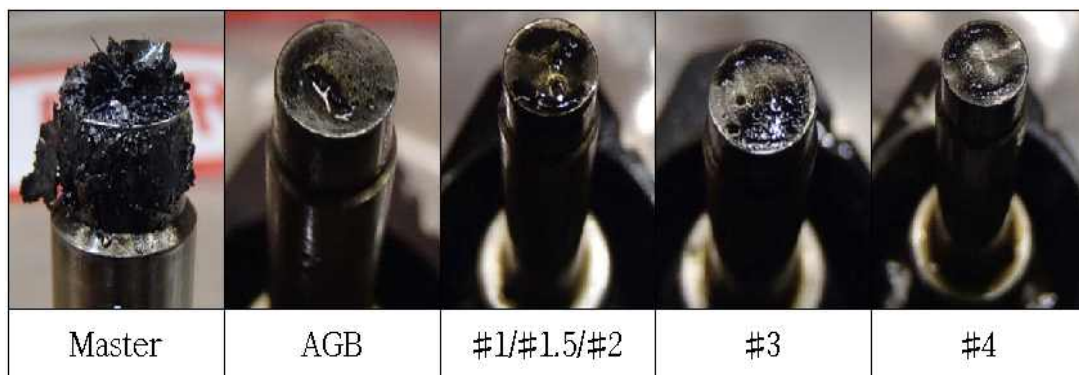
[Figure 5] MCD

As shown in [Figure 5], master MCD exhibited a large quantity of metal chips, whereas MCD for AGB, #1/#1.5/#2, #3, and #4 bearings exhibited a small quantity of fines, which were considered to be insignificant in comparison with the service time of the engine.

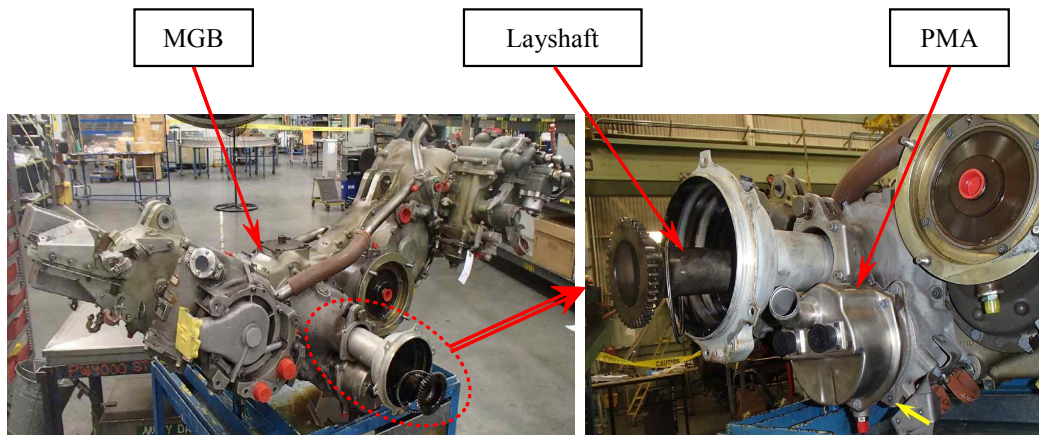
[Figure 6] Removed MGB

As shown in [Figure 6], the gearbox drive gear shaft moved forward from its assembled position, and thereby the gearbox drive gear shaft and the layshaft were disengaged, hanging downwards. One PMA attachment bolt (yellow arrow) was fractured and missing.

The damage to the MB-7 and MB-8 bearings can cause the gearbox drive gear shaft to move forward from the MGB, which can cause the outer spline to liberate gradually from its connected position with the layshaft's internal spline, thereby stopping power transmission. As the MGB driveshaft is the primary shaft that receives N2's rotational force through the layshaft, linking to many MGB drive gear shafts, the liberation of this driveshaft stopped the operation of all components on the MGB.

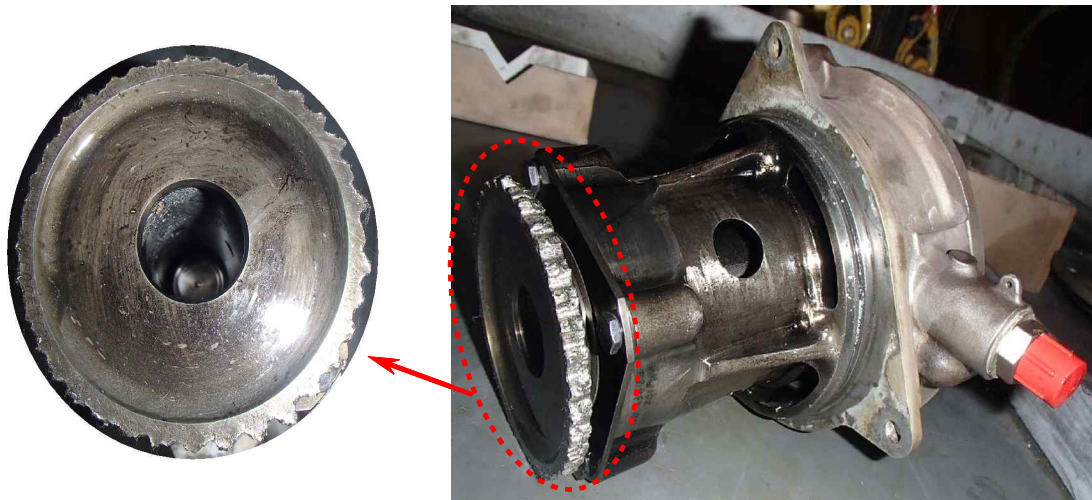
[Figure 8] PMA Gearshaft Teeth Damage

The PMA unit removed from the MGB underwent close examination. As shown in [Figure 8], all PMA gearshaft teeth were severely damaged with most of the teeth material was missing. However, the PMA rotor, PMA stator, two PMA shaft roller bearings,²⁶⁾ and support housing were generally in good condition.

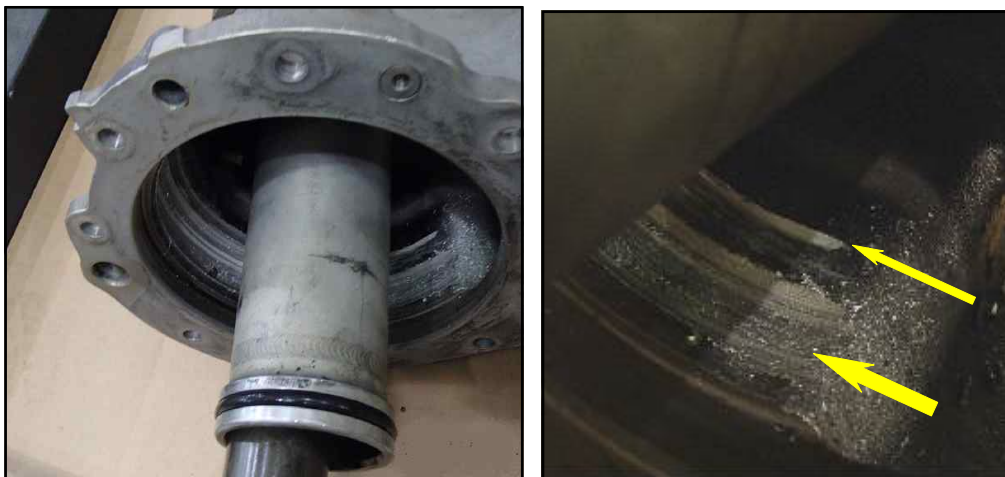
[Figure 9] Damaged Gearbox Driveshaft Front Housing

As shown in [Figure 9], the front housing of the gearbox driveshaft at the PMA drive spur gear location exhibited two circumferential grooves (yellow arrows) with circumferential rubbing marks. The aft one appears to be wider and shallower than the forward one.

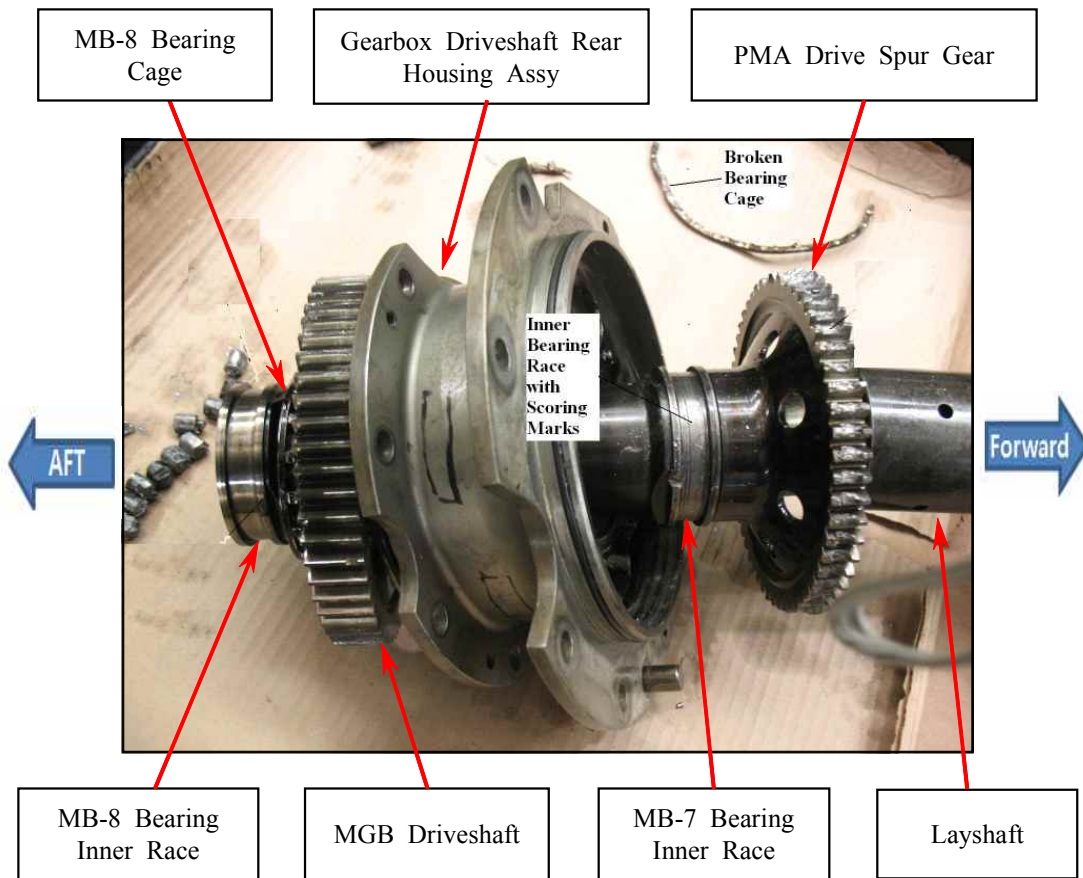
[Figure 10] Gearbox Driveshaft and Bearing

As shown in [Figure 10 and 11], the MB-7 bearing inner race was mounted on the gearbox drive gear shaft. The MB-7 bearing inner race O.D surface exhibited circumferential rubbing and smear. As shown in [Figure 11], The MB-7 bearing inner race appears to be fully seated on the AFT end surface exhibiting no apparent gap (blue arrow) with the gearbox drive gear shaft forward shoulder. The PMA drive spur gear side surface also exhibited no apparent gap (yellow arrow) with the MB-7 bearing inner race side surface.

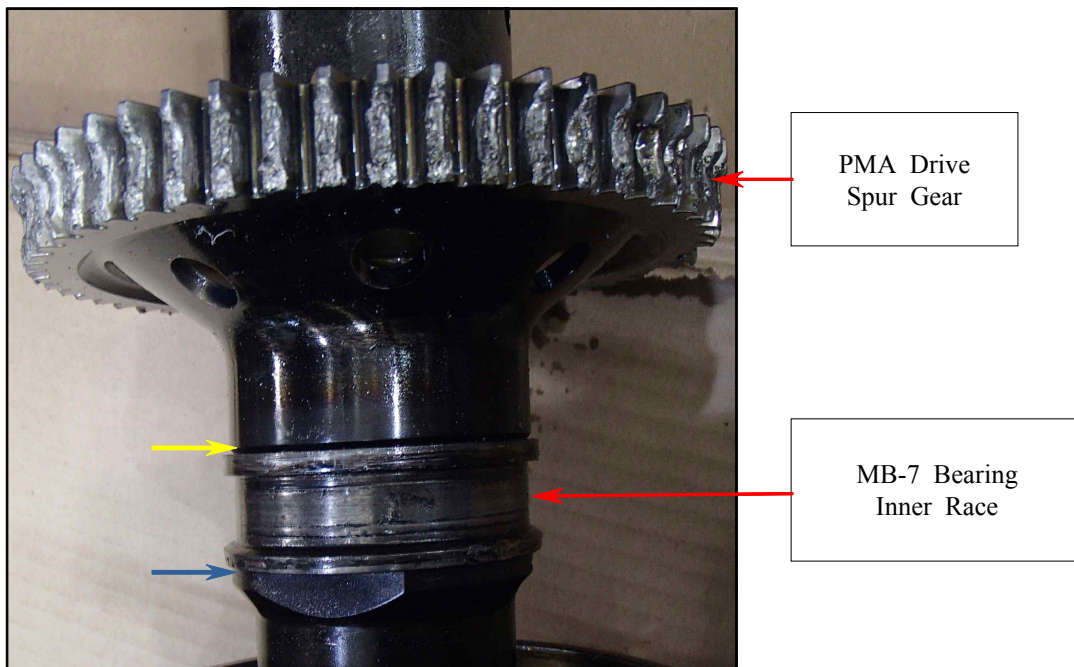
[Figure 11] PMA Drive Spur Gear and MB-7 Bearing Inner Race

The PMA drive spur gear on the gearbox driveshaft exhibited teeth damage from normal contact pattern on the forward edge to material loss at the AFT edge. This would be consistent with the gearbox drive gear shaft moving forward from its assembled position, with the PMA driveshaft fixed in a normal position.

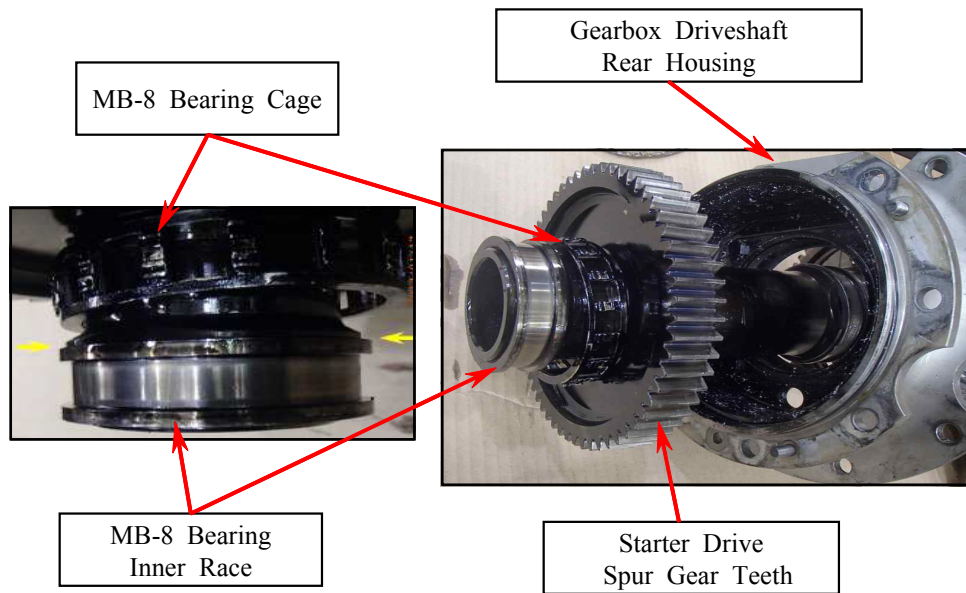
[Figure 12] Gearbox Driveshaft and MB-8 Bearing

As shown in [Figure 12], the MB-8 bearing rollers and the cage liberated from the assembled positions, but the MB-8 bearing roller cage was intact. The MB-8 bearing inner race was intact and exhibited no apparent damage. The MB-8 bearing inner race forward end surface was fully seated and exhibited no apparent gap with the aft shoulder (yellow arrow) of the MGB driveshaft. Loctite²⁷⁾ adhesive appears to have been used at the last shop visit, and a thin layer of Loctite at about 0.003 inch (0.076 mm) was visible on the forward end of the inner race. The starter drive spur gear of the MGB driveshaft exhibited no damage to its teeth which were in good condition.

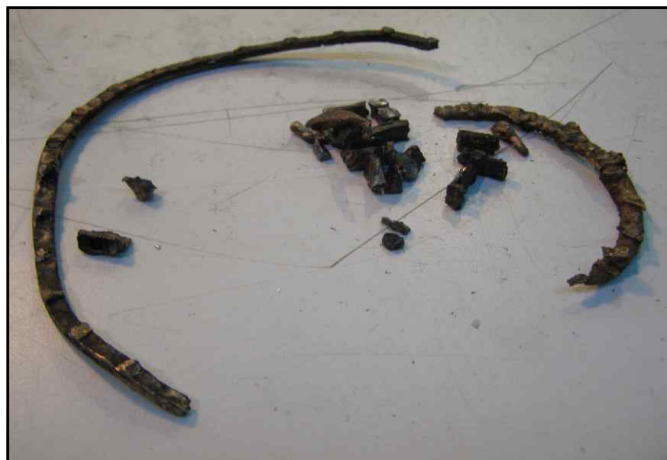
[Figure 13] MB-7 Bearing Cage

As shown in [Figure 13], the MB-7 bearing rollers and cage liberated from the assembled positions and were found in the MGB housing. Severely deformed MB-7 bearing roller cage fragments were retrieved inside the gearbox. Cage fragments were identified as from the MB-7 by default because the MB-8 bearing roller cage was intact. The cage supporting the bearing roller was broken into multiple pieces. MB-7 bearing cage remnants showed that all cross bars and one cage side rail were broken into multiple pieces, and that the other side rail hoop was fractured at one circumferential location and unwrapped into an extended semi-circle shape.

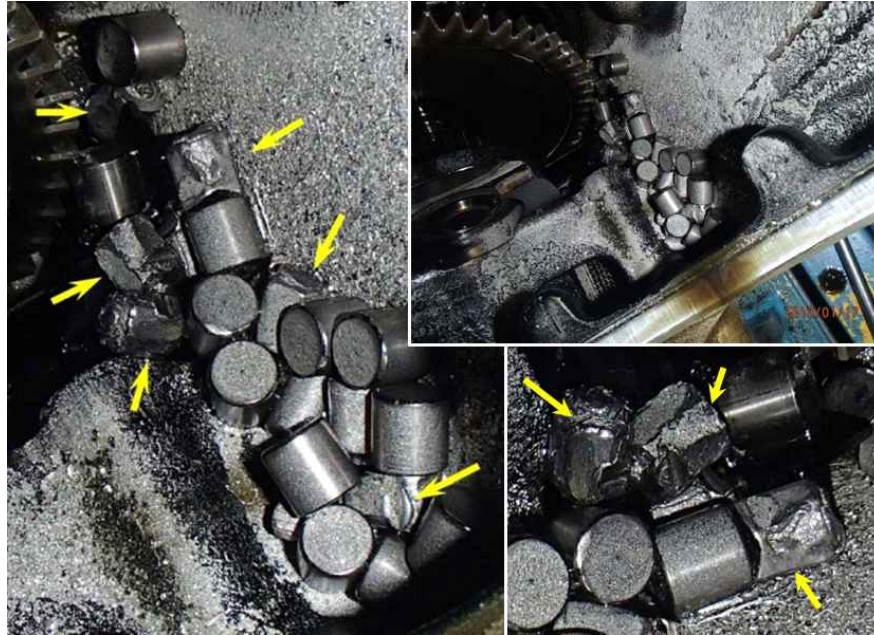
[Figure 14] Bearing Rollers

As shown in [Figure 14], bearing rollers were retrieved in the vicinity of the gearbox drive gear shaft inside the gearbox. They were mixed with intact bearing rollers and severely damaged bearing rollers with multiple flattened surfaces (yellow arrow).

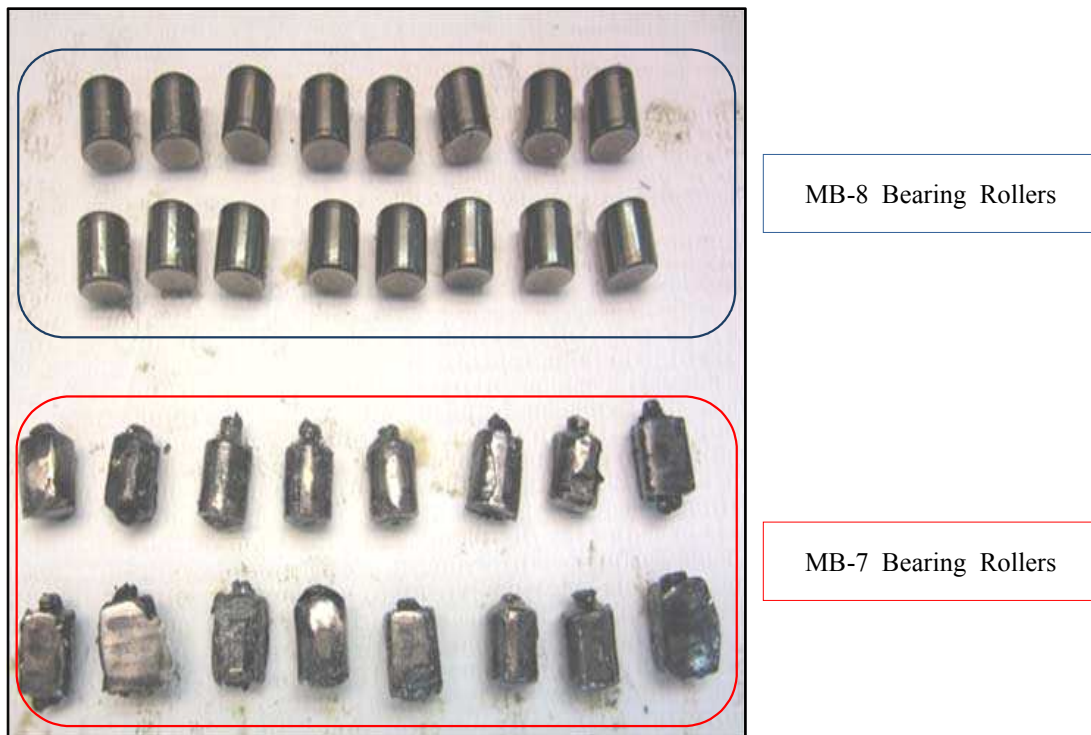
[Figure 15] MB-7 and MB-8 Bearing Rollers

As shown in [Figure 15], rollers in the MB-7 and the MB-8 have the same part number (PN 70R022), and both bearings have 16 rollers. Based on the conditions of the roller cages and inner races of the MB-7 and the MB-8 bearings, the intact rollers were most likely from the MB-8 and the rollers with multiple flattened surfaces were most likely from the MB-7.

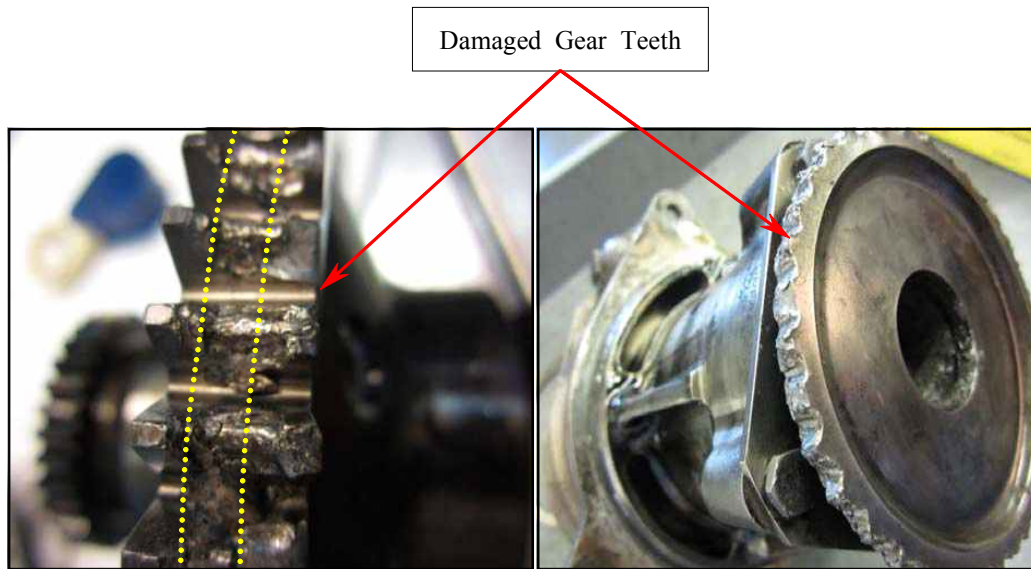
[Figure 16] PMA Drive Spur Gear (left) and PMA Gearshaft (right)

As shown in [Figure 16], there was heavy radial damage to tips of gear teeth on both the PMA drive spur gear (mounted forward of the MB-7 bearing) and the PMA gearshaft. This damage was believed to be secondary to the MB-7 bearing distress which would cause loss of center line and result in tooth tip-to-tooth tip contact of this mesh.

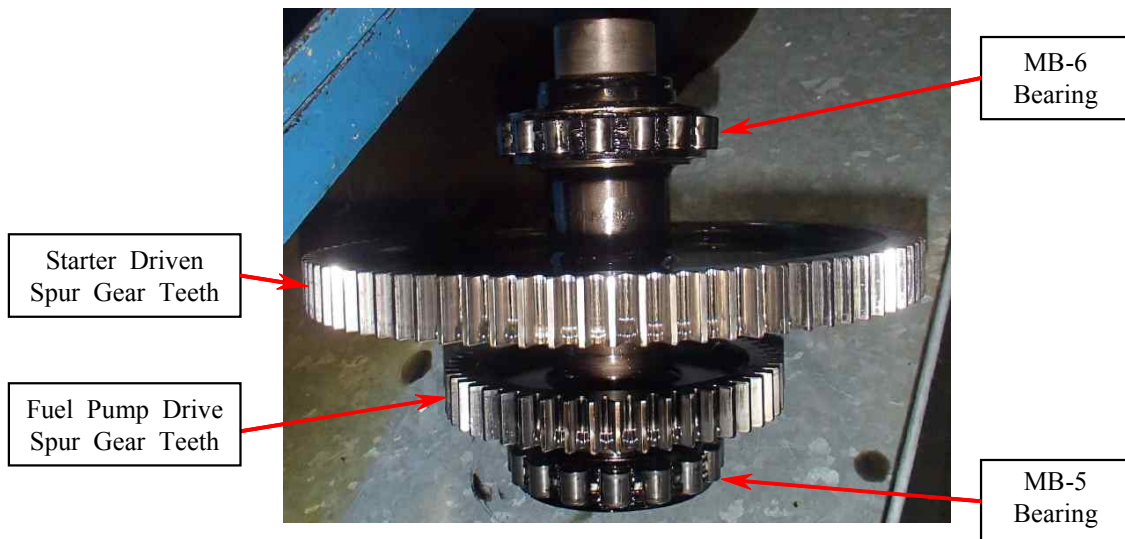
[Figure 17] Starter Driveshaft and Bearings

As shown in [Figure 17], the starter driveshaft was removed from the MGB for examination. The MB-5²⁸⁾ and MB-6²⁹⁾ bearings were in their assembled positions and in good condition. The driven spur gear of the starter and the drive spur gear for the fuel pump exhibited no apparent distress.

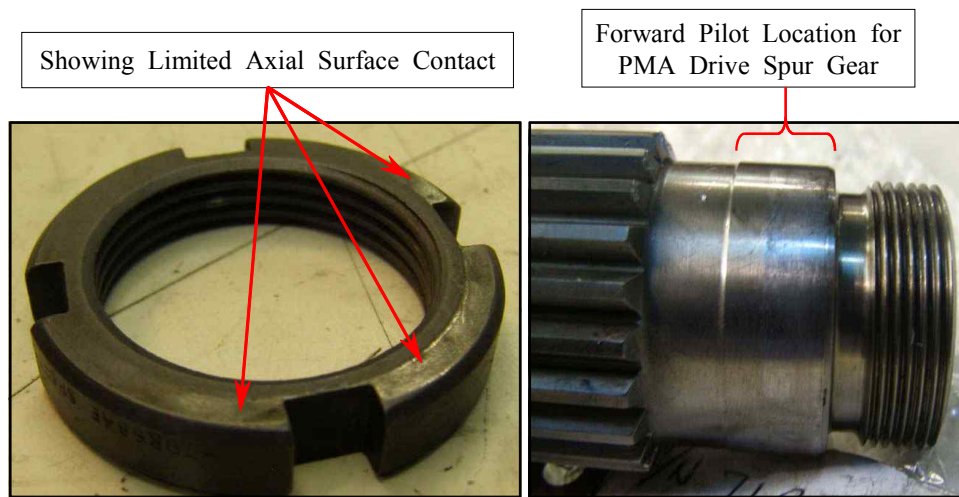
[Figure 18] PMA Drive Retaining Nut (left) and MGB Driveshaft (right)

United Airlines found during the engine disassembly examination that the PMA drive retaining nut had an extremely lower breakaway torque than the criteria specified in the EM.³⁰⁾ Yet the exact breakaway torque could not be measured at disassembly.

As shown in right [Figure 18], the MGB driveshaft forward piloting surface and its outer spline coupling were undamaged.

The cause of the low disassembly PMA drive retaining nut torque United Airlines had found during the engine disassembly examination was that the nut had not been tightened enough. It is highly likely that out of three assembly procedures above, the procedure ③ was implemented with a significantly lower torque than that prescribed by the EM, or that the procedure ③ was omitted after the retaining nut was loosened in the procedure ②.

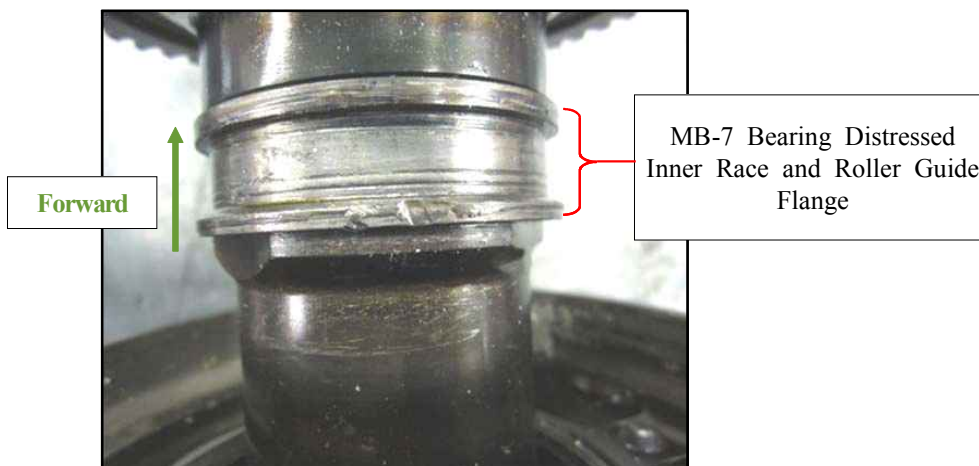
[Figure 19] MB-7 Bearing Inner Race

All of the MB-7 bearing components were found distressed. The MB-7 bearing inner race was still mounted on the MGB driveshaft. As shown in [Figure 19], however, the inner ring raceway, and the forward and aft roller guide flanges exhibited severe circumferential wear.

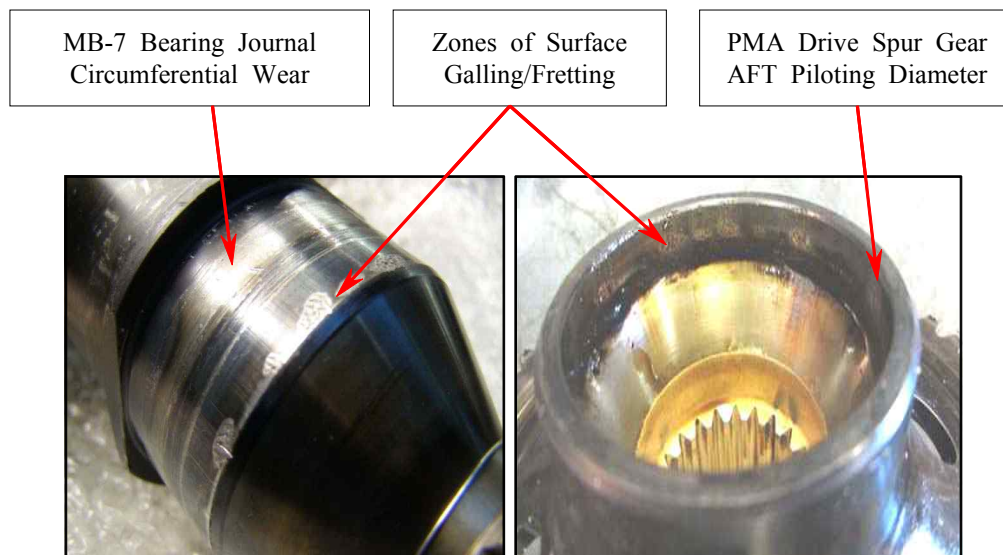
[Figure 20] MGB Driveshaft (left) and PMA Drive Spur Gear (right)

As shown in [Figure 20], zones of galling/fretting³¹⁾ with material transfer were observed between the MGB driveshaft MB-7 bearing journal surface and

As shown in left [Figure 20], the MB-7 bearing journal surface exhibited atypical circumferential wear, which is indicative of MB-7 bearing inner ring rotation relative to the gear shaft and spur gear.

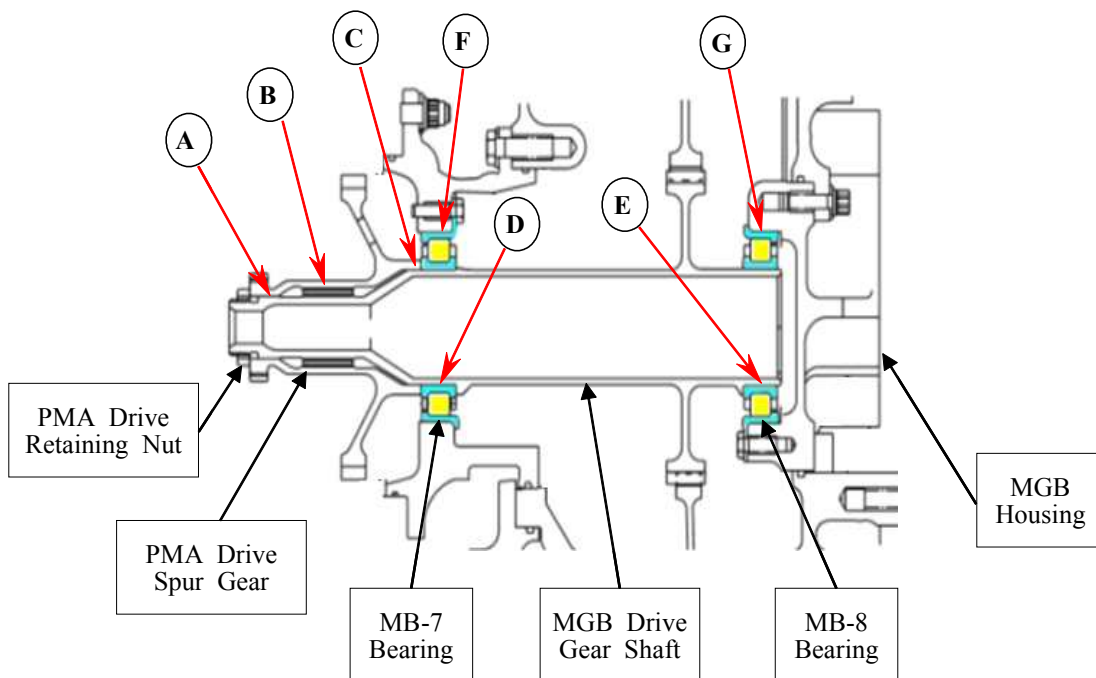
[Figure 21] MGB Driveshaft and Bearing

As shown in [Figure 21] and [Table 2], the fit between the forward (location ①) and the aft (location ③) of the PMA drive spur gear was tight fits at assembly, but when the PMA drive retaining nut has a low torque, two axes can move in the circumferential direction as much as the clearance between the splines (location ②), 0.0035 inches (0.089 mm).

According to the EM,³⁵⁾ when assembled as shown in [Figure 21] and [Table 2], the fit between the MGB driveshaft forward (location Ⓐ) and aft (location Ⓒ) pilot location O.D and the PMA drive spur gear I.D has a clearance³⁶⁾ of 0.0016 - 0.0009 inT (0.041 - 0.023 mmT). In addition, the MB-7 bearing I.D (location Ⓓ) is a tight fit as 0.0019 - 0.0010 inT (0.048 - 0.025 mmT), whereas the MB-7 bearing O.D (location Ⓔ) is a loose fit as 0.002 - 0.0016 inT (0.0051 - 0.041 mm).

As shown above, a tight fit assembly can first prevent the MB-7 bearing inner race from rotating on the MGB driveshaft, make the PMA drive spur gear compress the inner race side surface, and prevent the movement in the axial direction by tightening the PMA drive retaining nut. Yet if the PMA drive retaining nut is not tightened enough, the MB-7 bearing inner race will move, which can cause vibration on the MGB driveshaft, thereby damaging the MB-7

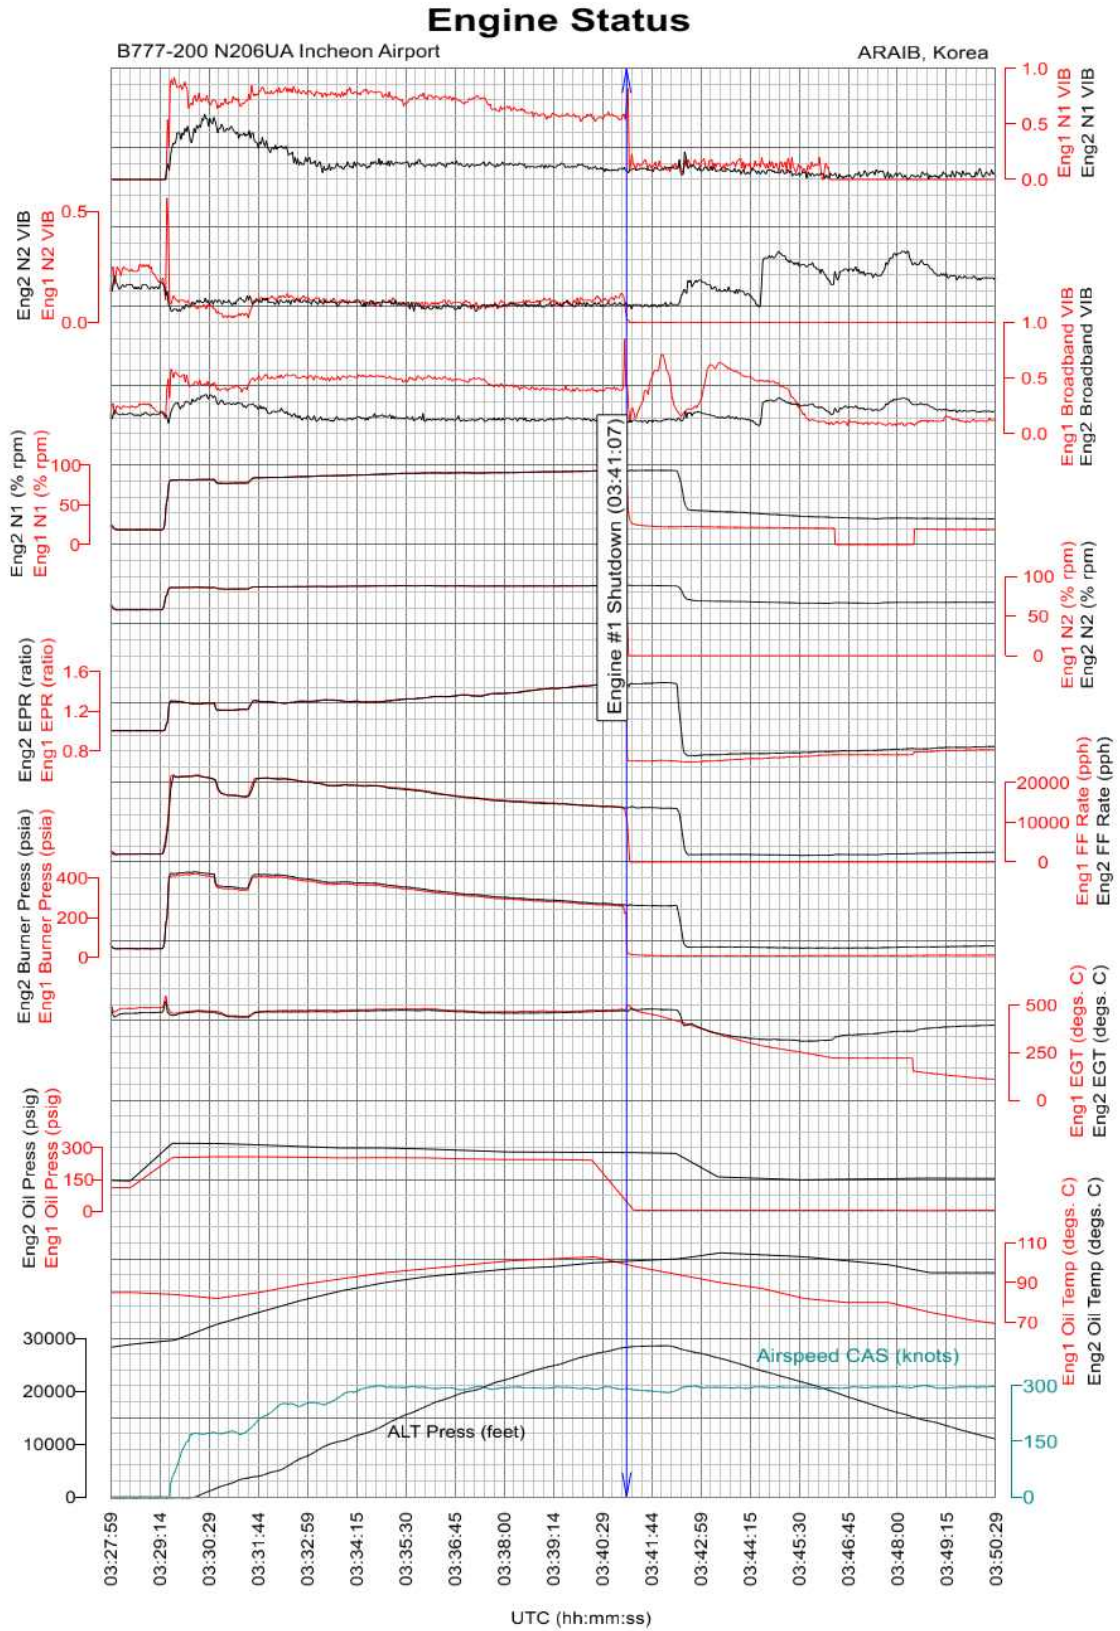
[Figure 22] Engine Parameters Analysis Graph

Among the data extracted from the event aircraft's FDR, major parameters relating to an engine failure were analyzed and displayed graphically as shown in [Figure 22].

At the same time, oil pressure dropped from 241 psi to 4 psi, outside atmospheric pressure, and oil temperature gradually decreased. The fuel flow rate and burner pressure declined from 13,952 pph to zero and from 250 psi to the minimum 7 psi, respectively. Exhaust gas temperature (EGT) gradually dropped.

At 03:42:38 UTC, the No. 1 engine fail warning was recorded, and the airplane began descending shortly thereafter and landed at 04:05:02 UTC. Meanwhile, all engine parameters of the No. 2 engine were within normal range during the entire flight.

The MB-7 bearing distress caused the MGB driveshaft to move forward and disengage from the layshaft, at the time when the HPC N2 shaft's rotational force could not be transferred to the MGB, thereby shutting down all components on the MGB. Accordingly, the No. 1 engine's N1, N2, EPR, oil pressure, burner pressure and fuel flow rate declined to the minimum and did not recover back to normal until the end of the flight.
