<b>AIRCRAFT ACCIDENT REPORT AND EXECUTIVE SUMMARY</b>
---

Reference:	CA18/2/3/9118	
<b>Aircraft registration</b>	ZU-EFH	<b>Date of accident</b>	1 January 2013		<b>Time of accident</b>	±0505Z
<b>Type of aircraft</b>	Aeroprakt A-22 (Aeroplane)		<b>Type of operation</b>	Private flight		
<b>Pilot-in-command licence type</b>	Private pilot		<b>Age</b>	41	<b>Licence valid</b>	Yes
<b>Pilot-in-command flying experience</b>	Total flying hours		909,8		Hours on type	396,9
<b>Last point of departure</b>	Phalaborwa aerodrome (FAPH), Limpopo province.					
<b>Next point of intended landing</b>	Phalaborwa aerodrome (FAPH), Limpopo province.					
<b>Location of the accident site with reference to easily defined geographical points (GPS readings if possible)</b>						
Open field next to the Phalaborwa aerodrome fence (GPS position: 23°56.695' South 031°09.344' East)						
<b>Meteorological information</b>	Surface wind: 260°2kts, Temperature: 24°C, Cloud base: 2 000 ft, CAVOK

## AIRCRAFT ACCIDENT REPORT

**Name of Owner** : J.W. Horn  
**Name of Operator** : Private flight  
**Manufacturer** : Aeroprakt  
**Model** : A-22  
**Nationality** : South African  
**Registration Marks** : ZU-EFH  
**Place

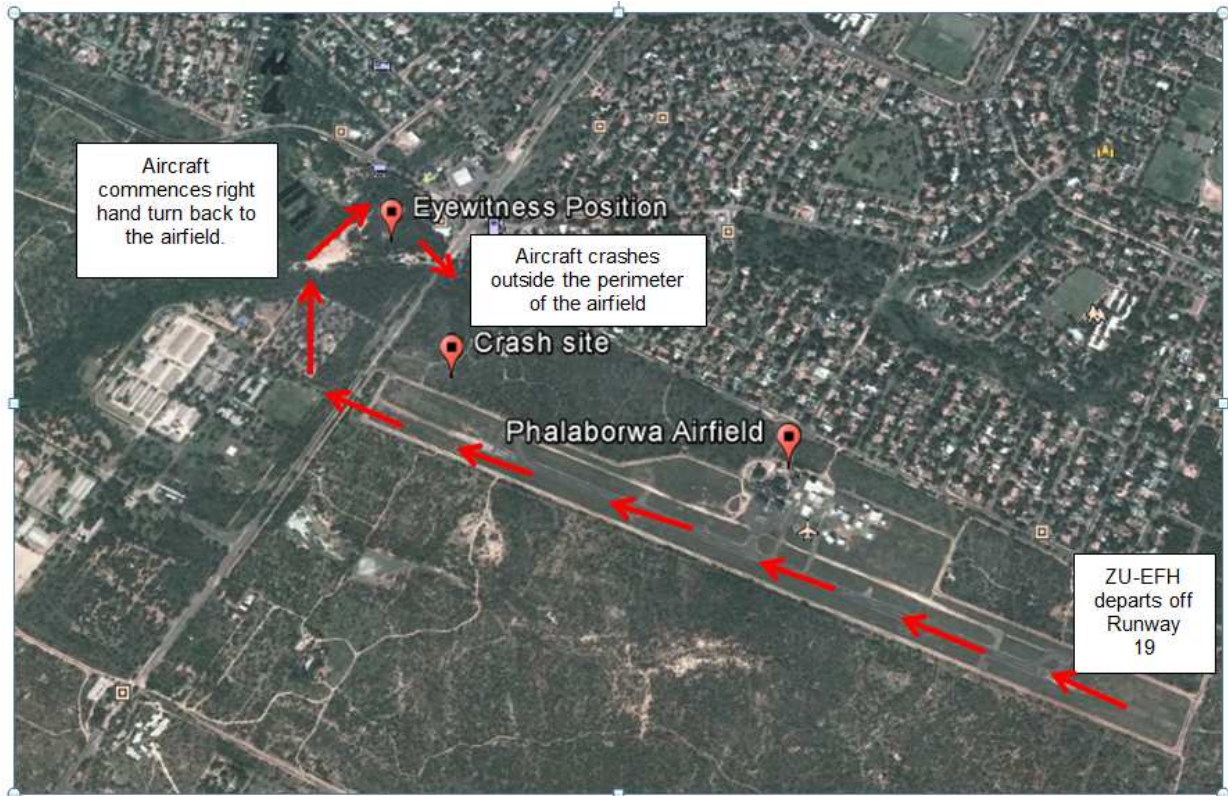
1.1.1 At approximately 0505Z on the morning of 1 January 2013, the pilot, accompanied by a passenger, also the holder of a valid private pilot licence took off from runway 19 at Phalaborwa aerodrome (FAPH) with the intention to conduct a private flight of the area. According to an eyewitness who was walking in the veld to the south of the aerodrome he first heard the aircraft as it took off and it flew in his direction (towards the South). As the aircraft was basically a beam overhead him, at a height of approximately 200-300 feet above ground level (AGL) the engine stopped. He then observed the aircraft executing a right turn as if it was turning back towards the runway/aerodrome. He was unable to follow its flight path all the way as his view

**Figure 1.** Illustration of the flight path of the aircraft after take-off from runway 19 (based on estimation).

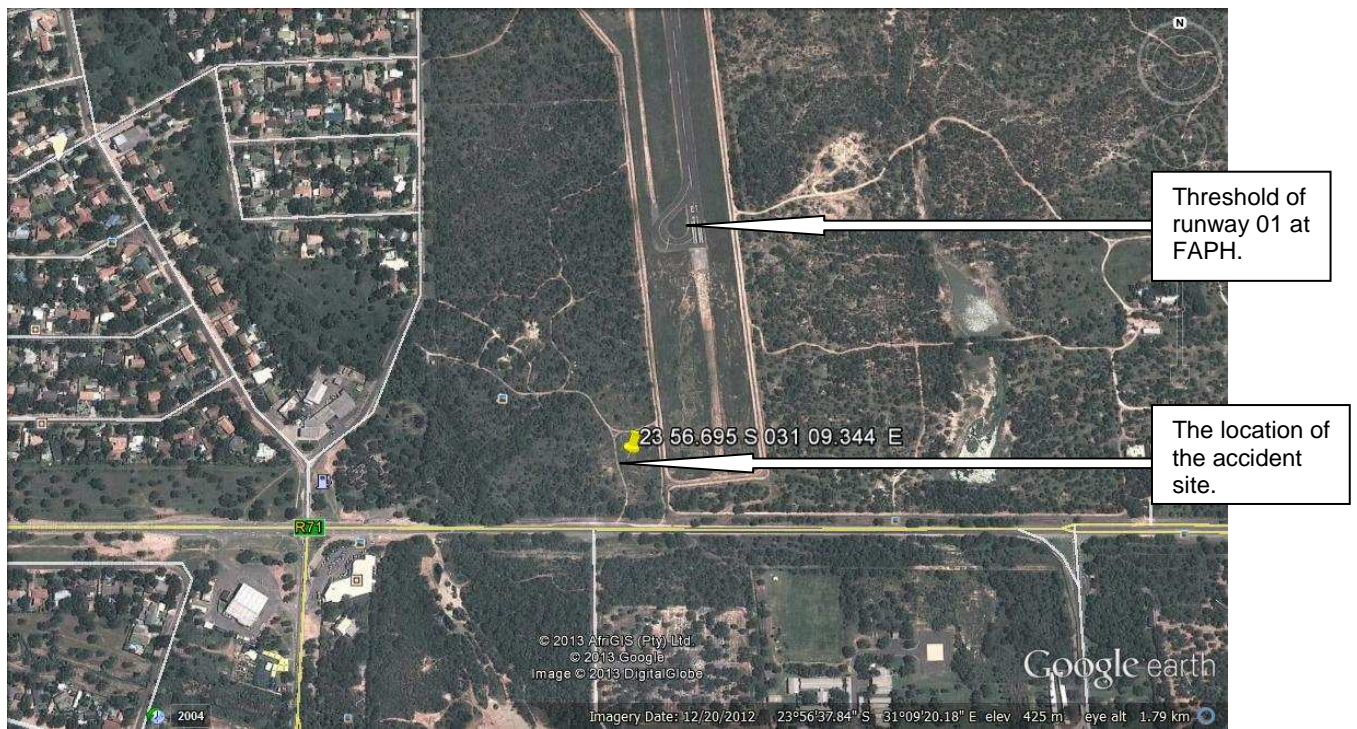
1.1.2 The accident occurred during daylight conditions at a geographical position that was determined to be 23° 56.695' South 031° 09.344' East at an elevation of 1 382 feet above mean sea level (AMSL). The Google earth image (figure 2) on the next page indicates the GPS position of the accident site in relation to the threshold of runway 01. The distance from the accident site to the threshold of runway 01 was 350 metres (m).

**Figure 2.** The GPS position indicates the location of the accident site to the West of the aerodrome fence.

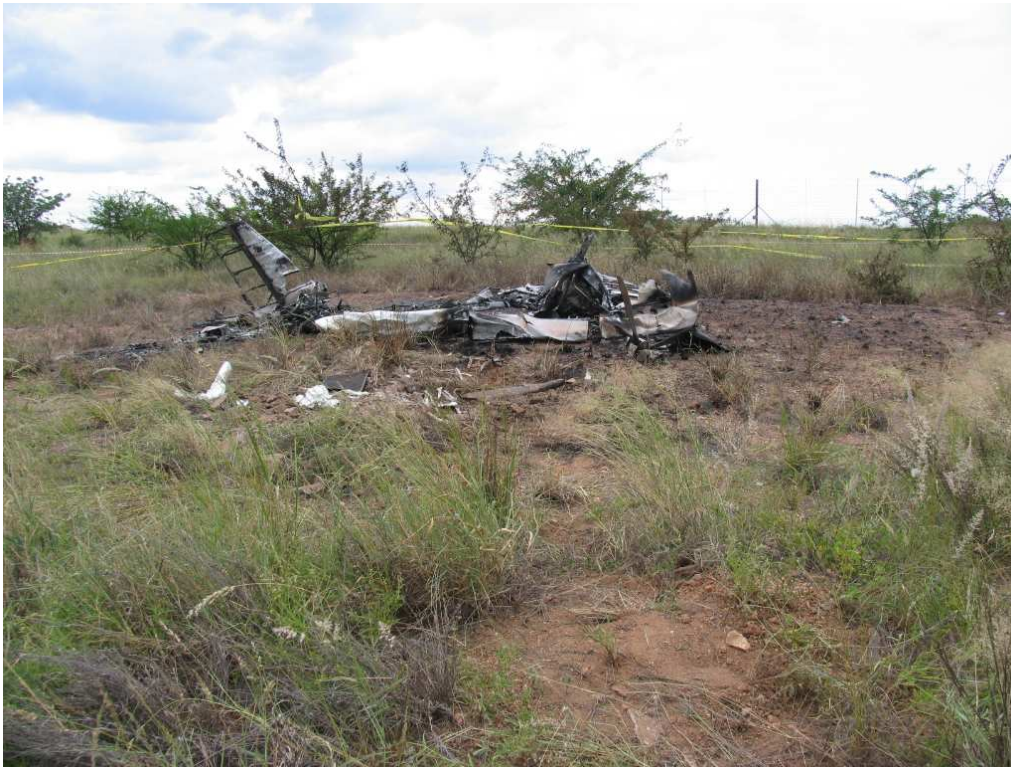
**1.3.1** The aircraft was destroyed by the post impact fire.

**Figure 3.** A photo of the burnt out wreckage adjacent to the aerodrome perimeter fence.

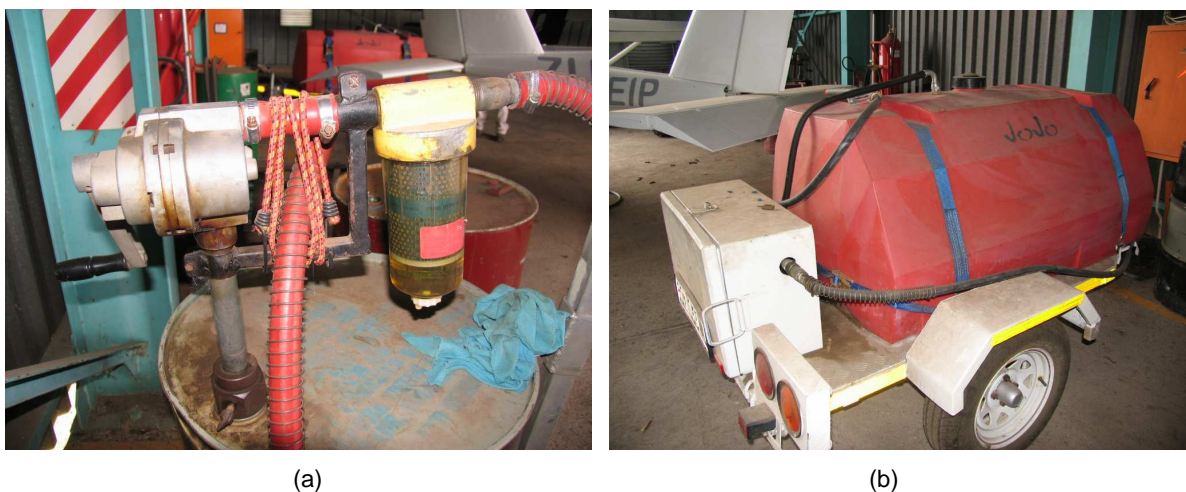
1.6.10 Due to the absence of documented evidence (aircraft flight folio) it was not possible to determine the fuel quantity onboard the aircraft for the flight with accuracy. Two empty 20 litre containers (Jerry cans) were found in the back of the pilot's vehicle that was parked at the aerodrome. It was believed that these containers were emptied into the aircraft prior to the flight, but following an interview with the late pilot's wife it was ascertained that these two containers were used to store fuel for a generator at their home and was never used to refuel the aircraft. It was noted that there was a trailer type fuel bowser parked in the hangar where the aircraft was standing along with several other aircraft. The meter reading on the pump display was 132 litres, which was well above that of the total capacity of the aircraft and was therefore not of any value to the investigating team. There were also two, 200 litre drums with a hand crank pump and filtering device secured to one of the drums. The possibility that the pilot might have pumped fuel from the drum into the aircraft

was possible. (See view of drum with hand crank pump and trailer in figure 5 on the next page).

**Figure 5.** A view of a 200 litre drum with a hand crank device (a) as well as a trailer type bowser in the hangar (b).

The source of fuel uplift could not be determined with accuracy nor the quantity of fuel that was in the aircraft prior to take-off. A 200 litre drum that contained some fuel was found in the hangar as well as a trailer type fuel bowser. Both the containers had filtering devices fitted to them.

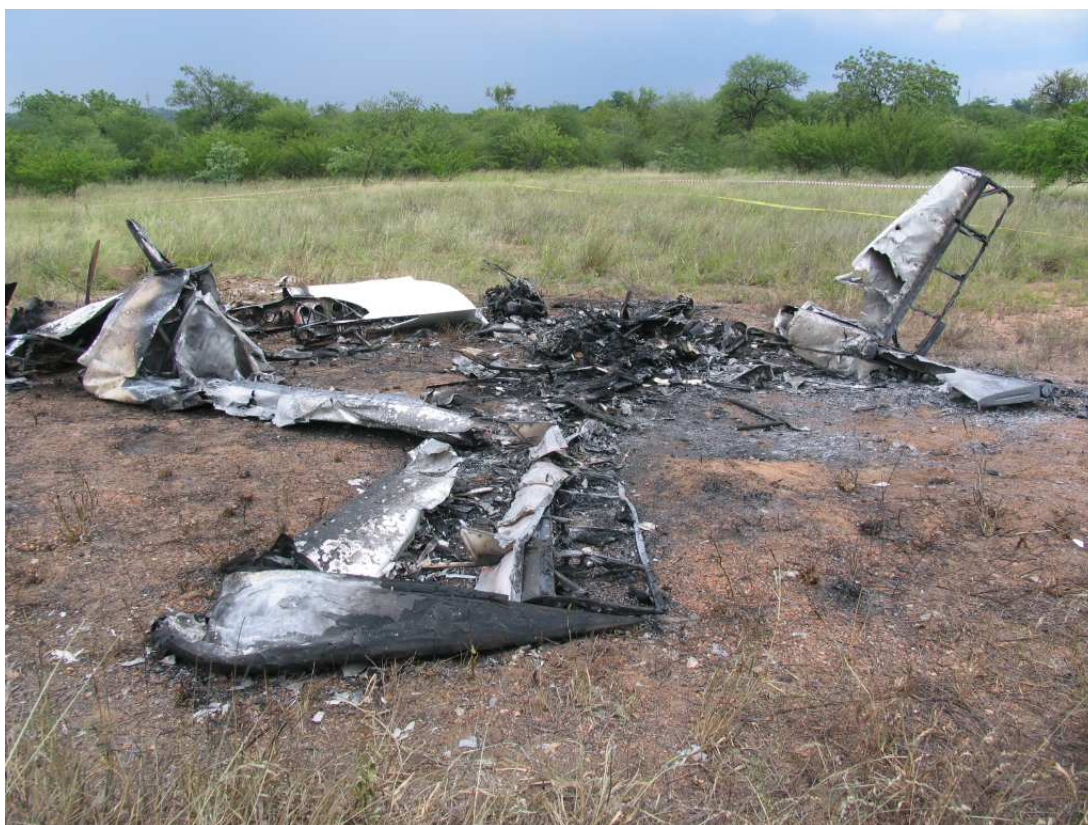
1.12.1 The wreckage came to rest in an open grass field just outside the aerodrome perimeter fence (western side). The first ground impact was with an embankment, which were approximately 70-80 centimetres (cm) in height on a heading of 045°M. The aircraft impacted with the embankment in a nose down attitude of approximately 30° to 45°, which caused one of the propeller blades to break off at the hub assembly on impact, the propeller hub assembly with the other two blades still attached was located on the accident site, attached to it was a section of the propeller reduction gearbox.

**Figure 7.** A view of the main wreckage as it came to rest.

1.12.2 The first impact point was about 15 meters from where the main wreckage came to rest. The wreckage was found to have rotated through approximately 120°. The fabric/composite covered fuselage and wings were consumed within a short period of time by the post impact fire that erupted. It was not possible to ascertain flight control continuity due to the fire damage.

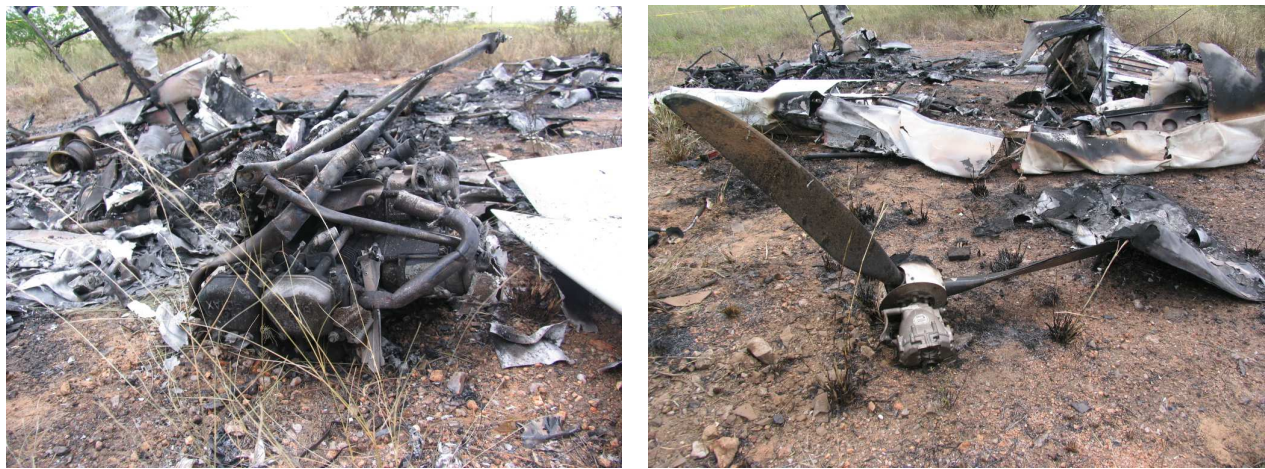
1.12.3 The propeller with hub assembly was located approximately 5 meters from the first impact point. Two of the three propeller blades were still attached to the propeller hub. The evidence presented by the propeller was indicative of non rotation, indicating it was most probably stationary on impact, which correlated with the

observation that was made by the eyewitnesses, which indicated that the engine stopped shortly after take-off. The damage to the engine was consistent with the impact sequence and was located lying in an inverted position next to the main wreckage. The engine was subjected to the post impact fire and all the electrical wiring, fuel and oil lines were destroyed as a result.

**Figure 8.** A view of the engine as it came to rest (a) and the propeller with two of the three blades still attached (b).

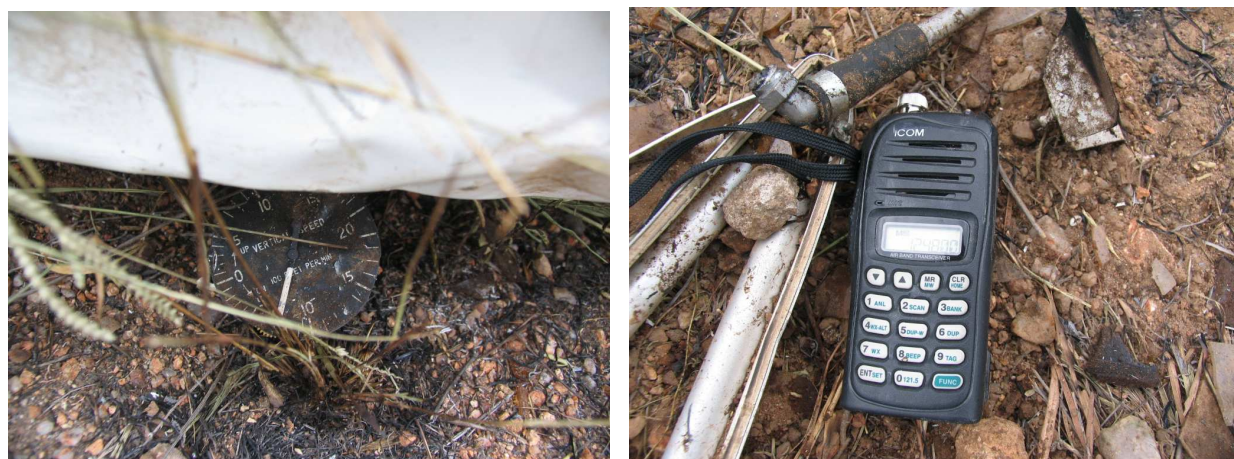
1.12.4 The face plate of the vertical speed indicator (VSI) with the needle mechanism intact was located on the accident site. The needle indicated a rate of descent of  $\pm 700$  feet per minute, as can be seen in figure 10(a) below. This was the only flight instrument that was not completely destroyed. A hand held VHF radio was located on site. The radio was still in a working order and displayed the Phalaborwa aerodrome frequency 124.80 MHz.

**Figure 9.** A photo of the VSI faceplate (a) as well as the VHF had held radio that was located on site (b).

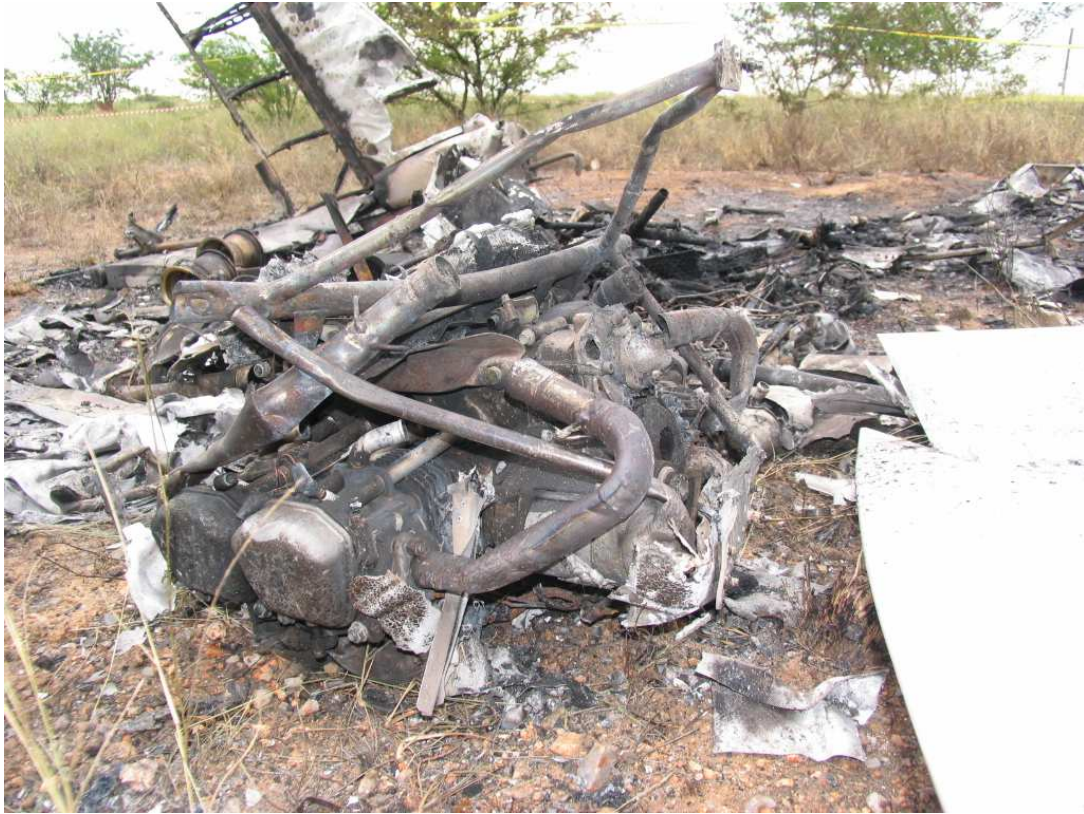
A photo of the engine that was taken on the scene of the accident lying in an inverted attitude.

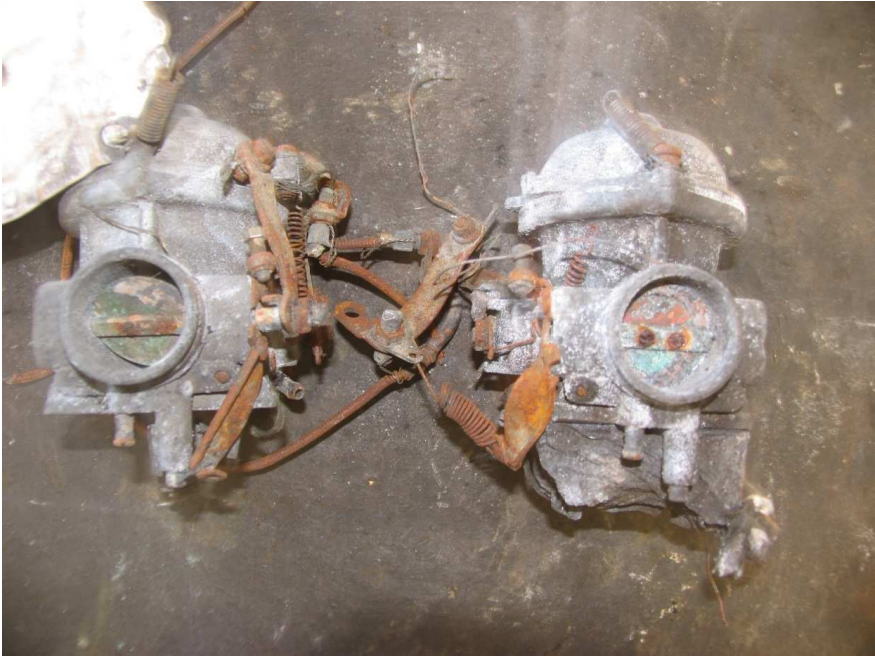
- 3.1.13 The choke was found to be partially applied with both carburettor units displaying a similar choke position, which correlated with the choke splitter position.

Carburettors	<p>The engine was equipped with two carburettors, with one unit located on the left side of the engine and the other one on the right side. Both the units sustained substantial fire damage and were found detached from the engine. The bowl of both units was removed and examined and were found not to contain any fuel. It is believed that the fuel in both the carburettor bowls had vaporized due to the heat that the units that were exposed to by the post impact fire. It was further noted that on both throttle quadrants the indication was that the throttle was in the close position. It was further noted that the choke setting displayed a partial application, with both carburettor units displaying the same choke position.</p>

<p>A photo of the two carburetors that was fitted to the engine.</p>
Electronic ignition	<p>The engine was equipped with an electronic ignition system consisting of two units A and B. The units had sustained substantial fire damage and no further testing was possible. (There was no magneto's fitted to this engine type).</p>

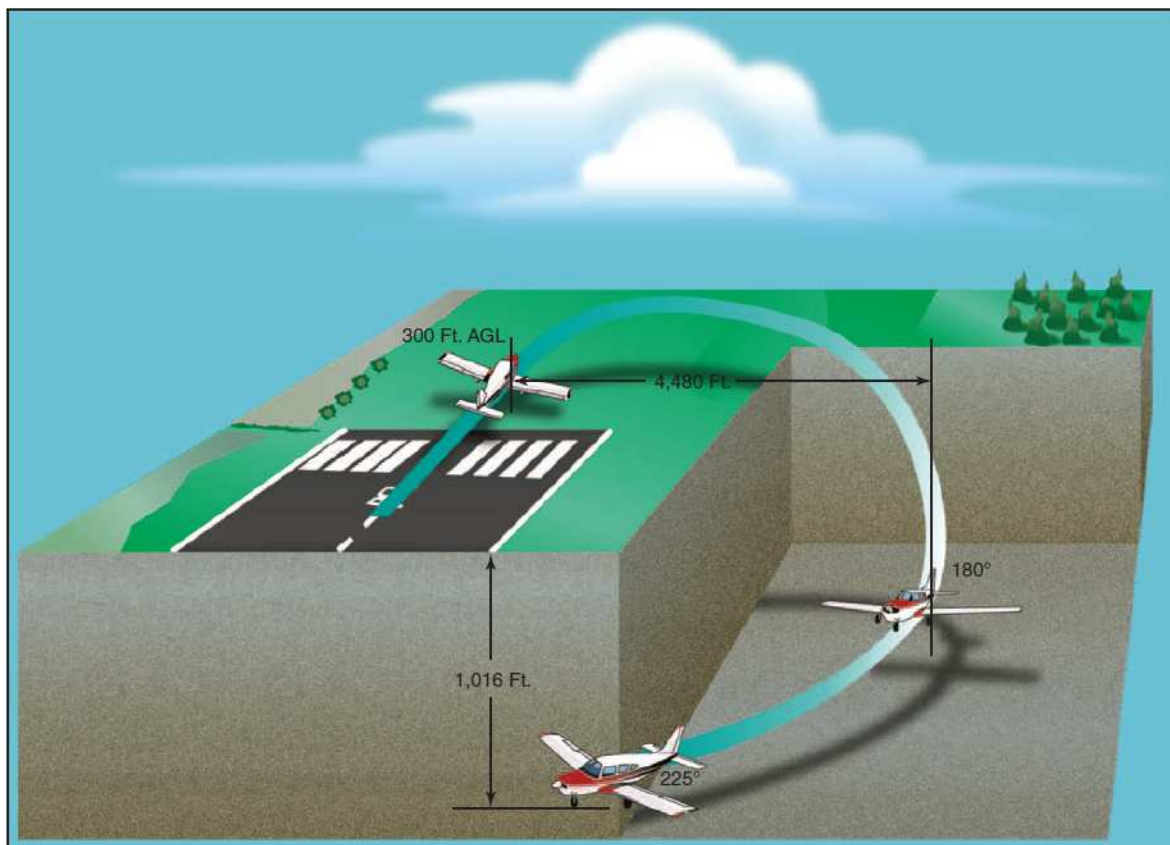
Consider the following example of an airplane which has taken off and climbed to an altitude of 300 feet AGL when the engine fails. (Figure 16-5 below) After a typical 4 second reaction time, the pilot elects to turn back to the runway. Using a standard rate (3° change in direction per second) turn, it will take 1 minute to turn 180°. At a glide speed of 65 knots, the radius of the turn is 2 100 feet (640 m), so at the completion of the turn, the airplane will be 4 200 feet (1 280 m) to one side of the runway. The pilot must turn another 45° to head the airplane towards the runway. By this time the total change in direction is 225° equating to 75 seconds plus the 4 seconds reaction time. If the airplane in a power off glide descends at approximately 1 000 feet per minute it will have descended 1 316 feet placing it 1 016 feet below the runway surface.

Figure 16-5. Turning back to the runway after engine failure.
