الهيئة العامة للطيران المدني
GENERAL CIVIL AVIATION AUTHORITY

- Final Report -

AIFN/0001/2013

Loss of Control – On Ground

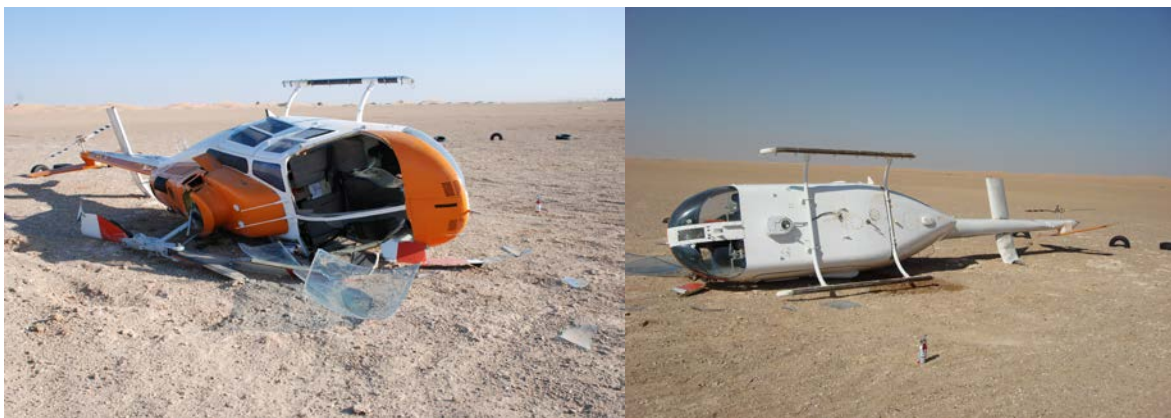
Figure 3: Accident Aircraft BHT 206-3B

The student applied left pedal to arrest the yaw, the aircraft rolled rapidly to the right, followed by the main rotor blades contacting the terrain as the aircraft rolled 90° onto the right-hand side of the fuselage.

Large outboard sections of the rotor blades separated from the rotor mast.

The aircraft was extensively damaged due to the abnormal contact with the terrain.

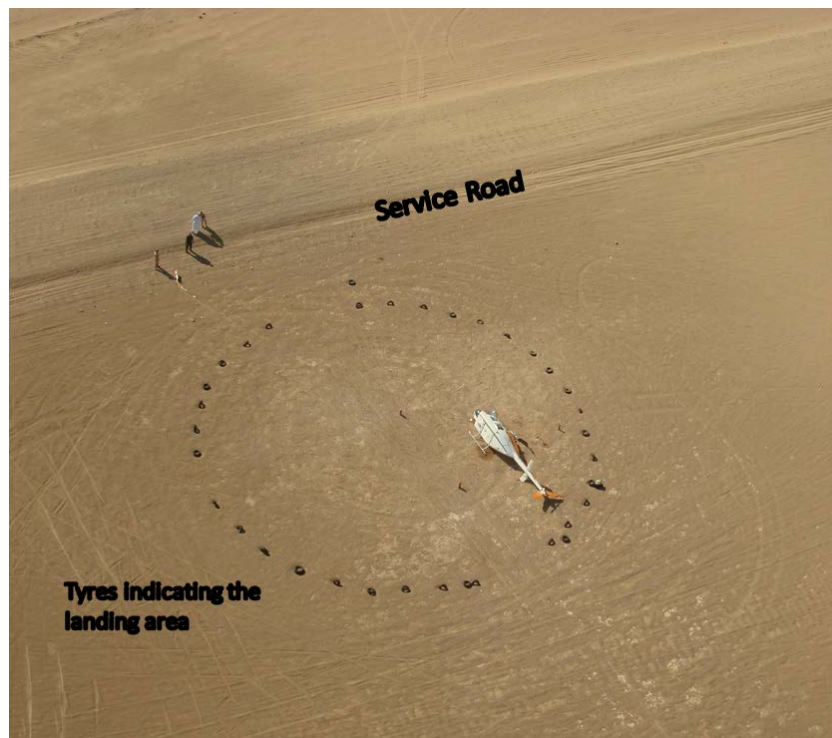
Figure 4: Accident Site Overview

- The location of the accident was in Training Area Six.
- The accident site was 18.25nm from OMAL on a radial of 295° from the operators fixed base.
- The accident site surface is level compacted sand, with an estimated CBR⁶ of 3-4, with blown and drift sand accumulations scattered locally.
- The wreckage is localised to the immediate area. Various structural parts and components were found up to 125 meters from the accident site; the majority of the wreckage is localised in one location.
