<b>AIRCRAFT ACCIDENT REPORT AND EXECUTIVE SUMMARY</b>
---

Reference:	CA18/2/3/9122	
<b>Aircraft Registration</b>	ZU-BFP	<b>Date of Accident</b>	10 January 2013		<b>Time of Accident</b>	0420Z
<b>Type of Aircraft</b>	Windlass Aquilla		<b>Type of Operation</b>	Commercial		
<b>Pilot-in-command Licence Type</b>	RPL	<b>Age</b>	54	<b>Licence Valid</b>	Yes	
<b>Pilot-in-command Flying Experience</b>	Total Flying Hours	± 1634.98		Hours on Type	± 1228.53	
<b>Last point of departure</b>	Wintervogel Private Airfield (Western Cape Province)					
<b>Next point of intended landing</b>	Wintervogel Private Airfield (Western Cape Province)					
<b>Location of the accident site with reference to easily defined geographical points (GPS readings if possible)</b>						
To the left of the threshold of Runway 08 at Wintervogel Private Airfield at a GPS position of S 33°37'674" E 18°40'947"						
<b>Meteorological Information</b>	<b>Wind:</b> NW / 3kts <b>Visibility:</b> CAVOK <b>Temperature</b> 11°C <b>Cloud Cover:</b> 3/8 to 4/8 <b>Cloud base:</b> 3000ft <b>Dew point:</b> 9.511°C <b>Visibility:</b> CAVOK

## AIRCRAFT ACCIDENT REPORT

**Name of Owner/Operator** : Mr P. Louw  
**Name of Operator** : Aquill

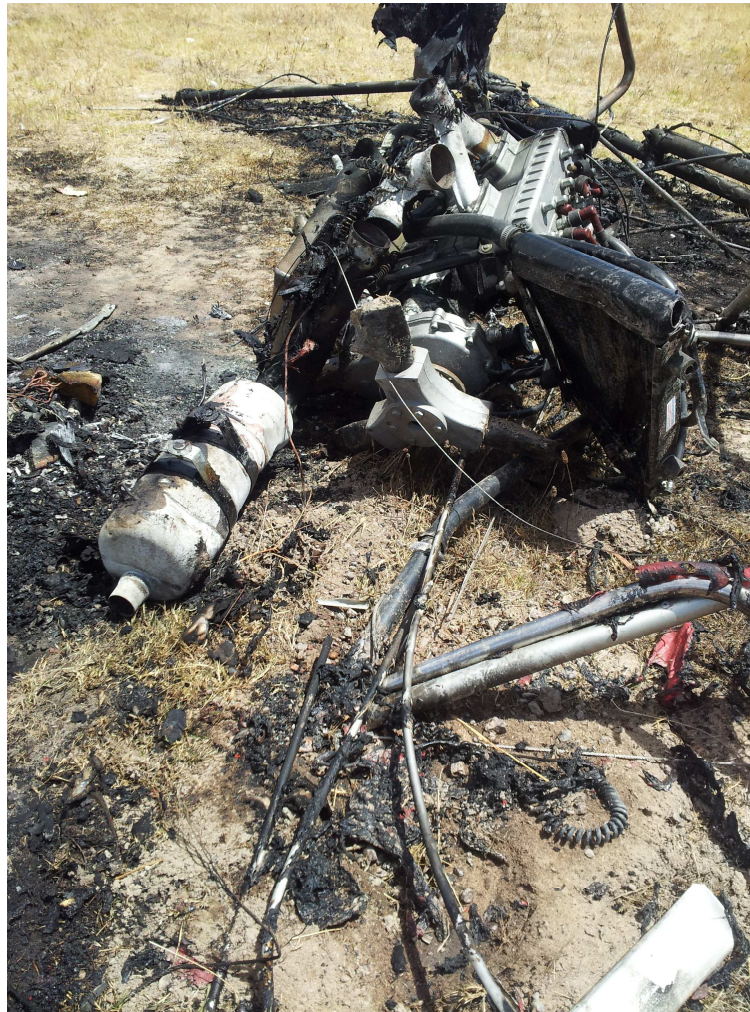
1.3.1 The microlight was consumed by the post impact fire.

Figure 1: The remains of the microlight

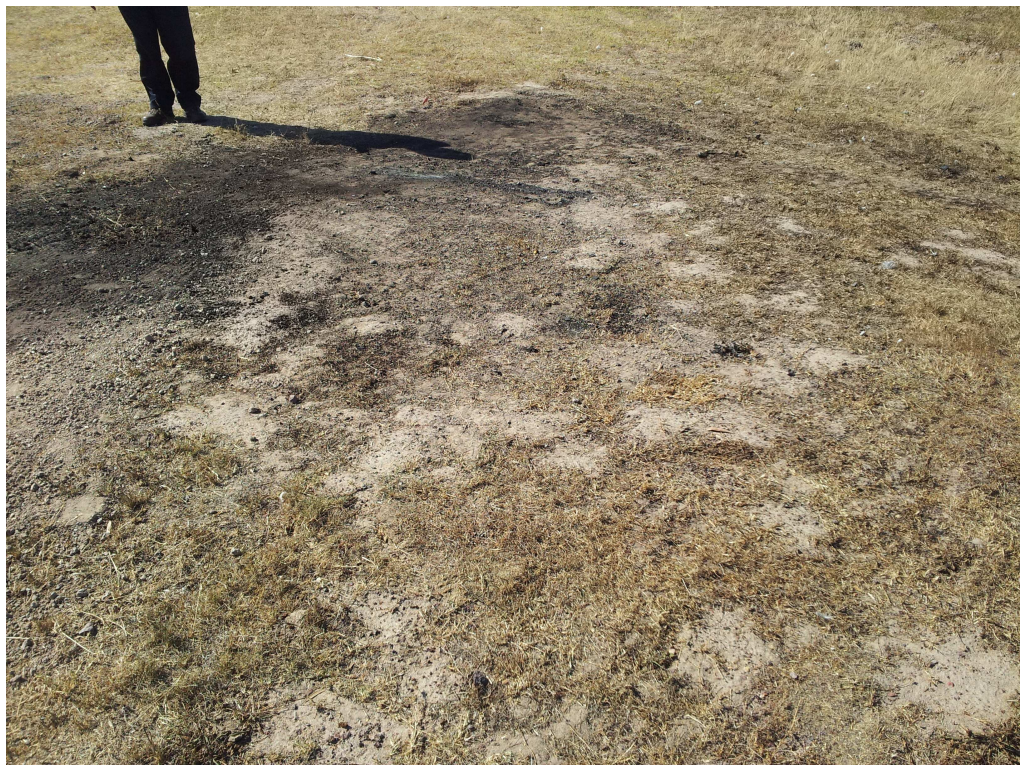
1.4.1 Fire damage was caused to the vegetation in the area of the accident.

**Figure 2: Burnt vegetation at accident site**

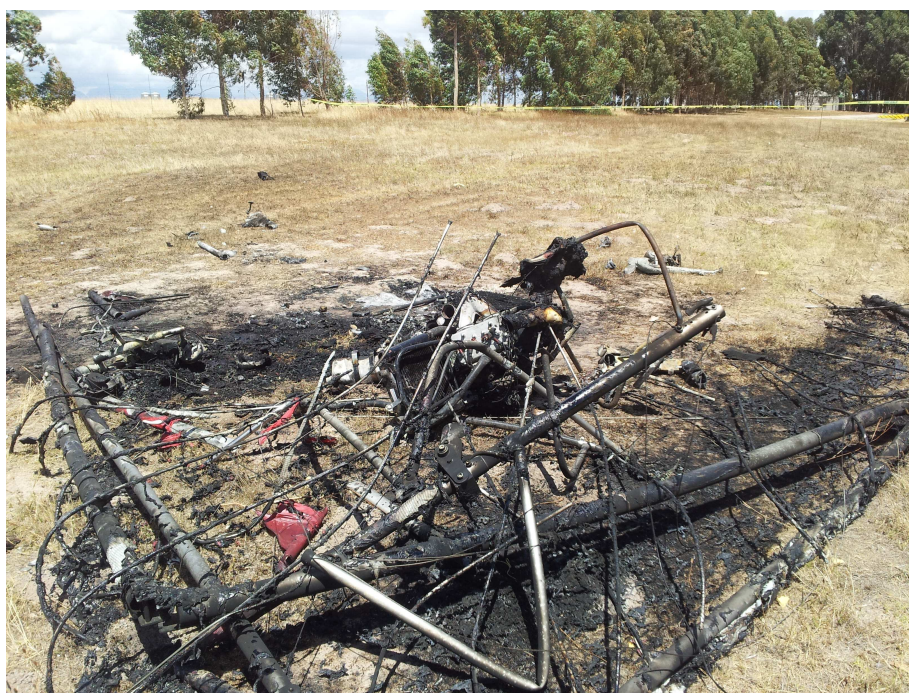
1.12.2 The microlight was completely consumed by the post-impact fire. The wreckage covered an area of 6m x 6m. The wreckage strewn on the ground was minimal and in close proximity to the main wreckage.

**Figure 5: The wreckage**

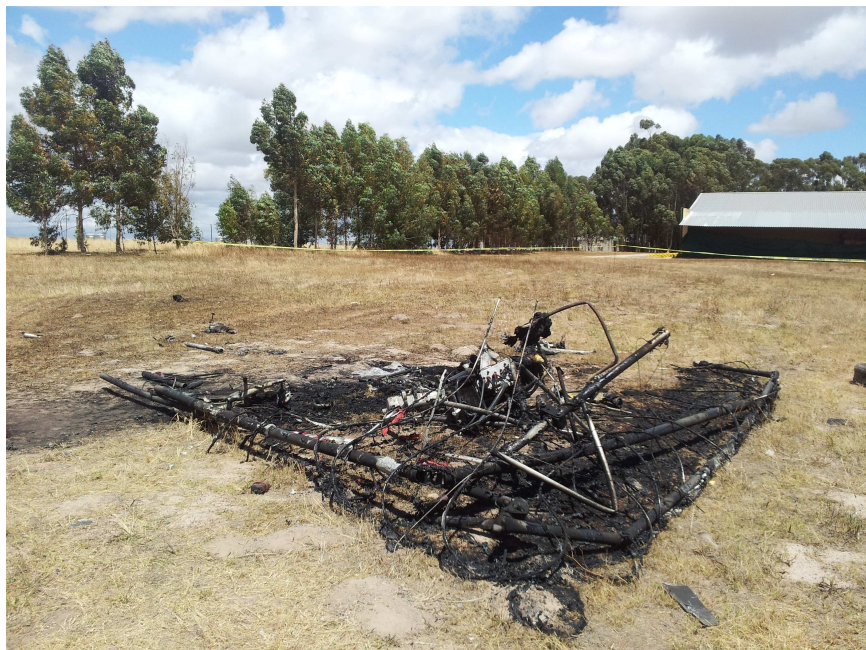
1.12.3 The accident site was a dry area of field with low vegetation of up to 20cm in height. Approximately 50m away, there is a row of tall eucalyptus trees. There are also 4 hangars to the right of the accident site.

**Figure 6: The accident site**

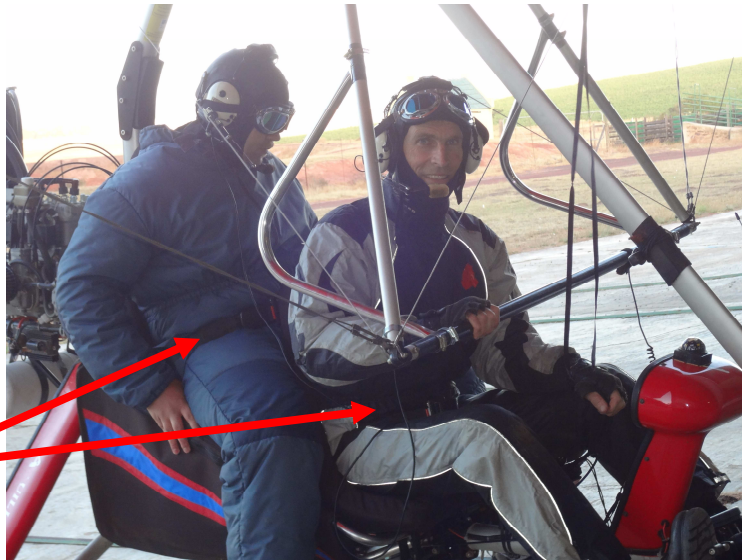
1.15.2 Although the pilot and passenger were properly restrained by the aircraft safety harnesses, the accident was not considered survivable due to high kinetic forces during the impact, as well as the post-impact fire.

**Figure 7: Secured with safety harnesses before take-off**

1.18.8 With reference being made to Figure 7, the photo clearly shows that the training bars were attached for the flight in question. These commercial flights were used as an Introduction Flight to acquire potential students for the Aviation Training School. Several witnesses confirmed that passengers did get the opportunity to take control of the aircraft once in the aircraft, if they so wished to do so.

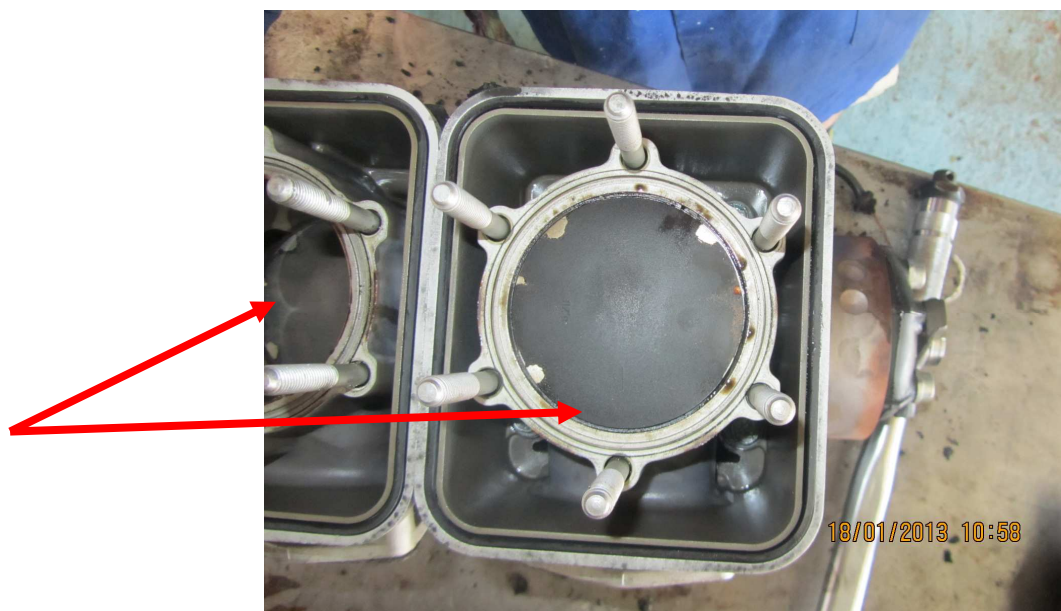
1.16.3 Severe carbon build up was found on the pistons of the engine.

**Figure 8: Carbon build-up on the pistons**

An engine strip was carried out and the general overview of the engine determined that the engine was running at a fairly high RPM on impact, as all three propeller blades were broken off near the root at the hub of the propeller. The gearbox showed no damage was sustained. Severe carbon build up found on the pistons of the engine could be an indication of a rich mixture, possibly flown with the choke being partially open.

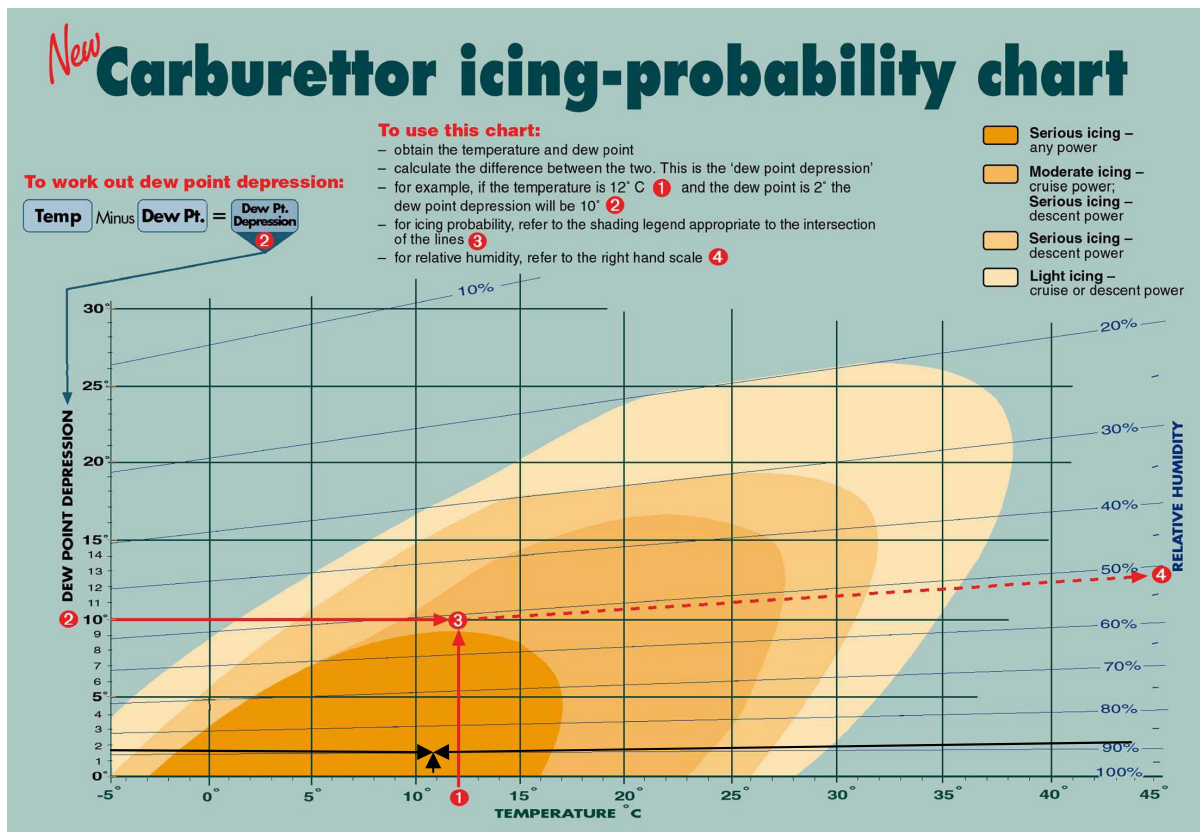
Figure 9: The Carburettor Icing-probability Chart

1.18.9 According to the weather information obtained from the SA Weather Services and the Carburettor icing chart below icing could be a possibility as it falls in the serious icing at any power category. Carb icing would have resulted in an engine not functioning 100% (Refer to the black lines on the graph below).

Temperature	11° C
Humidity	90%
Dew-point	9.5° C
Dew-point depression	1.5° C

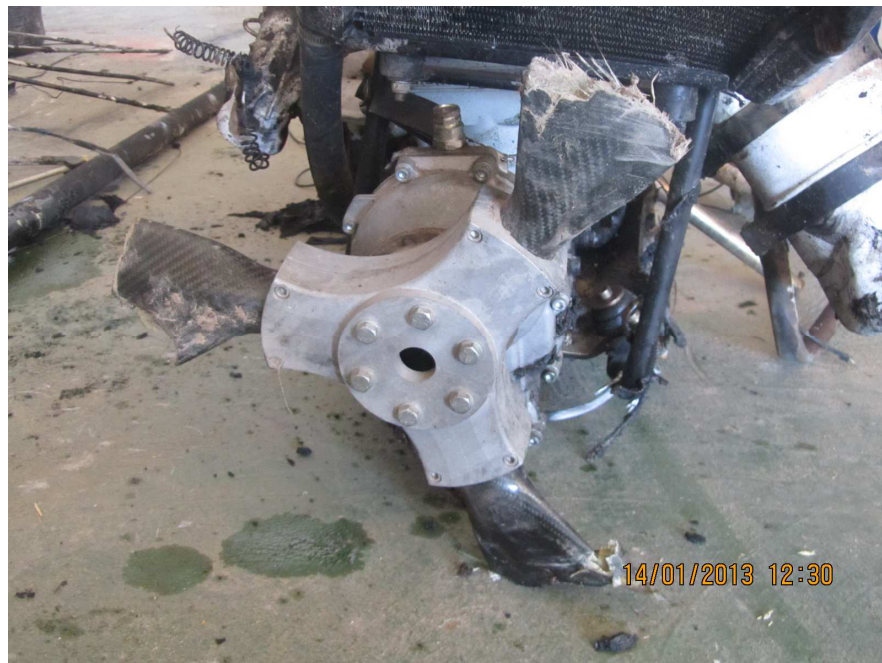
**Figure 10: The Propeller**

- 3.1.11 All control surfaces were accounted for, and the aircraft was destroyed by the severe impact forces and post-impact fire.
- 3.1.12 Propeller blade damage and twist was consistent with the engine producing power at impact.
